Field Inspection Report

Client	CNRL		Date of Inspection	March 30, 2012					
Prov. Reg.#	A0437520		Inspection Type	VE & UT					
Equipment	Dehy Tower		Location	Grand Forks					
Tag/Equip. #	V-480		LSD	10-22-012-14W4M					
Vessel Status	Not In Service		Comp./Unit #						
Manufacturer	Opsco '92 Industries Ltd		MAWP / Temp	1440 PSIG @ 120 F					
Serial #	V-2810A2	CRN #	L 0916.213	MDMT@ Pressure	-20 F @ 1440 PSIG				
Corrosion Allowance	0.125"	Shell Material	SA-516-70N	Shell Thickness	1.125"				
Year Built	1998	Head Material	SA-516-70N	Head Thickness	1.140"				
Diameter	24" OD	Length		Height	26'	RT	RT-1	HT	Yes
Service	Sour	Next Inspection		Next Insp. Type					
ASME Stamp	Yes	Next Inspection		Next Insp. Type					
PSV Tag #		CRN#		OG 2369.5C	Set Pressure	1440 PSIG			
Manufacturer	Farris			NB#		ASME Stamp			
Type/Model		Serial	44158-5-A10	Inlet Size	1.5"				
Capacity	9312 SCFM	Service Company	Tarpon	Outlet Size	2"				
Service Date	June 2010		Next Service Date

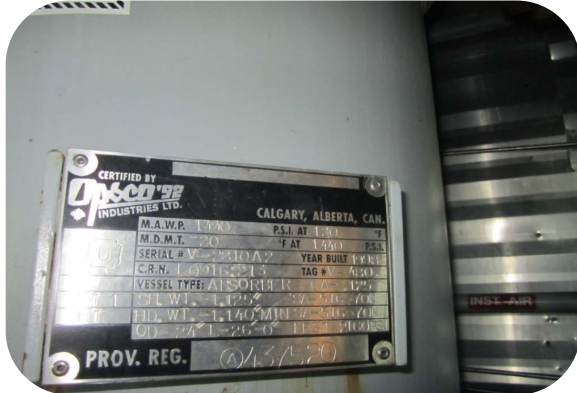
A0437520_Name plate_30Mar2012

- Name plate was attached and readable.
- External paint was in good condition with slight external corrosion present on bottom head inside the skirt in the form of rusting.

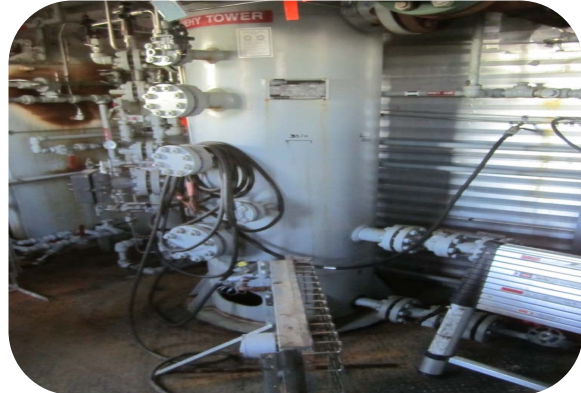
A0437520_Lower shell_30Mar2012

- No deflection or deformation of the shell, heads or nozzles.
- Shell to roof interface seal was in good shape with no corrosion noted.
- All associated piping was intact and secure.

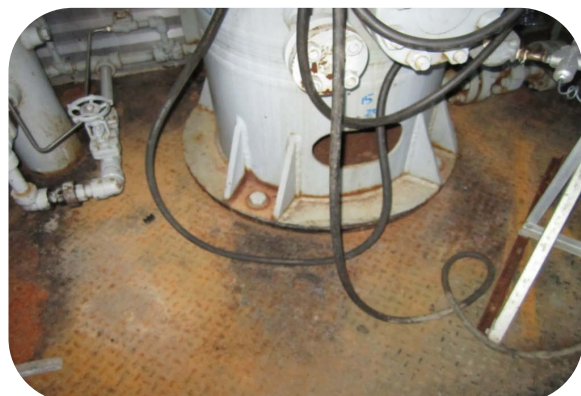
A0437520_Supported securely_30Mar2012

- Vessel is supported on a skirt, bottom head to skirt weld was in good shape.
- Skirt was bolted securely to the floor.
- All external nozzles were in good condition, no leaking flanges, gaskets, or threaded connections.
