Ultrasonic Inspection Report

Job #:	Report #:	Inspection Date:
	UT-BV-1	March 30, 2012

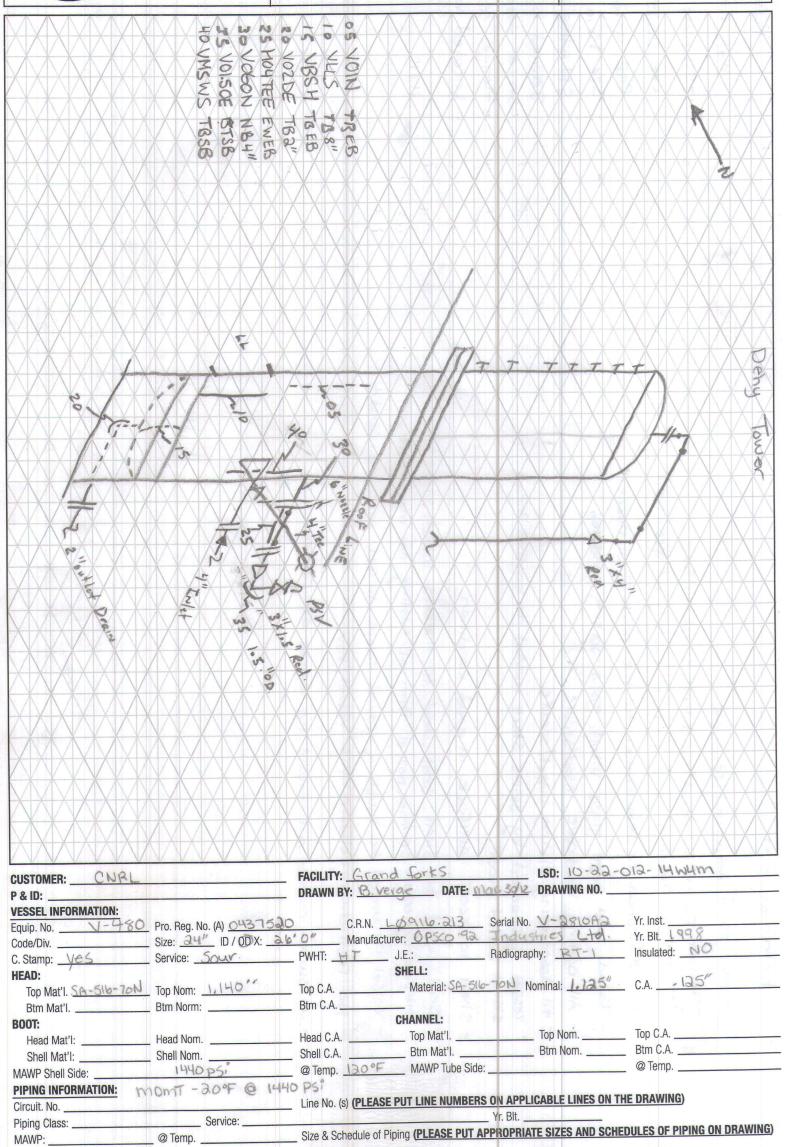
UT Readings for Dehy Tower A0437520

<u>Minimum</u>	<u>Maximum</u>	<u>Average</u>
LOC 5	1.132	1.134	1.134
LOC 10	1.133	1.149	1.135
LOC 15	1.176	1.239	1.191
LOC 20	0.388	0.408	0.388
LOC 25	0.492	0.668	0.566
LOC 30	1.044	1.076	1.049
LOC 35	0.319	0.328	0.327
LOC 40	1.13	1.131	1.131
