Canadian Natural Resources Limited GENERAL PRESSURE VESSEL INFORMATION Job # 10.112227												
District: Fort St. Jo	ohn BC.	Skid No.										
Facility: Milligan	Location (LSD): b-63-G-94-H-2											
Vessel Name Equipment Number: Glycol Contactor												
Orientation: Vertical												
			Regulatory Inspection									
Status: In Ser												
"A" or "G" o	or "S" (Sask.) or BC R	AMEPLATE DATA CRN Number:										
	N7770 01											
Vessel serial numbe	A0445902	N7770.21 Size: 24 in. X 28 ft.										
Shell thickness: 31.8	Size: 24 in. X 28 ft. Shell material: SA 516-70											
Head thickness: 30.5		Head material: SA 516-70										
Tube wall thickness		Tube material:										
Tube diameter:	•			Tube length:								
Channel thickness:				Channel material:								
Design pressure		Operating pressure		Shell:								
Design pressure	Tubes:			Tubes:								
Design Temp.	Shell: 130 Deg F.	Operating temperature		14000

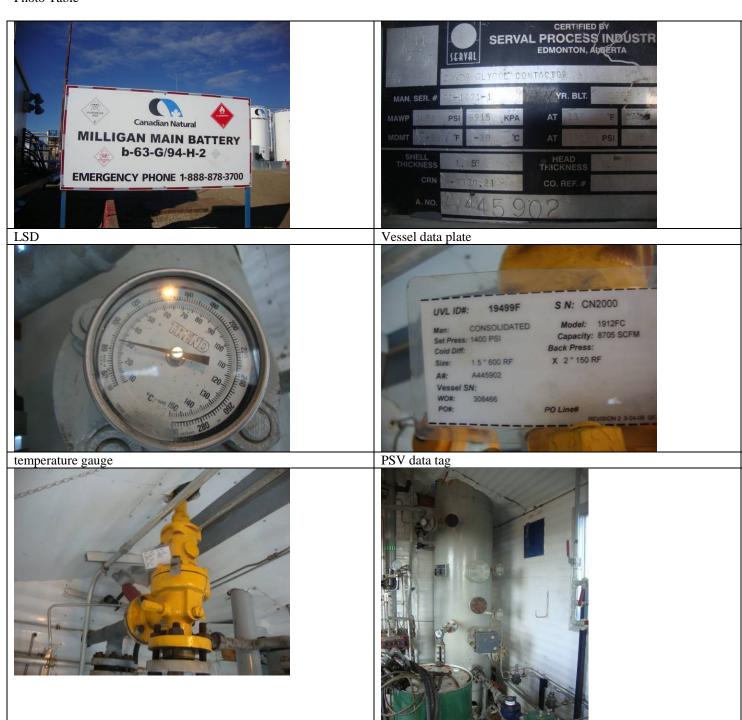
Valve: Ensure no leaks are visible. Valves are properly supported and chained if necessary.	X				Valves are supported properly – no leaks.
PSV Ensure PSV is set at pressure at or below that of vessel.	X				Location: lower shell – set below MAWP of vessel. No block valve between vessel and PSV- PSV seal in place. Discharge piping same size as valve outlet.
NDE methods Was UT/ MPI done on vessel (MI coordinator to review results)	X				Ultrasonic thickness survey carried out – no metal thickness detected below nominal minus corrosion allowance.
Other

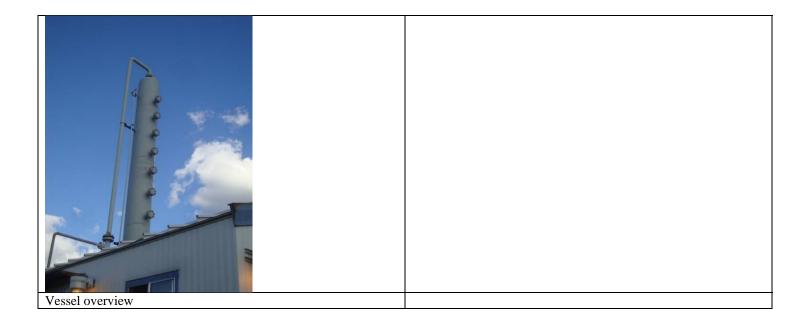
Vessel overview

Summary: Vessel is in overall good condition, visual external inspection and ultrasonic corrosion survey performed – no metal thickness detected below nominal minus corrosion allowance.
