**Canadian Natural Resources Ltd.
GENERAL PRESSURE VESSEL INFORMATION**

Job# 105.00390

District: Fort St John, BC	Skid No.
Facility: Ladyfern Compressor	Location (LSD): b-88-H/94-H-01
Vessel Name Equipment Number: Glycol Contactor	
Orientation: Vertical	
Status: In Service	Regulatory Inspection

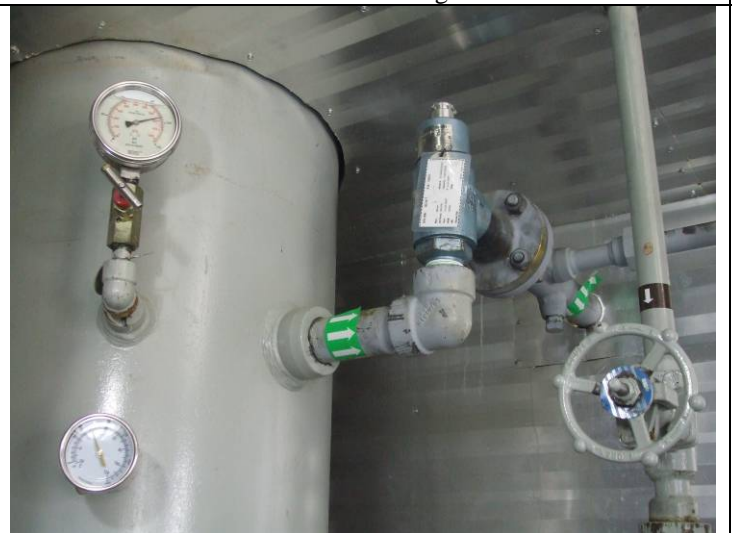
PSV location

Valving Ensure no leaks are visible. Valves are properly supported and chained if necessary.	X				Well supported – no leaks.
PSV Ensure PSV is set at pressure at or below that of vessel.	X				Located on the gas inlet piping - set at the Contactors MAWP. Discharge piping is the same size as the inlet to PSV. No block valve present. Seal is intact. PSV vents to Flare.
NDE methods Was UT/ MPI done on vessel (MI coordinator to review results)	X				Ultrasonic thickness survey carried out-no metal thickness detected below nominal minus corrosion allowance.
Other					
Recommendations or corrective actions : Vessel is Fit for Service or describe corrective actions required) (MIC to review corrective actions with Operations, discuss with Chief Inspector where necessary, and get remedial action implemented) Recommendations: 1. No recommendations at this time. Summary: This vessel is in good over all condition, visual external and ultrasonic thickness survey carried out-no metal thickness detected below nominal minus corrosion allowance. Vessel is fit for service.
