**Canadian Natural Resources Limited
GENERAL PRESSURE VESSEL INFORMATION**

Job 10.180192

District: Grande Prairie, Ab.		Skid No.					
Facility: Thunder Creek Compressor Station		Location (LSD): d-31-H/93-I-15					
Vessel Name & Equipment Number: Glycol Contactor							
Orientation: Vertical							
Status: Not in Operation.		Regulatory Inspection					
PRESSURE VESSEL NAMEPLATE DATA							
"A" or "G" or "S" (Sask.) or BC Registration Number. A0506261		CRN Number P 5021.213					
Vessel serial number: 2004 -7204 -01A		Size: 24 in. OD x 30 ft. S/S					
Shell thickness: 25.4 mm		Shell material: SA 516 70 N					
Head thickness: 23.8 mm		Head material: SA 516 70 N					
Tube wall thickness:		Tube material:					
Tube diameter:		Tube length:					
Channel thickness:		Channel material:					
Design pressure	Shell: 9929 kPa	Operating pressure	Shell:				
	Tubes:		Tubes:				
Design Temp.	Shell: 54°C	Operating temperature	Shell:				
	Tubes:		Tubes:				
X-ray: RT 1		Heat treatment: HT					
Code parameters: ASME VIII / Div 1		Coated: No

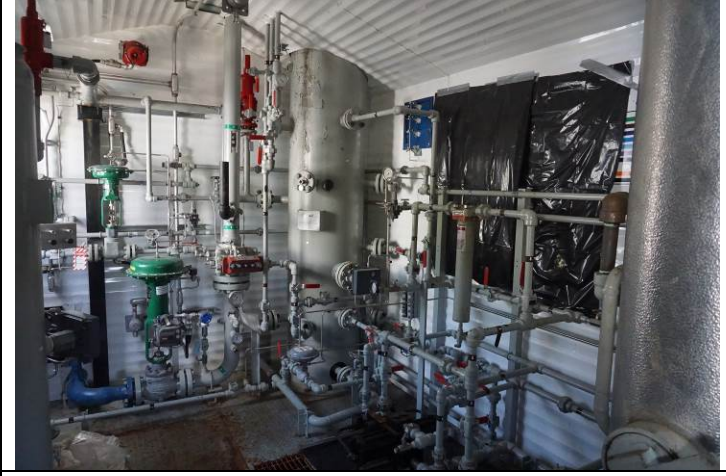
Vessel overview

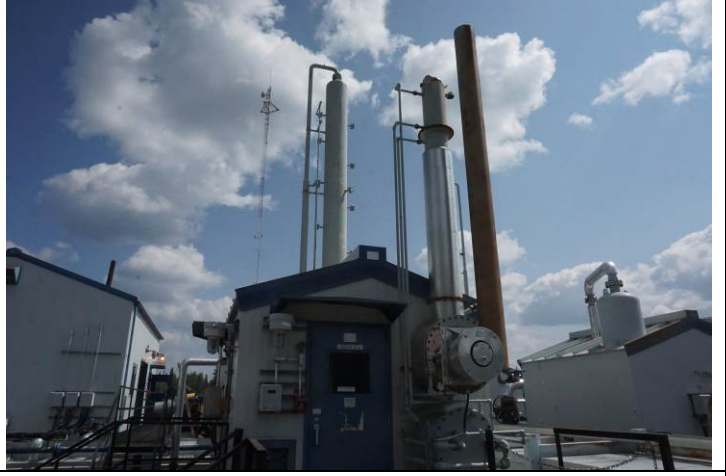
Vessel overview

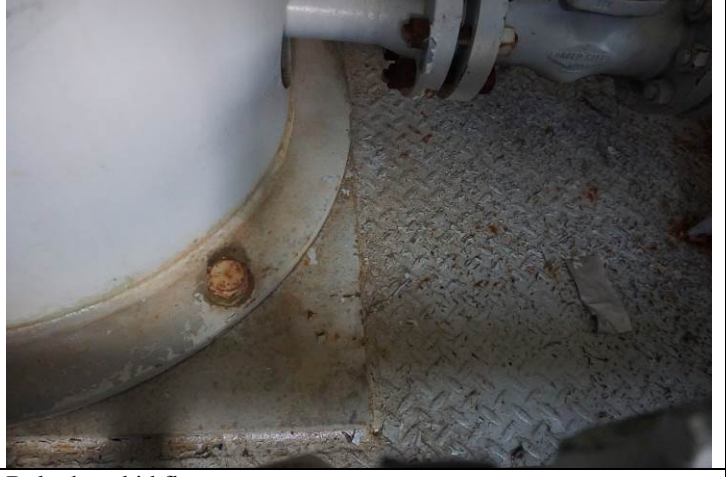
External Inspection Items	G	F	P	N/A	Comments
Insulation: Verify sealed around manways, nozzles, no damage present, and there is no egress of moisture.				X	Vessel is not insulated.
External Condition: Assess paint condition, areas peeling, record any corrosion, damage, etc (record location, size and depth of corrosion or damage)	X				Paint in fair condition – no exposed metal.
Leakage: Record any leakage at flanges, threaded joints, weep holes on repads, etc.	X				No leaks detected.
Skirt: Assess condition of paint, fire protection, concrete. Look for corrosion, buckling, dents, etc. Look at vessel surface area near supports. Verify no signs of leakage at attachment to vessel and attachment welds are acceptable. Ground wire attached?	X				Skirt: Separator is mounted firmly to skid deck, no distortion or buckles. No corrosion at head to shell weld – no leaks. Skid Package is grounded.
Anchor Bolts: Hammer tap to ensure secure. Look for cracking in treads or signs of deformation.	X				Firmly bolted to skid deck.

Bolted to skid floor

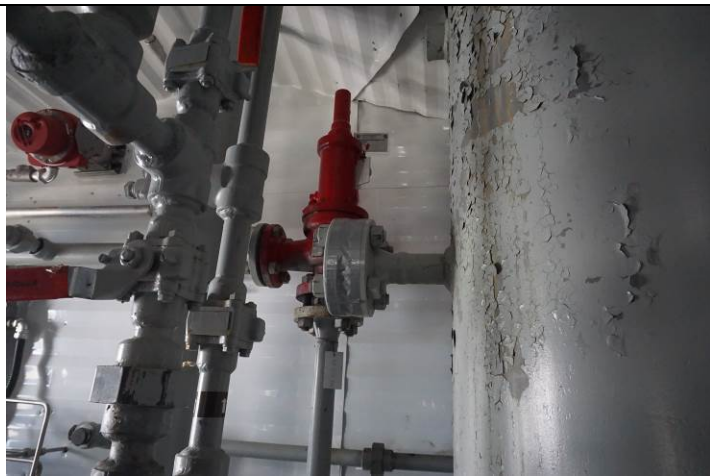
PSV: Ensure PSV is set at pressure at or below that of vessel.					Located on lower shell, set below MAWP of vessel. Seal is intact. No block valve. Discharge piping is same size as outlet orifice.
NDE methods: Was UT/ MPI done on vessel (MI coordinator to review results)	X				Ultrasonic thickness survey carried out – pipe metal thickness detected below nominal minus corrosion allowance. Thickness calculations carried out: UT point 2220 (2” circ nozzle) – nominal thickness is 11.1mm / min thickness is 7.8mm / T min thickness is 2.5mm.
Other:					Vessel is not operating at time of inspection – no blinds removed.
<p>Recommendations or corrective actions: (Vessel is Fit for Service or describe corrective actions required) (MIC to review corrective actions with Operations, discuss with Chief Inspector where necessary, and get remedial action implemented)</p> <p>Recommendations: No recommendations at this time.</p> <p>Summary: This vessel is in good condition, visual external and ultrasonic thickness inspection carried out – pipe metal thickness detected below nominal minus corrosion allowance. Thickness calculations carried out to ensure sufficient metal exists for safe operation.</p> <p>Corrosion rate based on greatest thickness loss (nozzle) 0.021mm per year. Retirement Date to “T”min is year 2265. Vessel is fit for Service.</p>

PSV
