Client	Petronas Energy Canada Ltd.	Inspection Date	Nov 4, 2014		
Prov. Reg. #	AB 0586305 BC BPV-048528	Inspection Type	VE / UT		
Equipment Type	Glycol Contactor	Location	Graham		
Tag/Equip.		LSD	AB C-087-F/094-B-08		
Status	Not In Service	Downhole LSD			
Manufacturer	lfc Industrial Fabrication Corporation	Area	Cypress A		
Serial Number	18089-01	Year Built	2007		
CRN #	U0772.21	Service	Sweet		
Comp/Unit Id	Dehy #1	Manway	None		
Nat.Board #		Coating	No		
Interim Insp'n		Interim Type			
Next Thorough Insp		Next Insp Type	VE / UT		
Length		Height			
Volume		Client Reference	1006102		
Owner	Petronas Energy Canada Ltd.	RT	1	HT	YES
Foreman	SBU	RAE Job No.	4934		
ABSA	Plant: H Vessel: P Process: G Special: B	ASME	Sec. VIII div. 1		
History Log	BC Design Registration - dated February 18, 2009 - entered December 8, 2017. PSV Service Report - dated October 14, 2014

RAE Engineering and Inspection Ltd 4810 - 93 Street Edmonton, AB, T6E 5M4 ph: 780-469-2401 fx: 780-468-2422	Inspection Date:	4-Nov-14	Ultrasonic Thickness Examination
		Page:	1 of 4	
Client:	Progress	RAE Report #:	14-4934-LC-UT-05	
Address:	Suite 1200, 205-5th Ave, SW, Calgary, T2P2V7	Project #:	4934	
Client P.O.#:	NS	Location/LSD

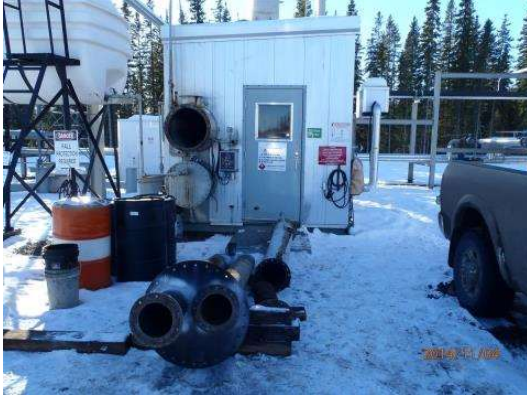
Figure: 1

The building was generally in serviceable condition and well supported. The building was well lit. The checker plate metal floor was clean and in serviceable condition. The doors and windows functioned well and were in serviceable condition. The cladding was generally in serviceable condition. There were no combustibles in the building. There was generally good access to the equipment in the building. The building structure was level. The ground wire was securely attached to the building structure. The building was supported by pilings. The building roof was leaking around the vessel seal.

Building Overview

1. Fix roof seal around the vessel.

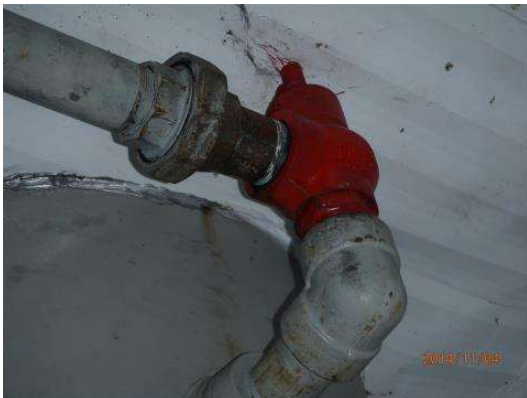
Figure: 2

The PSV was located on associated piping within the building. The PSV was mounted in the vertical position, securely attached to the piping, and in serviceable condition. The nameplate was securely attached and legible. The set pressure was acceptable for the vessel. The service tag was securely attached. The PSV seal wire was attached and intact. The vent size was adequate and vent lines were positioned safely. The outlet piping provided positive drainage for the PSV. There were no valves on the PSV piping.

PSV Overview

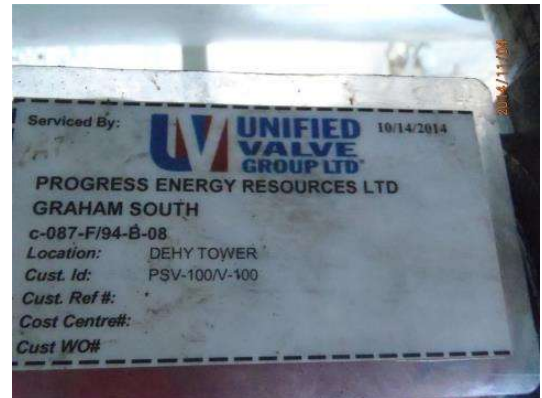
Figure: 3

PSV Service Tag

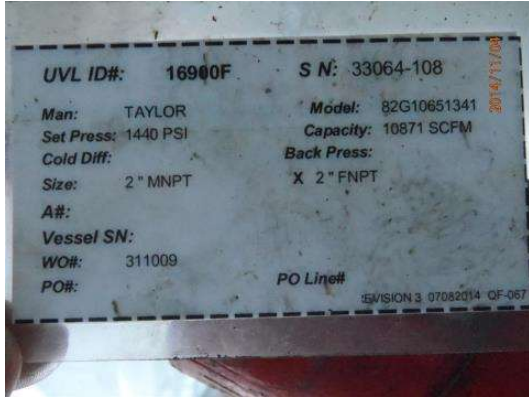
Figure: 4

PSV Service Tag 1

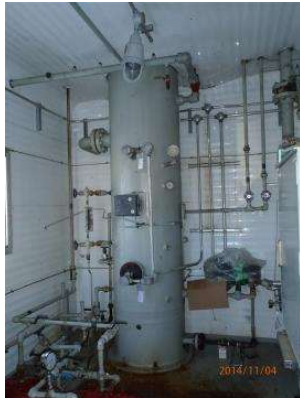
Figure: 5

The vessel is located partially inside a building. The nameplate was legible and securely mounted to the vessel. The heads and shell appeared to be in serviceable condition. The vessel is not insulated. The vessel was fully painted and the paint was in serviceable condition. There was minor scattered corrosion visible on the vessel surfaces. There was no damage, distortion, or stress evident on piping connections. The vessel was vertical and adequately supported by a skirt which was bolted to the floor. There are no structural attachments on vessel.

Vessel Overview

The vessel appeared suitable for continued service.

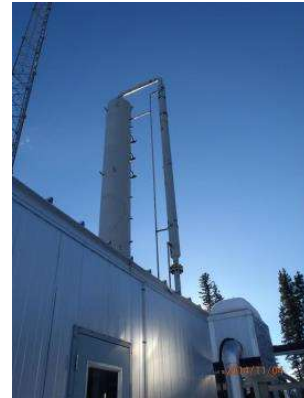
Figure: 6

Vessel Overview 1

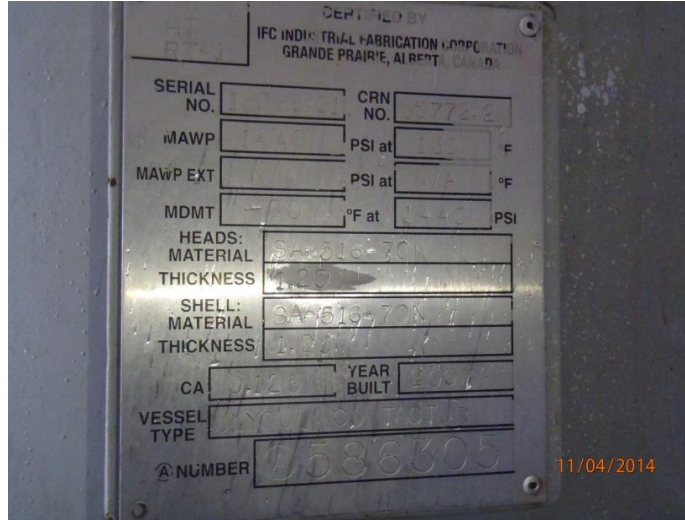
View of Nameplate

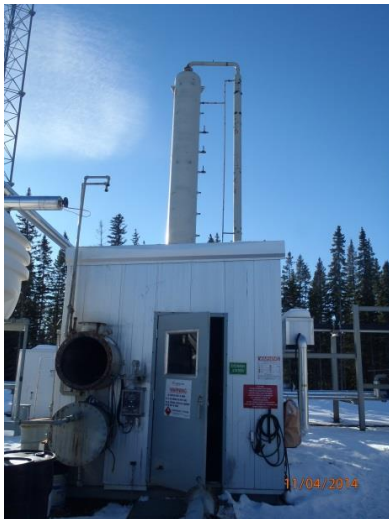
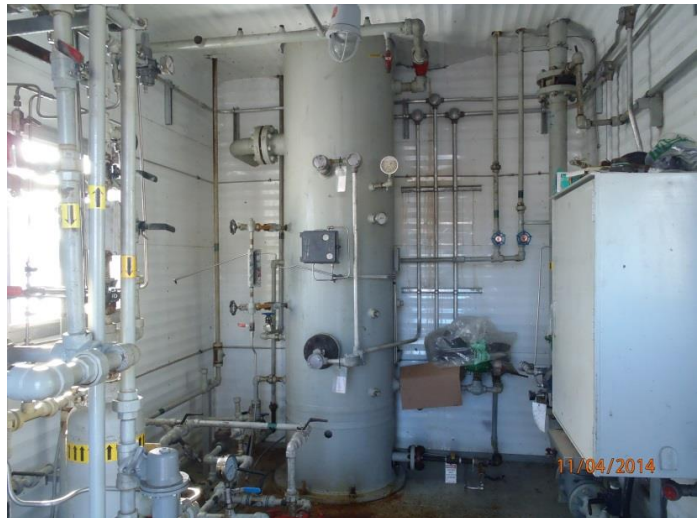
Overall View of Equipment

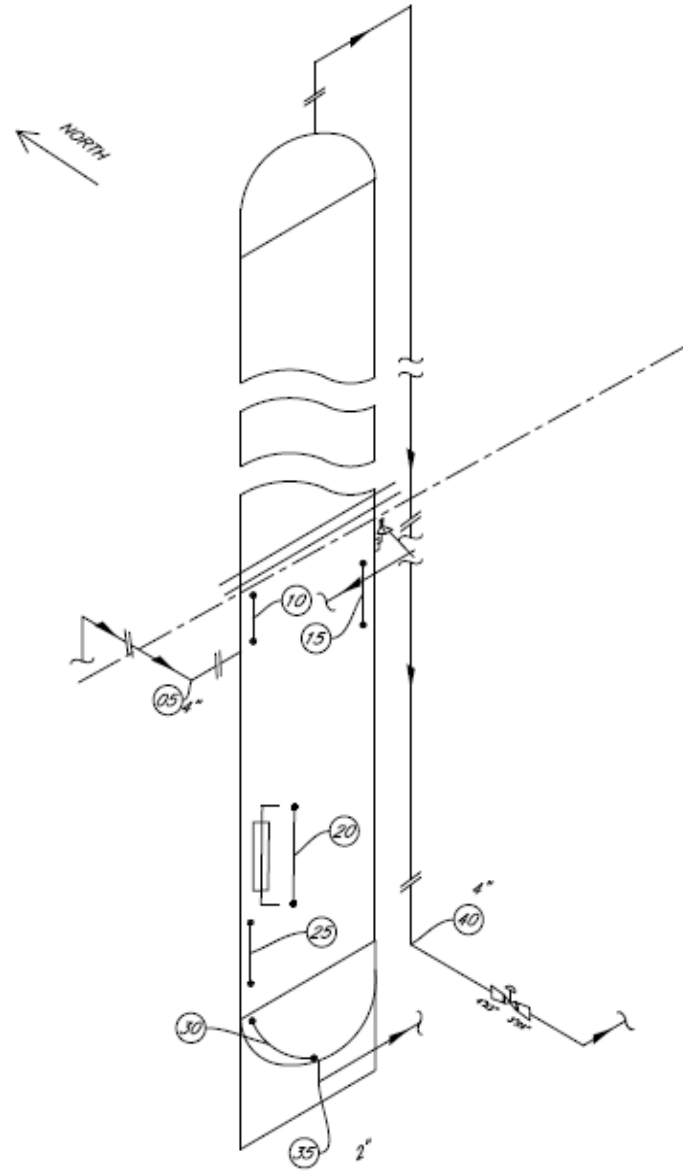
Glycol Conductor (586305)

Results: The measurements obtained from the inspection locations show the thickness of all of the components inspected to be at or around nominal. There were no signs of wall thinning, internal corrosion, erosion, laminations or inclusions at the time of inspection. All piping measurements were within the 12.5% mill tolerance, as per ASTM specifications.
