**Canadian Natural Resources Limited
GENERAL PRESSURE VESSEL INFORMATION**

Job# 10.111397

District: Fort St. John North	Skid No.
Facility: North Nig Compressor	Location (LSD): b-97-H/94-H-04
Vessel Name Equipment Number: Glycol Contactor	
Orientation: Vertical	
Status: In Service	Regulatory Inspection

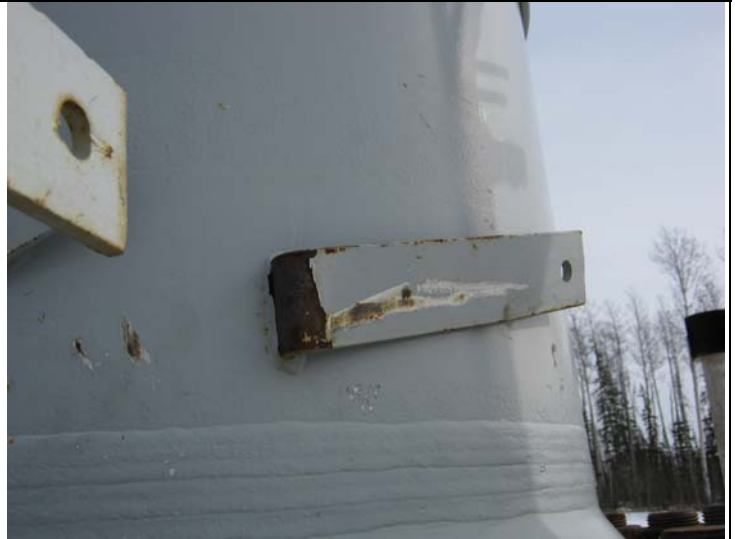
Ladder Support bent – bolts missing

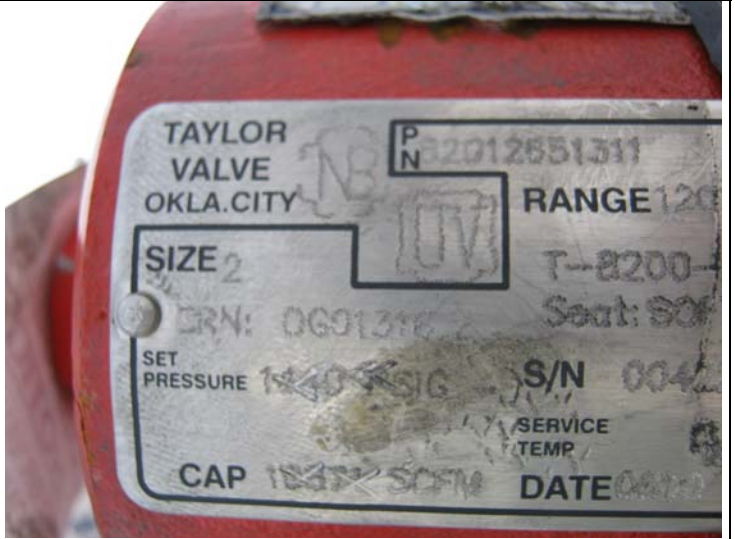
Valving Ensure no leaks are visible. Valves are properly supported and chained if necessary.		X			Valves are properly supported – No leaks
PSV Ensure PSV is set at pressure at or below that of vessel.	X				Located on upper shell – set below the vessel MAWP - No block valve present - Seal is intact - PSV vents to closed header.
NDE methods Was UT/ MPI done on vessel (MI coordinator to review results)	X				Ultrasonic thickness survey carried out-no metal thickness detected below nominal minus corrosion allowance.
<p>Recommendations or corrective actions : Vessel is Fit for Service or describe corrective actions required) (MIC to review corrective actions with Operations, discuss with Chief Inspector where necessary, and get remedial action implemented)</p> <p>Recommendations: Summary: This vessel is in good over all condition, visual external and ultrasonic thickness survey carried out-no metal thickness detected below nominal minus corrosion allowance. Long term corrosion rate based on greatest thickness loss (shell) 0.056mm per year. Retirement Date to “T”min is year 2084.</p> <p>Vessel is fit for service.</p>
