**Canadian Natural Resources Limited  
GENERAL PRESSURE VESSEL INFORMATION**

**Job # 10.112195**

District: <b>Fort St. John BC.</b>	Skid No.
Facility: <b>Jedney</b>	Location (LSD): <b>A-62-E-94-G-8</b>
Vessel Name Equipment Number: <b>Flare Knockout Drum</b>	
Orientation: <b>Horizontal</b>	
Status: <b>In Service</b>	<b>Regulatory Inspection</b>

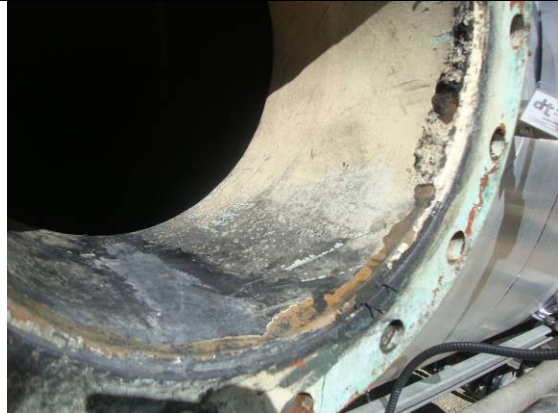
<b>Internal Inspection Items</b>	<b>G</b>	<b>F</b>	<b>P</b>	<b>N/A</b>	<b>Comments</b>
<b>Coating</b> Assess coating. Describe area coated, general condition of coating.	X				<b>Coating in man way peeling and outlet nozzle. Corrosion on exposed metal.</b>
<b>Anodes.</b> How many, type, condition. % consumed. Are they being replaced?				X	<b>No anodes in vessel</b>
<b>Internal Piping</b> Is there any? If so, carbon or stainless steel. Describe condition, dents, corrosion, erosion, etc. Ensure supports are secure and any bolts are suitable for future use.	X				<b>Heat medium coil in place and clamped securely. No deflections or dents. Coating blistered and peeling from coil – corrosion on exposed metal.</b>
<b>Trays</b> How many? Type of material. Are valves in place. Check for erosion/ corrosion; wear on tray valve legs. Cleanliness?				X	<b>No trays</b>
<b>Baffles, deflector plates, etc.</b> If present, describe condition. Look closely at welds attached to vessel wall.	X				<b>Inlet deflector plate welded to head – no mechanical damage. No erosion or corrosion- coating in place.</b>

Coating peeling in man way

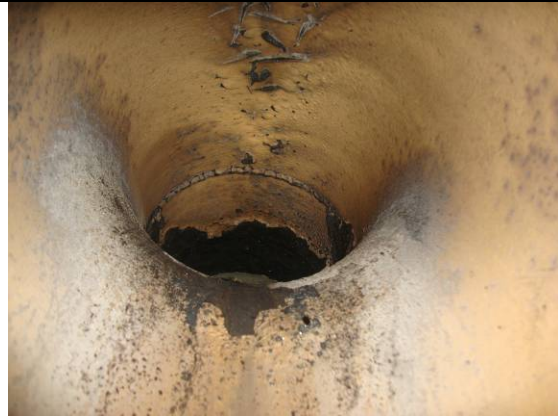
<b>Top Head</b> Note all corrosion, erosion or mechanical damage. (If vessel is horizontal identify direction of this head)	X				<b>East head – No mechanical damage or peeling coating.</b>
<b>Bottom Head</b> Note all corrosion, erosion or mechanical damage. (If vessel is horizontal identify direction of this head)	X				<b>West head – heat medium coil piping welded to head- no corrosion or service related damages.</b>
<b>Shell Sections</b> Record number of shell sections. Record location, size and depth of all erosion, corrosion or mechanical damage. Describe general condition. If any corrosion greater than corrosion allowance is observed in either shell or head, discuss with Chief Inspector before closing vessel.	X				<b>Shell in good condition –No mechanical damage. Man way coating peeling to 50% of area – corrosion pitting on exposed metal – pit depth of .005”. Level floats operational. Nozzles are clear- outlet nozzle peeling to 80% of area- corrosion on exposed metal.</b>

Coating peeling in outlet nozzle

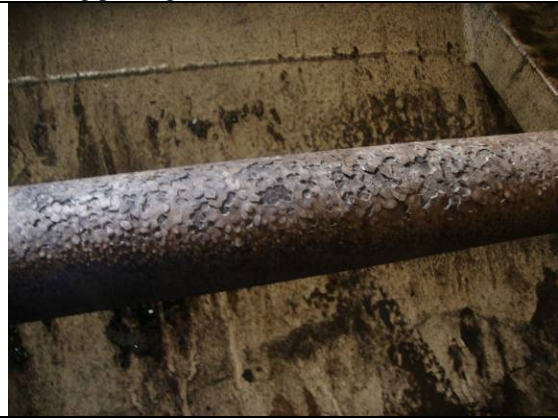
Coating blistered on heat medium piping
