District: Fort St. John BC. Skid No.							
	Skid No.						
Facility: Jedney Gas Plant Location (LSD): a-62-E/94-G-8							
• •							
Vessel Name Equipment Number: Flare Knockout Drum							
Orientation: Horizontal							
Status: In Service Regulatory Inspection PRESSURE VESSEL NAMEDIATE DATA							
*A" or "G" or "S" (Sask.) or BC Registration Number. CRN Number:							
A of G of S (Sask.) of BC Registration Number.	CKN Number.						
C 35076 None code							
	Size: 72 in. x 12 ft.						
	Shell material: SA 516 70N						
	Head material: SA 516 70N						
	Tube material:						
Tube diameter: Tube length:							
	Channel material:						
Design pressure Shell: 14.7 PSI Operating pressure Shell:	Shell:						
Tubes: Tubes:	Tubes:						
Shell: 100 Deg F Operating temperature Shell:	Shell:						
Design Temp. Tubes: Operating temperature Tubes:	Tubos						
	Heat treatment: Nil						
Code parameters: Non Code Coated: No

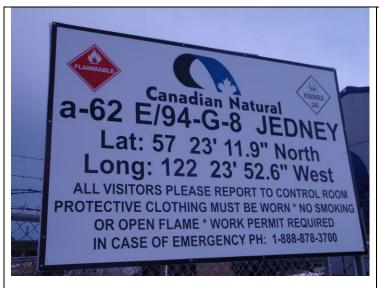
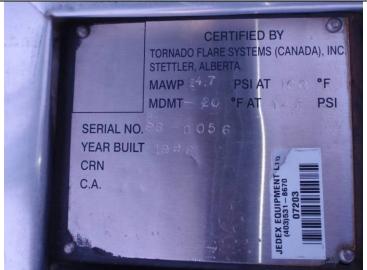
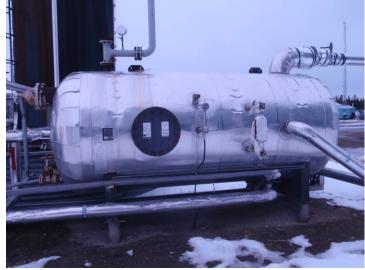
Summary: Vessel is in overall good condition, visual external inspection and ultrasonic corrosion survey performed— no metal thickness detected below nominal minus corrosion allowance.

vessel overview

Vessel is fit for service.
