**Canadian Natural Resources Limited
GENERAL PRESSURE VESSEL INFORMATION**

Job # 05.003187

District: Fort St. John, BC	Skid No.
Facility: North Jedney	Location (LSD): a-62-E/94-G-8
Vessel Name Equipment Number: Flare Knockout Drum	
Orientation: Horizontal	
Status: In Service	Regulatory Inspection

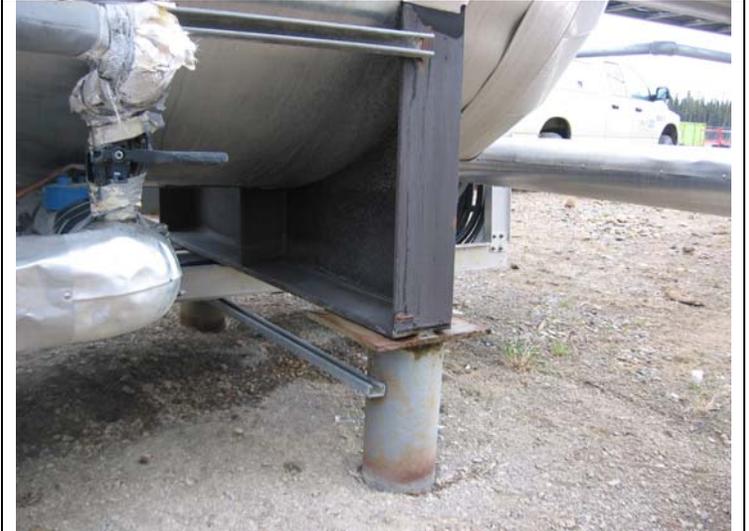
Saddle/Pilings

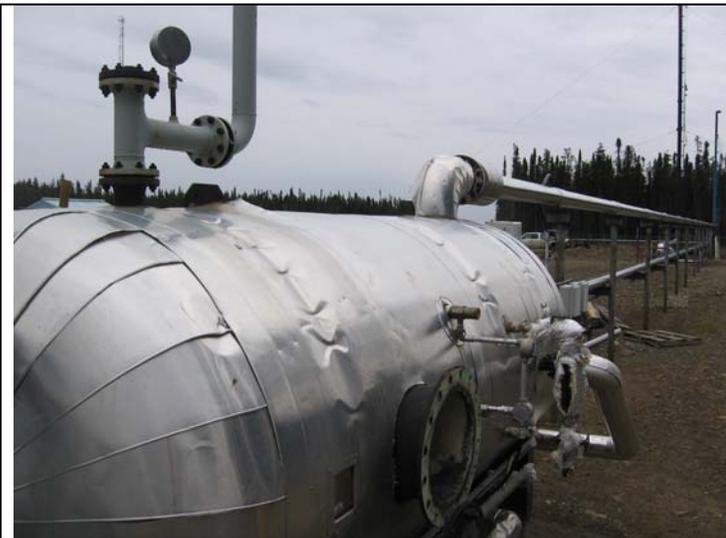
External Inspection Items	G	F	P	N/A	Comments
Insulation Verify sealed around manways, nozzles, no damage present, and there is no egress of moisture.	x				100 % insulated vessel Minor damage/buckling to cladding Cladding not sealed at manway and Hoisting Lug
External Condition Assess paint condition, areas peeling, record any corrosion, damage, etc (record location, size and depth of corrosion or damage)	x				
Leakage Record any leakage at flanges, threaded joints, weep holes on repads, etc.	x				No signs of leakage
Saddle/skirt Assess condition of paint, fire protection, concrete. Look for corrosion, buckling, dents, etc. Look at vessel surface area near supports. Verify no signs of leakage at attachment to vessel and attachment welds are acceptable. Ground wire attached?	x				Saddle is in good condition with no signs of buckling or distortion. Saddle is mounted onto piling platforms with stitch welding Vessel is grounded to pilings/saddle

Buckling of Cladding

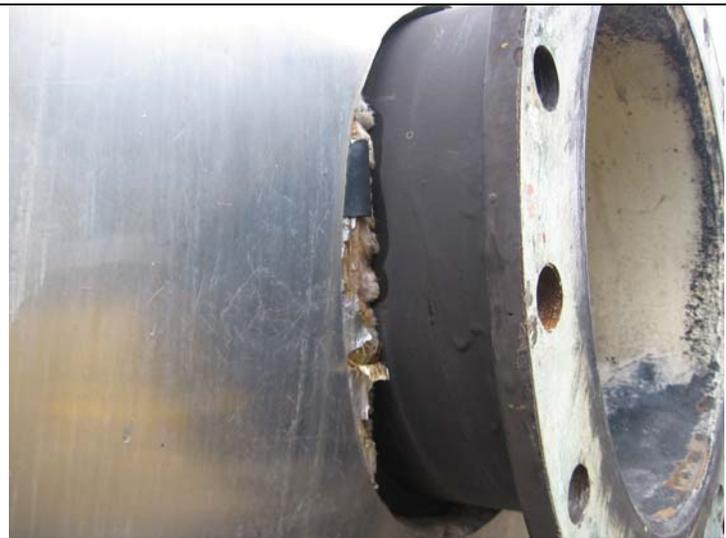
Cladding at Manway not sealed

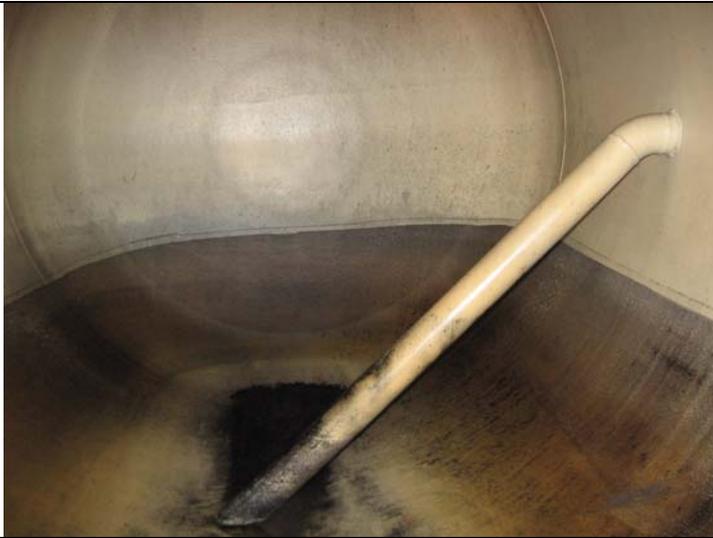
South head and suction piping

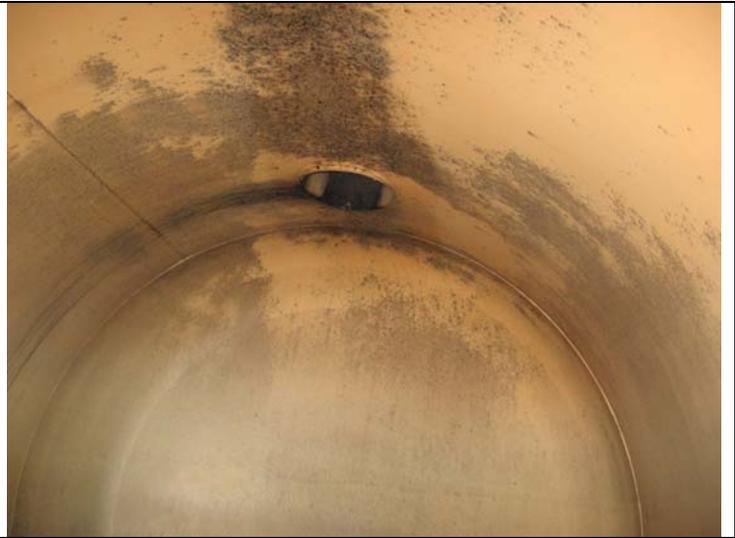
South Head and Outlet Nozzle

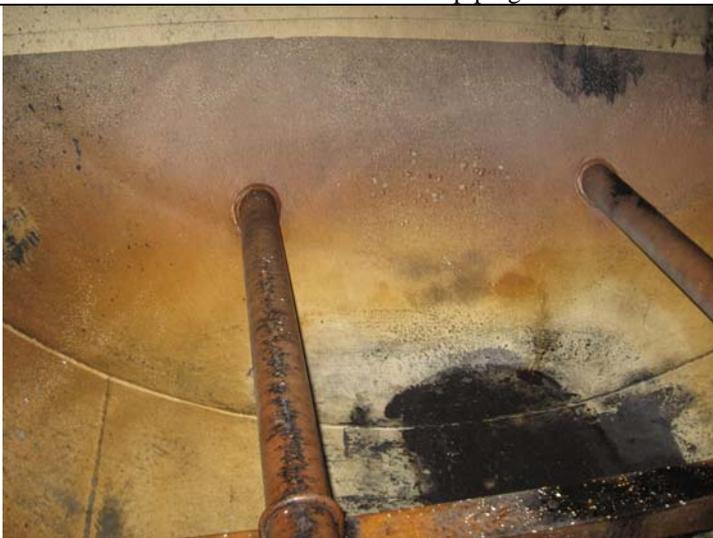
North Head and Heating Pipe Loop

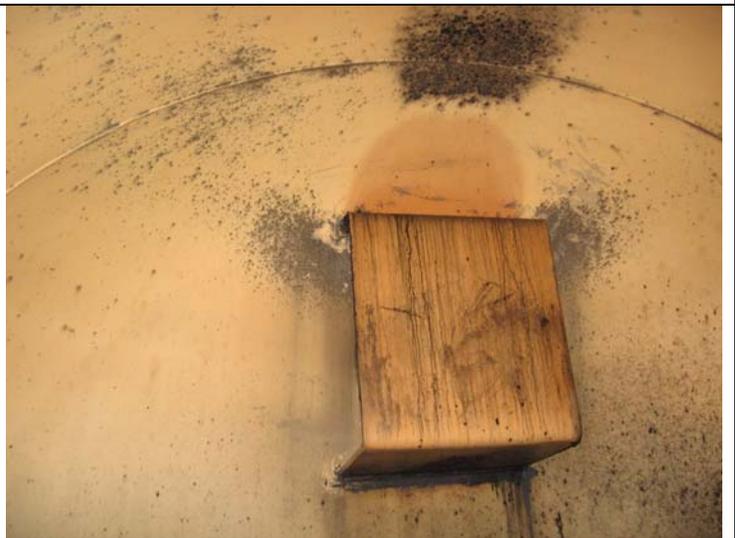
North Head and Inlet Deflector Plate

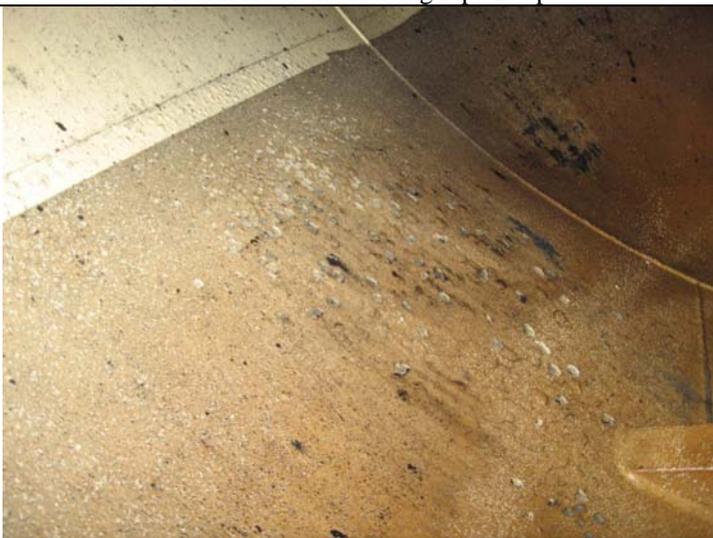
Internal Inspection Items	G	F	P	N/A	Comments
Coating Assess coating. Describe area coated, general condition of coating.	X				Vessel is 100 % coated with previous patch repairs. Minor erosion of coating on shell area and Manway. See pictures
Anodes. How many, type, condition. % consumed. Are they being replaced?				X	
Internal Piping Is there any? If so, carbon or stainless steel. Describe condition, dents, corrosion, erosion, etc. Ensure supports are secure and any bolts are suitable for future use.	X				2 inch steam coil (carbon) well supported with no signs of deflection. Coating has minor erosion. See pictures
Trays How many? Type of material. Are valves in place. Check for erosion/ corrosion; wear on tray valve legs. Cleanliness?				X	
Baffles, deflector plates, etc. If present, describe condition. Look closely at welds attached to vessel wall.	X				One deflector plate at inlet. Plate is well coated. Welds are in good condition.

Coating Damage – lower west shell

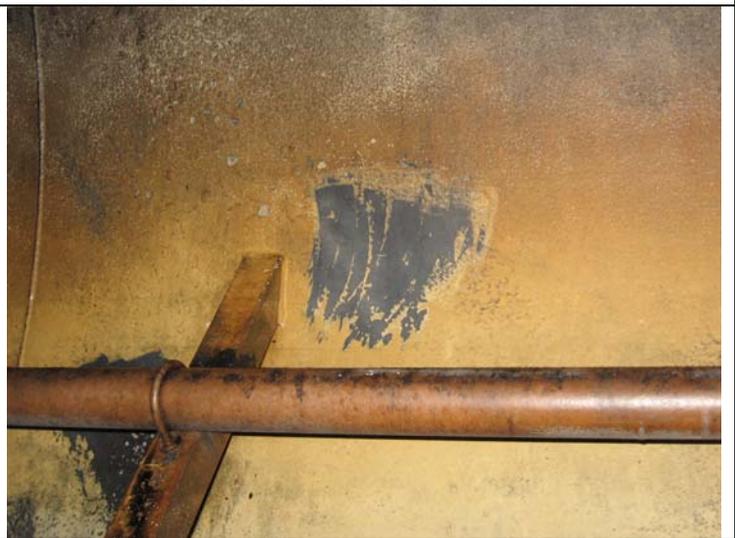
Minor Coating Damage and patching – lower east shell

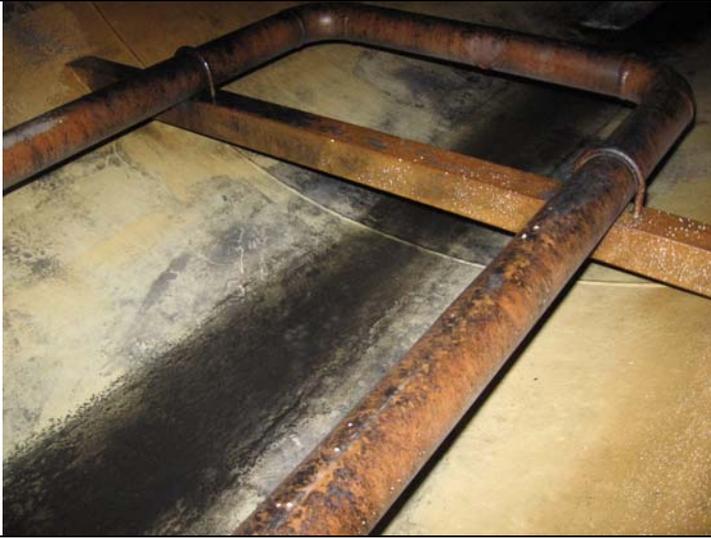
Heating Pipe Loop – Mounting Secure

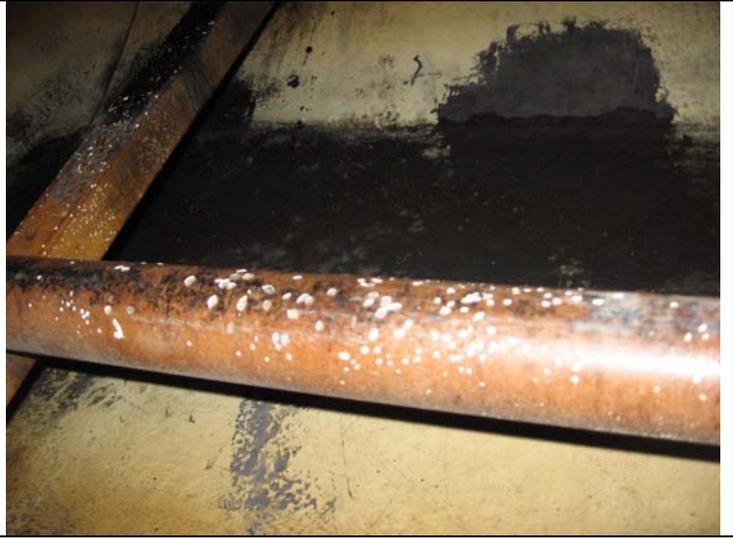
Coating chipped on piping

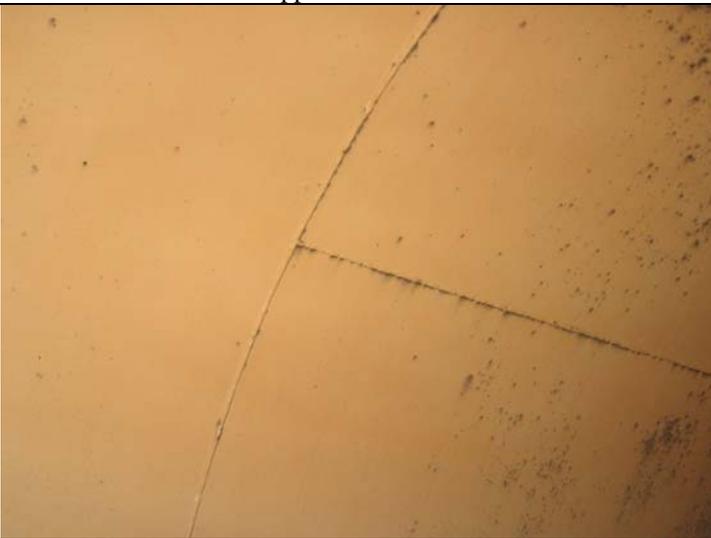
Shell welds

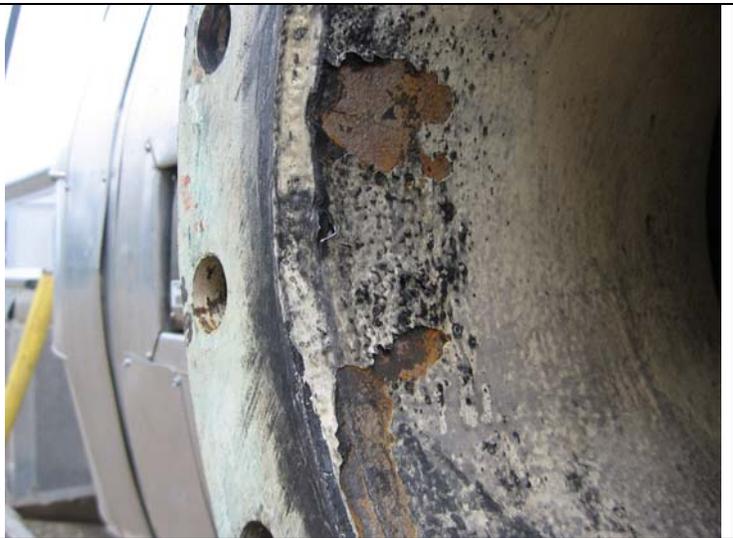
Coating Damage at Manway
