**Canadian Natural Resources Limited  
GENERAL PRESSURE VESSEL INFORMATION**

**Job# 10.113785**

District: <b>Fort St John, BC</b>	Skid No.
Facility: <b>West Blueberry Battery</b>	Location (LSD): <b>12-29-88-25-W6M</b>
Vessel Name Equipment Number: <b>Flare Knock out Drum</b>	
Orientation: <b>Horizontal</b>	
Status: <b>In Service</b>	<b>Regulatory Inspection</b>

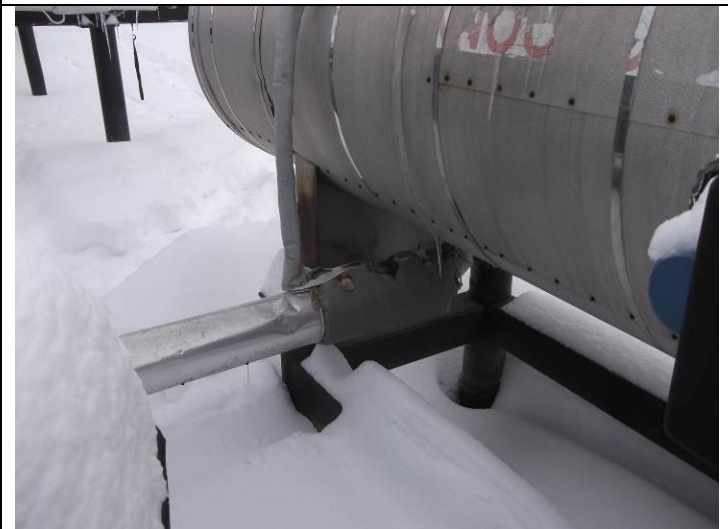
Base

<b>Anchor Bolts</b> Hammer tap to ensure secure. Look for cracking in treads or signs of deformation.	X				<b>Saddle welded to skid frame.</b>
<b>Concrete foundation</b> Check for cracks, spalling, etc.				X	
<b>Ladder / Platform</b> Describe general condition, ensure support is secure to vessel, and describe any hazards.				X	
<b>Nozzle</b> Assess paint, look for leakage, and ensure stud threads are fully engaged. Record any damage, deflection, etc. Are nozzles gusseted?	X				<b>Stud threads are fully engaged to nuts. No leaks observed. No damage or deflections. Nozzles are not gusseted</b>
<b>Gauges</b> Ensure gauges are visible, working, no leakage, and suitable for range of MAWP/ Temp.	X				<b>No gauges</b>
<b>External Piping</b> Ensure pipe is well supported. All clamps, supports, shoes, etc. in place. Look for evidence of structural overload, deflection, etc. Paint condition, external corrosion?	X				<b>Piping is well supported – all clamps, supports and shoes are in place. No structural overloads or deflections. Piping is insulated no damage present.</b>
