**Canadian Natural Resources Limited
GENERAL PRESSURE VESSEL INFORMATION**

Job # 05.001952

District: Fort St. John BC.	Skid No.
Facility: West Blueberry Battery	Location (LSD): 12-29-88-25-W6M
Vessel Name Equipment Number: Flare Knock out Drum	
Orientation: Horizontal	
Status: In Service	Regulatory Inspection

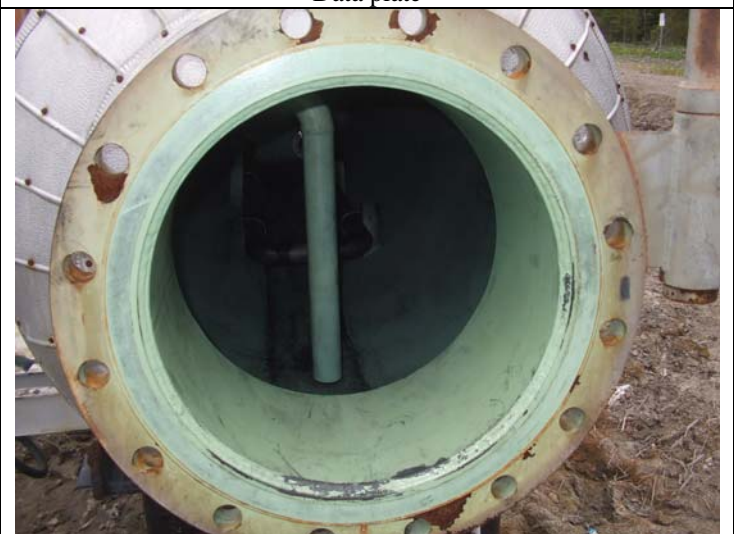
The manway throat

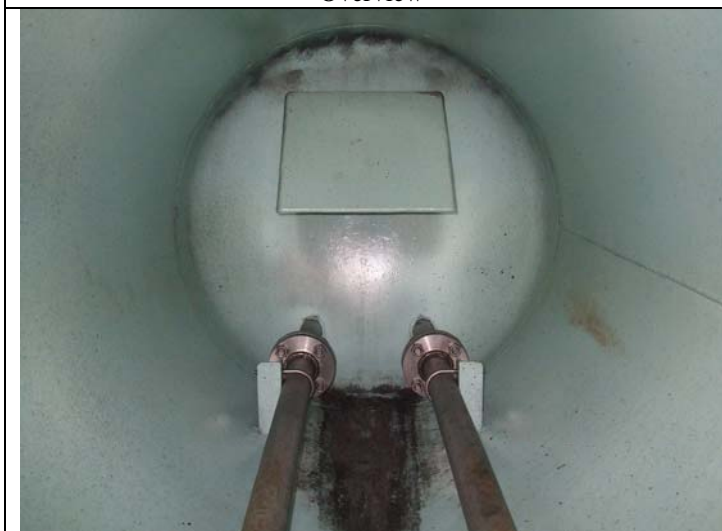
East Head Note all corrosion, erosion or mechanical damage. (If vessel is horizontal identify direction of this head)	X				No mechanical damage, corrosion or erosion was found. Good overall condition.
Shell Sections Record number of shell sections. Record location, size and depth of all erosion, corrosion or mechanical damage. Describe general condition. If any corrosion greater than corrosion allowance is observed in either shell or head, discuss with Chief Inspector before closing vessel.	X				One shell section was found to form the vessel - Good overall condition no mechanical damage corrosion or erosion was noted shell is fully coated.
Demister pad Is it in place? Is it clean? If any corrosion is apparent in vessel, lift pad and check top head for corrosion.				X	None.
Welds Inspect all welds, including attachment welds. Record all service-related damages and if there is any discuss with Chief Inspector before closing.	X				All visible welds appear to be in good overall condition.

East head overview

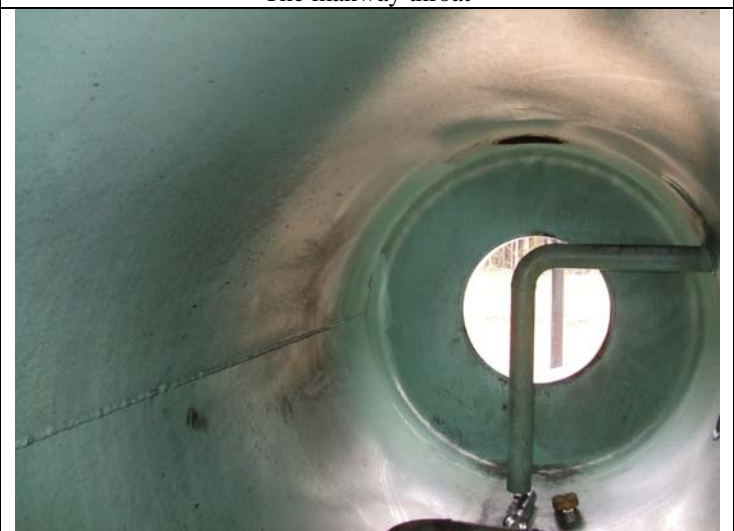
West head and shell overview
