**Canadian Natural Resources Limited
GENERAL PRESSURE VESSEL INFORMATION**

Job # 105.00774

District: Fort St. John BC.	Skid No.
Facility: West Blueberry Battery	Location (LSD): 12-29-88-25-W6M
Vessel Name Equipment Number: HP Flare Knock out Drum	
Orientation: Horizontal	
Status: In Service	Regulatory Inspection

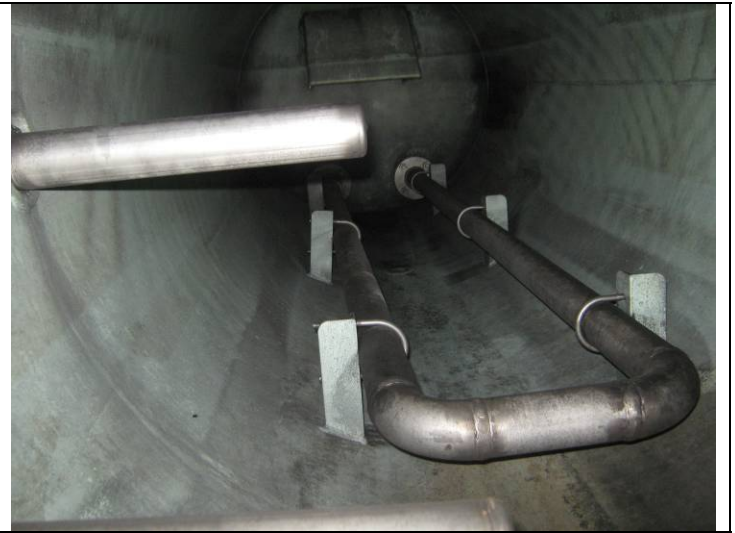
Overview - Internal

Shell Sections Record number of shell sections. Record location, size and depth of all erosion, corrosion or mechanical damage. Describe General condition.	X				1 shell sections. 100% coated. No areas of failed coating. No damage. No corrosion.
Demister pad Is it in place? Is it clean? If any corrosion is apparent in vessel, lift pad and check top head for corrosion.				X	None
Welds Inspect all welds, including attachment welds. Record all service-related damages and if there is any discuss with Chief Inspector before closing.	X				Welds are in good condition. No pitting. No corrosion.
Repairs Required. If yes, ensure procedure and copy of AB 40 is on file, and one sent to local ABSA, and Chief Inspector				X	None.
Other				X	
NDE Inspections				X	No internal NDE at this time.
Recommendations or corrective actions (indicate if fit for service)					
Recommendations: None at this time					
Summary: This vessel is in good overall condition, visual internal carried out.

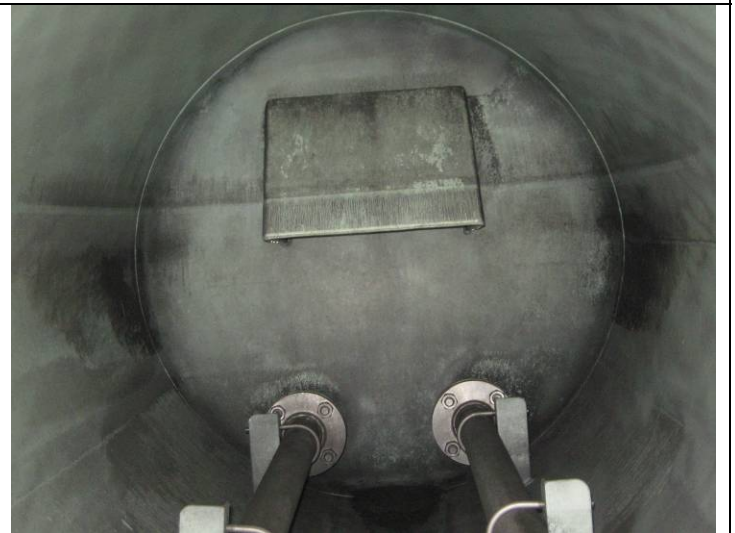
North head

Internal Inspection Items	G	F	P	N/A	Comments
Coating Assess coating. Describe area coated, general condition of coating.	X				Vessel is 100% epoxy coated. No areas of failed coating.
Anodes. How many, type, condition. % consumed. Are they being replaced?				X	No anodes.
Internal Piping Is there any?	X				2 inch stainless steel piping. No mechanical damage.
Trays How many? Type of material. Are valves in place. Check for erosion/ corrosion; wear on tray valve legs. Cleanliness?				X	No trays.
Baffles, deflector plates, etc. If present, describe condition. Look closely at welds attached to vessel wall.	X				Inlet deflector plate in good condition. No corrosion. No damage.
North Head Note all corrosion, erosion or mechanical damage. (If vessel is horizontal identify direction of this head)	X				100% coated no areas of failed coating. No damage. No corrosion.
Sourth Head Note all corrosion, erosion or mechanical damage. (If vessel is horizontal identify direction of this head)	X				100% coated no areas of failed coating. No damage. No corrosion.
