**Canadian Natural Resources Limited
GENERAL PRESSURE VESSEL INFORMATION**

Job # 105.00774

District: Fort St. John BC.	Skid No.
Facility: West Blueberry Battery	Location (LSD): 12-29-88-25-W6M
Vessel Name Equipment Number: Flare Knock out Drum	
Orientation: Horizontal	
Status: In Service	Regulatory Inspection

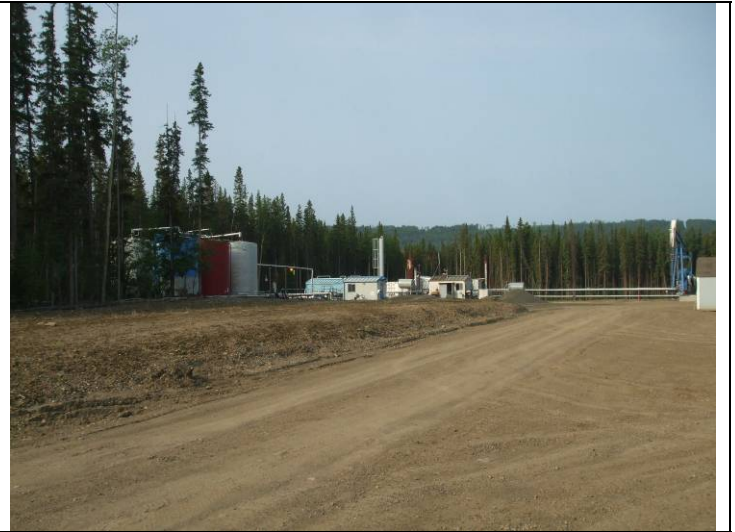
Site overview

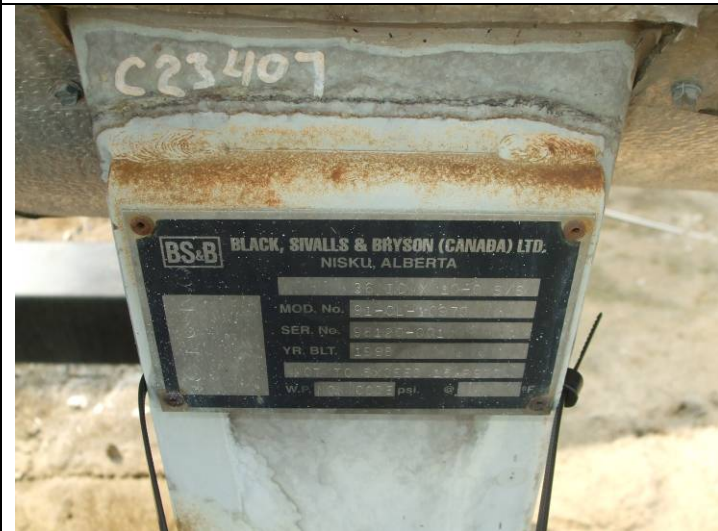
Data plate

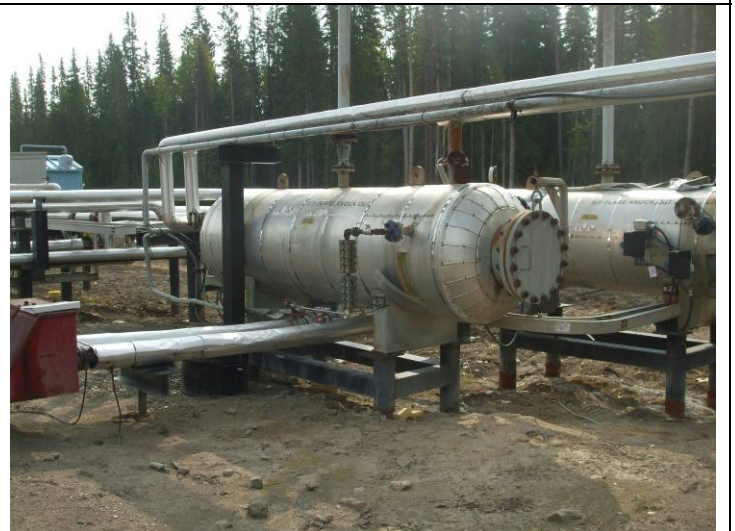
Vessel overview

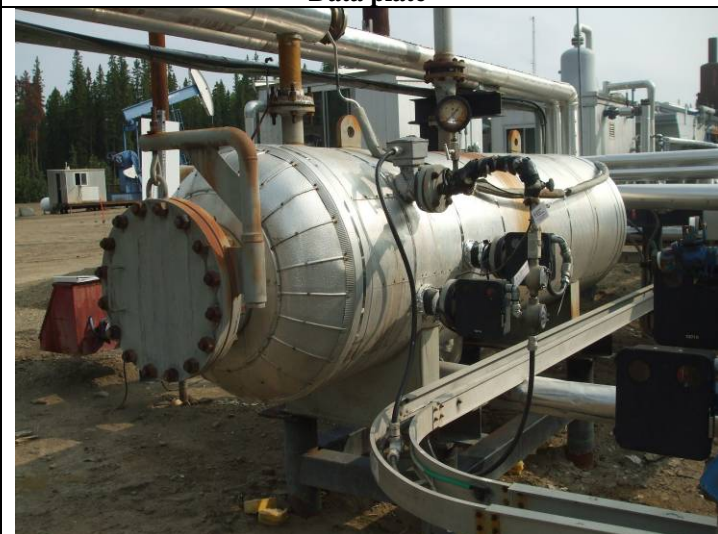
Vessel overview
