**Canadian Natural Resources Limited  
GENERAL PRESSURE VESSEL INFORMATION**

**Job # 105.00774 / 10.110446**

Facility: <b>West Blueberry Battery</b>	Location (LSD): <b>12-29-88-25-W6M</b>
---	--

Vessel Name Equipment Number: **LP Flare Knock out Drum**

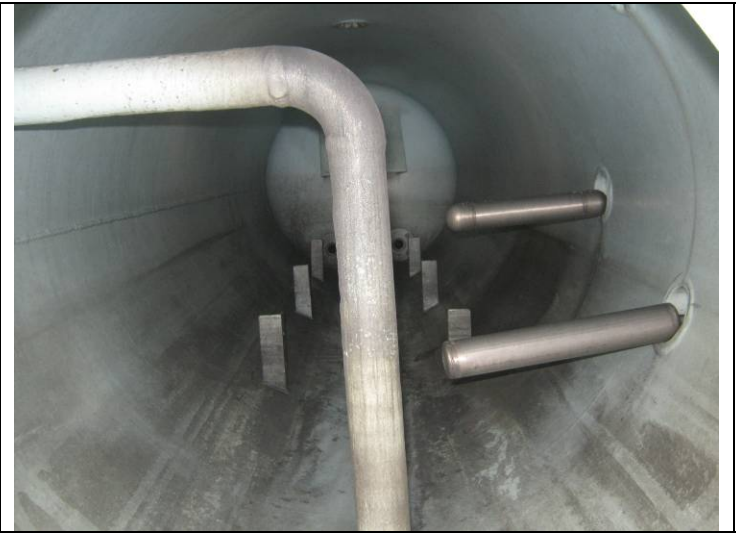
**Overview - Internal**

<b>Internal Inspection Items</b>	<b>G</b>	<b>F</b>	<b>P</b>	<b>N/A</b>	<b>Comments</b>
<b>Coating</b> Assess coating. Describe area coated, general condition of coating.	X				<b>Vessel is 100% epoxy coated. No areas of failed coating.</b>
<b>Anodes.</b> How many, type, condition. % consumed. Are they being replaced?				X	<b>No anodes.</b>
<b>Internal Piping</b> Is there any?	X				<b>2 inch carbon steel piping, coated. No corrosion. No mechanical damage.</b>
<b>Trays</b> How many? Type of material. Are valves in place. Check for erosion/ corrosion; wear on tray valve legs. Cleanliness?				X	<b>No trays.</b>
<b>Baffles, deflector plates, etc.</b> If present, describe condition. Look closely at welds attached to vessel wall.	X				<b>Inlet deflector plate in good condition. No corrosion. No damage.</b>
<b>North Head</b> Note all corrosion, erosion or mechanical damage. (If vessel is horizontal identify direction of this head)	X				<b>100% coated no areas of failed coating. No damage. No corrosion.</b>

<b>Other</b>				X	
<b>NDE Inspections</b>				X	<b>No internal NDE at this time.</b>
<b>Recommendations or corrective actions (indicate if fit for service)</b>					
<b>Recommendations:</b> None at this time					
<b>Summary:</b> This vessel is in good overall condition, visual internal carried out.					
<b>Vessel is fit for service.</b>
