GENERAL INSPECTION FORM						
Company Name: Canadian Natural Resources Limited			Inspection Date: December 11 th , 2023			
Facility: West Blueberry			Location (LSD): 12-29-88-25 W6			
Vessel Name & Equipment Number: Low Pressure Flare Knockout						
Orientation: Horizontal <input checked="" type="checkbox"/> or Vertical <input type="checkbox"/>			Status: operating <input type="checkbox"/> or shut-in <input checked="" type="checkbox"/>			
Internal Inspection <input checked="" type="checkbox"/> and / or External Inspection <input checked="" type="checkbox"/>			Commissioning Inspection <input type="checkbox"/> or Corporate Inspection <input checked="" type="checkbox"/>			
PRESSURE VESSEL NAMEPLATE DATA						
"A" or BC Registration Number:			Company Tag # (if applicable): C23407			
CRN Number: Non-code			Associated PSV Tag # (if applicable):			
Vessel serial number: 98120-001			Size (diameter x length- estimate if necessary): 36" ID x 10'- 0" S/S

LOW PRESSURE FLARE KNOCKOUT

WEST BLUEBERRY COMPRESSOR STATION
12-29-88-25

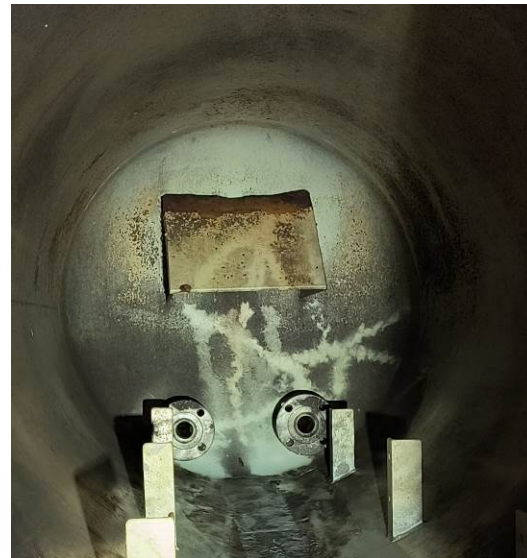
Picture 4:
East
head /
inlet
deflector
plate

Trays How many? Type of material. Are valves in place? Check for erosion/ corrosion; wear on tray valve legs. Cleanliness?				✓	No trays present
Baffles, deflector plates, etc. If present, describe condition. Look closely at welds attached to vessel wall.	✓				The inlet had a deflector housing around it, no signs off corrosion damage. But limited visual from manway only.
East Head Note all corrosion, erosion or mechanical damage. (If vessel is horizontal identify direction of this head)	✓				The head appeared to be in good condition, with no corrosion damage noted. But limited visual from manway only.
West Head Note all corrosion, erosion or mechanical damage. (If vessel is horizontal identify direction of this head)	✓				The head appeared to be in good condition, with no corrosion damage noted. But limited visual from manway only.
Shell Sections Record number of shell sections. Record location, size and depth of all erosion, corrosion or mechanical damage. Describe general condition. If any corrosion greater than corrosion allowance is observed in either shell or head, discuss with Chief Inspector before closing vessel.	✓				The shell appeared to be in good condition, with no corrosion damage noted. But limited visual from manway only.
