**Canadian Natural Resources Limited  
GENERAL PRESSURE VESSEL INFORMATION**

**Job 10.118582**

District: <b>Grande Prairie, Alberta</b>	Skid No.
Facility: <b>Spirit River Battery</b>	Location (LSD): <b>08-09-77-07W6M</b>
Vessel Name Equipment Number: <b>Flare Knockout Drum</b>	
Orientation: <b>Horizontal</b>	
Status: <b>In Service</b>	<b>Regulatory Inspection</b>

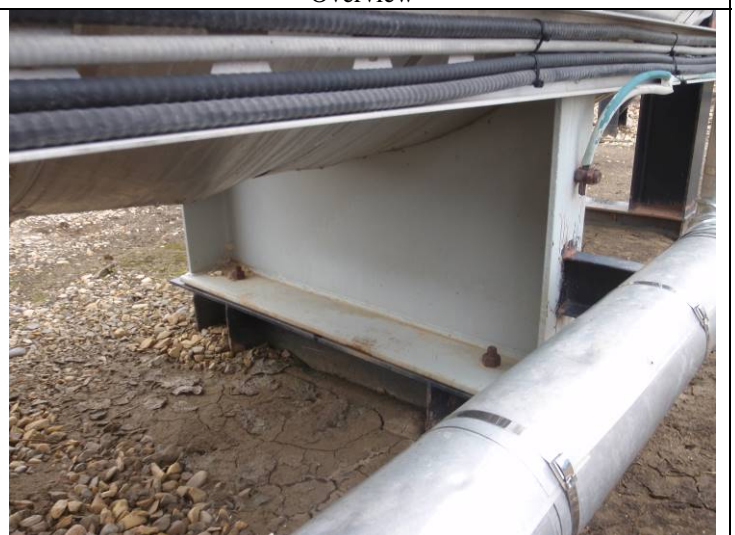
Saddle bolting

<b>Anchor Bolts</b> Hammer tap to ensure secure. Look for cracking in treads or signs of deformation.	X				<b>Vessel is securely bolted to skid floor – no deformation</b>
<b>Concrete foundation</b> Check for cracks, spalling, etc.				X	<b>None</b>
<b>Ladder / Platform</b> Describe general condition, ensure support is secure to vessel, and describe any hazards.				X	<b>None</b>
<b>Nozzle</b> Assess paint, look for leakage, and ensure stud threads are fully engaged. Record any damage, deflection, etc. Are nozzles gusseted?	X				<b>Paint in good condition – no leaks – stud threads fully engaged – no damage or deflection – no gussets</b>
<b>Gauges</b> Ensure gauges are visible, working, no leakage, and suitable for range of MAWP/ Temp.				X	<b>No gauges present</b>
<b>External Piping</b> Ensure pipe is well supported. All clamps, supports, shoes, etc. in place. Look for evidence of structural overload, deflection, etc. Paint condition, external corrosion?	X				<b>Piping is well supported – all clamps in place – no evidence of structural overload or deflection – paint in good condition – no corrosion</b>
