**Canadian Natural Resources Limited
GENERAL PRESSURE VESSEL INFORMATION**

District: Fort St. John, BC		Skid No.					
Facility: Flatrock Compressor Station		Location (LSD): 15-20-85-17 W6M					
Vessel Name & Equipment Number: Flare Knockout							
Orientation: Horizontal							
Status: In Service		Regulatory Inspection					
PRESSURE VESSEL NAMEPLATE DATA							
"A" or "G" or "S" (Sask.) or BC Registration Number. C45029		CRN Number Non Code					
Vessel serial number: SWT-0175		Size: 48 in x 10 ft					
Shell thickness: 0.375 in		Shell material: SA 516 70					
Head thickness: 0.375 in		Head material: SA 516 70					
Tube wall thickness:		Tube material:					
Tube diameter:		Tube length:					
Channel thickness:		Channel material:					
MAWP	Shell: 14.9 PSI	Operating pressure	Shell:				
	Tubes:		Tubes:				
Design Temp.	Shell: 100 ° F	Operating temperature	Shell:				
	Tubes:		Tubes:				
X-ray: Not Stated		Heat treatment: Not Stated					
Code parameters: ASME Section VIII Div 1		Joint efficiency (if on nameplate):

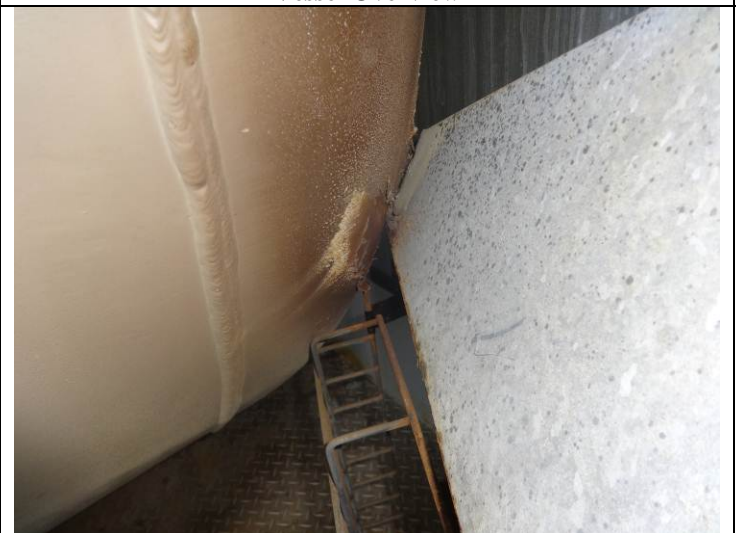
Heat damage to paint on east facing head

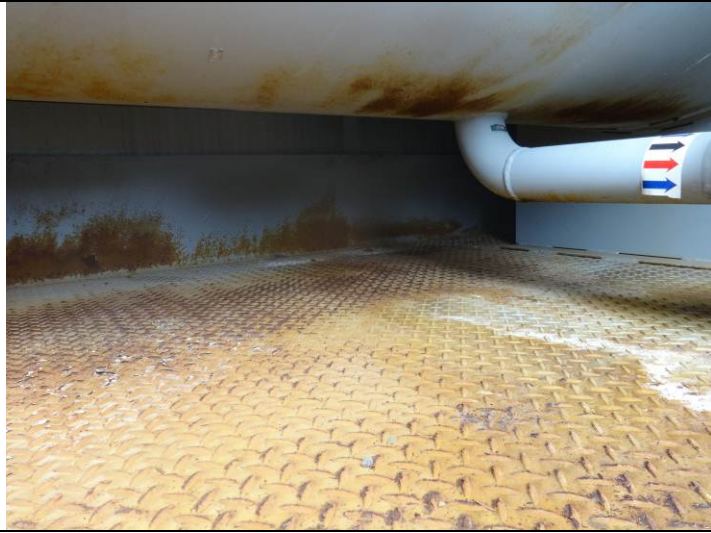
Corrosion bottom shell
