**Canadian Natural Resources Limited
GENERAL PRESSURE VESSEL INFORMATION**

District: Fort St. John, BC		Skid No.					
Facility: Flatrock Compressor Station		Location (LSD): 15-20-85-17 W6M					
Vessel Name & Equipment Number: HP Flare Knockout							
Orientation: Horizontal							
Status: In Service		Regulatory Inspection					
PRESSURE VESSEL NAMEPLATE DATA							
"A" or "G" or "S" (Sask.) or BC Registration Number. C 73501 (No Data Plate)		CRN Number Non Code					
Vessel serial number:		Size: 30 in x 7 ft					
Shell thickness:		Shell material:					
Head thickness:		Head material:					
Tube wall thickness:		Tube material:					
Tube diameter:		Tube length:					
Channel thickness:		Channel material:					
MAWP	Shell:	Operating pressure	Shell:				
	Tubes:		Tubes:				
Design Temp.	Shell:	Operating temperature	Shell:				
	Tubes:		Tubes:				
X-ray:		Heat treatment:					
Code parameters: ASME Section VIII Div 1		Joint efficiency (if on nameplate):					
Manufacturer: Tornado Flare Systems		Year built:

Date: April 01, 2015

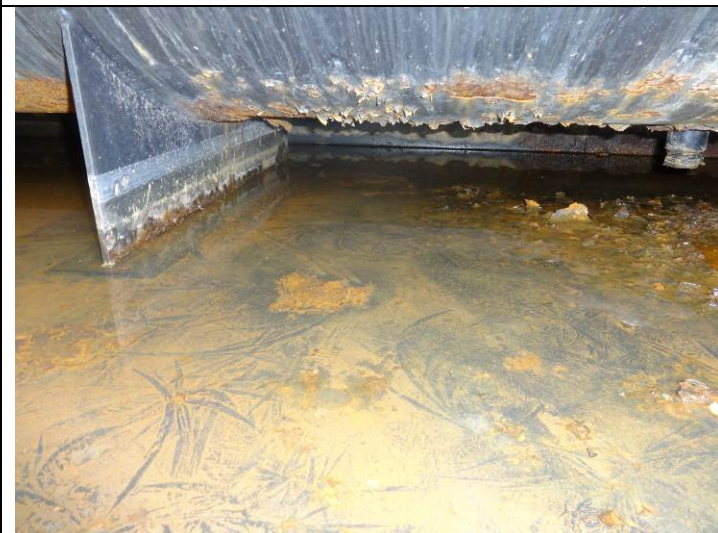
Saddle

External Inspection Items	G	F	P	N/A	Comments
Insulation Verify sealed around manways, nozzles, no damage present, and there is no egress of moisture. Are straps secured?				X	
External Condition Assess paint condition, areas peeling, record any corrosion, damage, distortion etc (record location, size and depth of corrosion or damage)	X				Paint is in good condition. Surface corrosion present on bottom shell, no pitting.
Leakage Record any leakage at flanges, threaded joints, weep holes on repads, etc.	X				No leaks observed.
Skirt: Assess condition of paint, fire protection, and concrete. Look for corrosion, buckling, dents, etc. Look at vessel surface area near supports. Verify no signs of leakage at attachment to vessel and attachment welds are acceptable. Is ground wire attached?	X				Saddle: Paint is in overall good condition. Surface corrosion present on base of saddle. No pitting. No sign of leakage at attachment weld. Ground wire attached to skid.

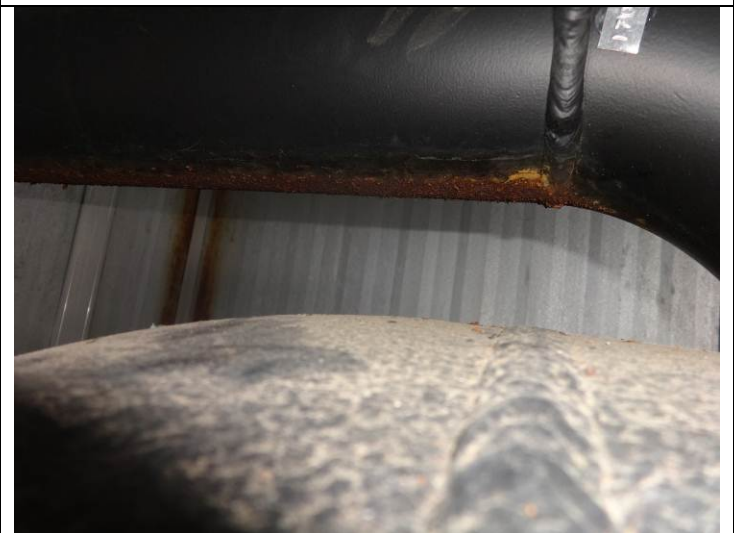
Corrosion on piping
