CLIENT	CANADIAN NATURAL RESOURCES LTD
FACILITY	PASS CREEK FIELD LSD: 05-05-61-19 W5M
ITEM	LINE HEATER
BY: NB	DATE: 09/2005 DWG.# 46

**Canadian Natural Resources Limited
GENERAL PRESSURE VESSEL INFORMATION**

Job # 10.114960

District: SwanHills, Ab.	Skid No.
Facility: Pass Creek Field	Location (LSD): 05-05-61-19 W5M
Vessel Name Equipment Number: Line Heater	
Orientation: Horizontal	
Status: Not In Service	Regulatory Inspection

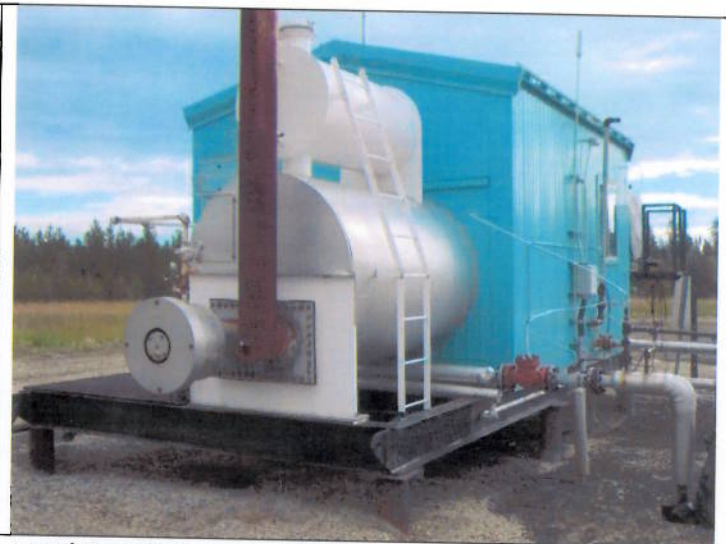
vessel Overview

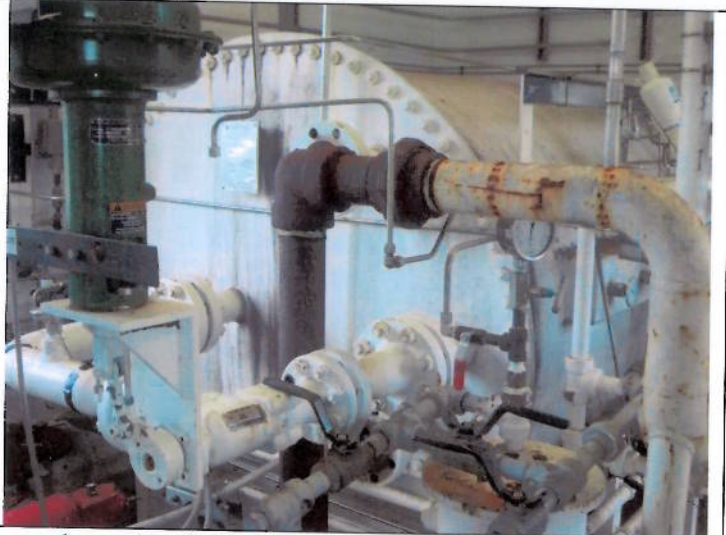
vessel overview inside

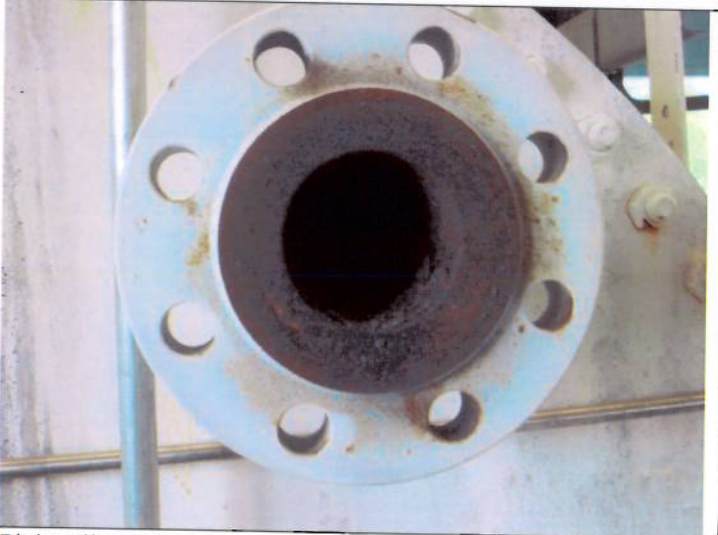
Piping disconnected
