CLIENT	CANADIAN NATURAL RESOURCES LTD	
FACILITY	PASS CREEK FIELD LSD 03-06-61-19 W5M	
ITEM	LINE HEATER	
BY: KB/JH	DATE: 09/2013	DWG.# 65

**Canadian Natural Resources Limited
GENERAL PRESSURE VESSEL INFORMATION**

District: SwanHills, Ab.	Skid No.
Facility: Pass Creek Field	Location (LSD): 03-06-61-19 W5M
Vessel Name Equipment Number: Line Heater	
Orientation: Horizontal	
Status: Not In Service	Regulatory Inspection

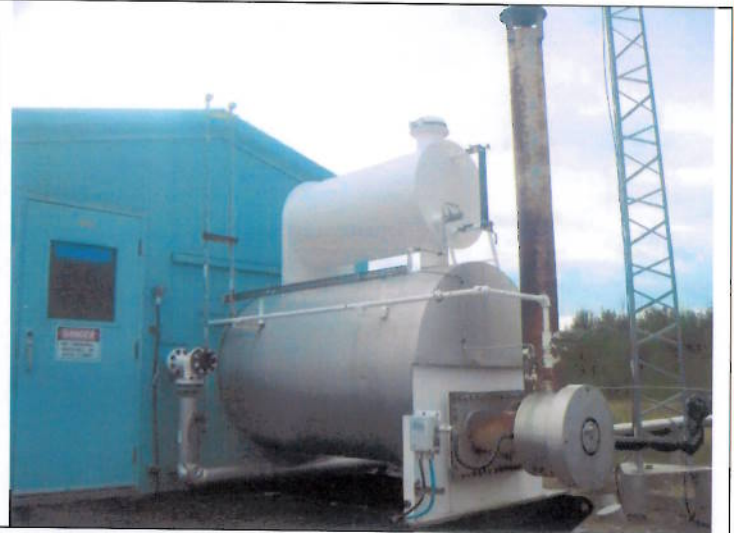
vessel Overview

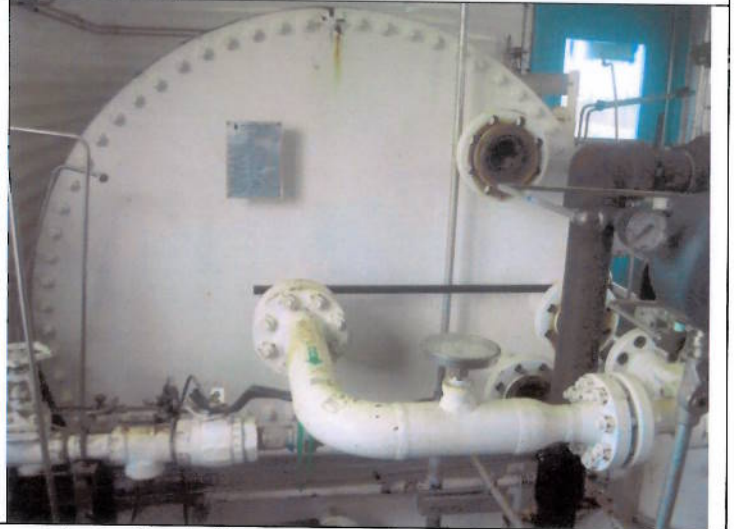
vessel data plate

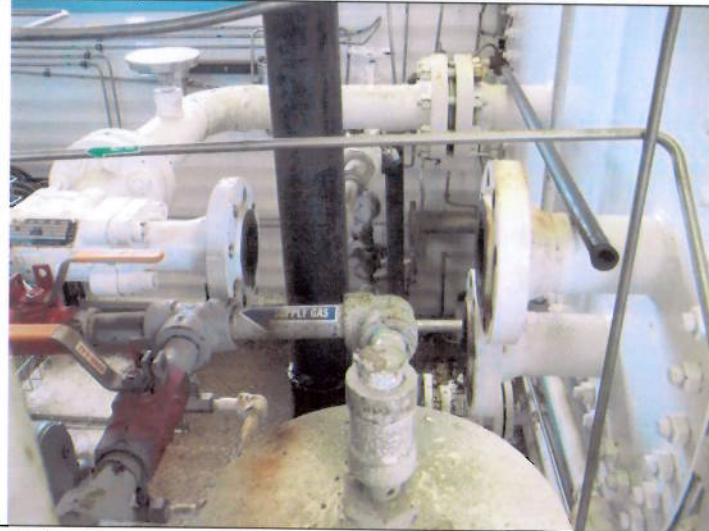
vessel overview inside
