Canadian Natural Resources Limited GENERAL PRESSURE VESSEL INFORMATION										
District: Grande Pi	Skid No.									
Facility: Pass Cre		Location (LSD): 03-06-60-19 W5M								
Vessel Name Equipment Number: Line Heater										
		eatei								
Orientation: Horizontal Status: Not in Service Regulatory Inspection										
Status: Not in	Service	PRESSURE VESS	CEI N	Regulatory In	_					
"A" on "C" o	or "S" (Sask.) or BC R		SEL IV.	AMEPLATE DA		CRN Numb				
A of G	H-9622.12									
Vessel serial number	Size: 55 in x 20 ft									
Shell thickness: 9.:				Shell material: SA 36						
Head thickness: 9.				Head material: SA 36						
Tube wall thickness Tube diameter:	3:			Tube material:						
Channel thickness:				Tube length: Channel material:						
Design pressure		Operating pressure		Shell:						
	Tubes:					Tubes:				
	Shell: 93°C	Operating temperature		a						
Design Temp.				Shell:						
	Tubes:			Tubes:

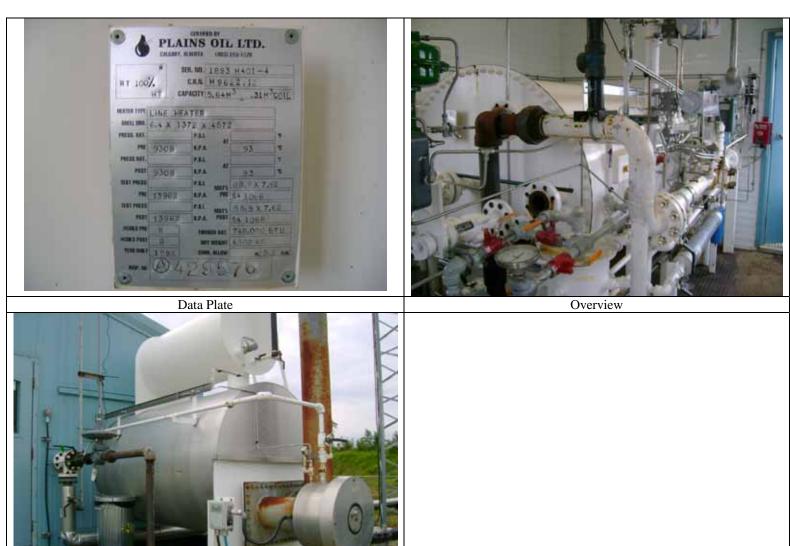
Over view

Summary: This line heater is in good overall condition, visual external and ultrasonic thickness survey carried out on piping – no metal thickness detected below nominal minus corrosion allowance.
