**Canadian Natural Resources Limited  
GENERAL PRESSURE VESSEL INFORMATION**

**Job # 10.113498**

<b>District: Fox Creek</b>	Skid No.
<b>Facility: Pass Creek Field</b>	<b>Location (LSD): 03-06-61-19 W5M</b>
Vessel Name Equipment Number: <b>Line Heater</b>	
Orientation: <b>Horizontal</b>	
Status: <b>Not In Service</b>	<b>Regulatory Inspection</b>

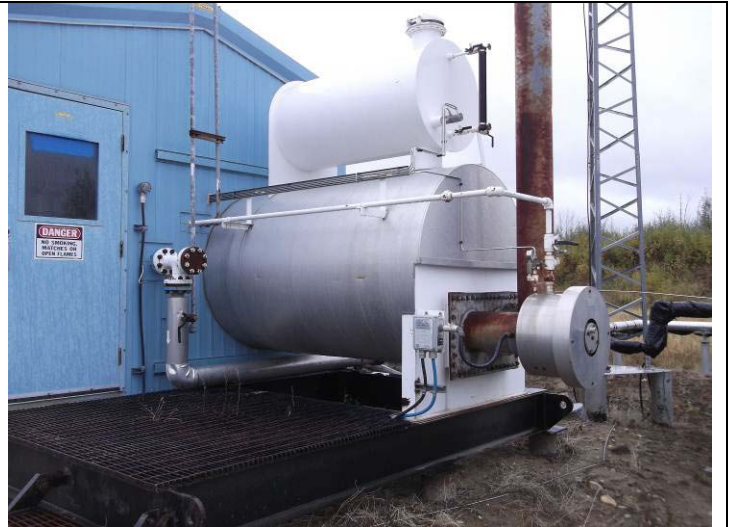
vessel Overview

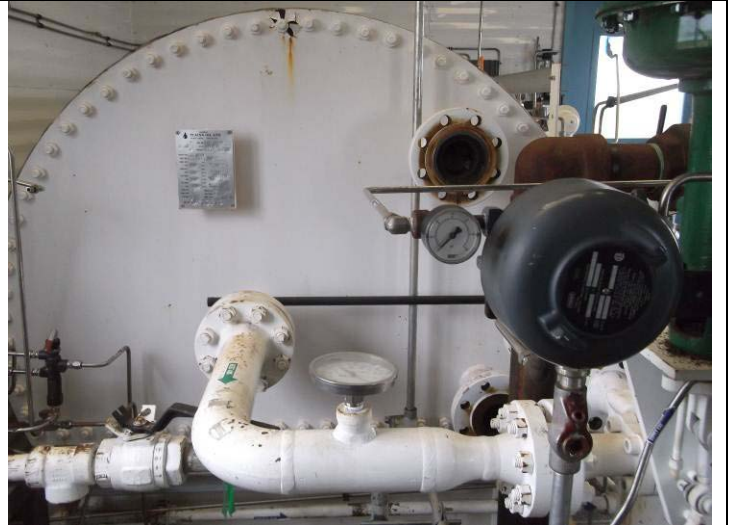
vessel overview inside

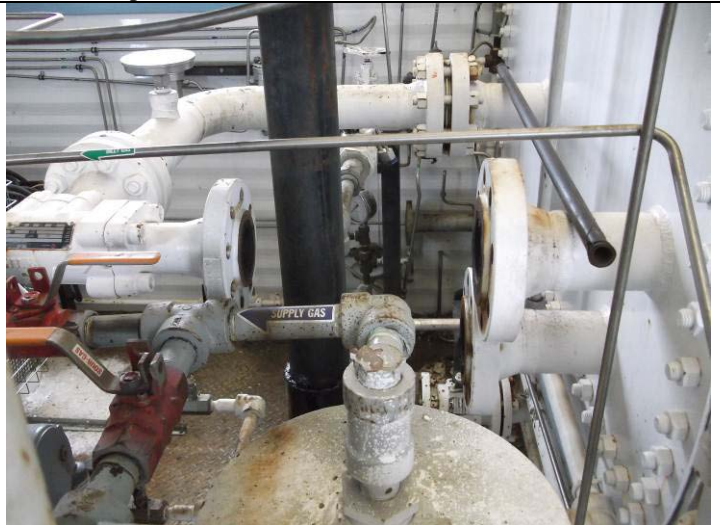
Piping disconnected
