CLIENT	CANADIAN NATURAL RESOURCES LTD	
FACILITY	GOLD CREEK FIELD LSD 04-30-68-05 W6M	
ITEM	LINE HEATER	
BY: IM	DATE: 08/2016	DWG.# 161

**Canadian Natural Resources Limited
GENERAL PRESSURE VESSEL INFORMATION**

Job 4019962

District: Grande Prairie, AB	Skid No.
Facility: Gold Creek Field	Location (LSD): 04-30-68-05 W6M
Vessel Name Equipment Number: Line Heater	
Orientation: Horizontal	
Status: Not in service	Integrity Inspection

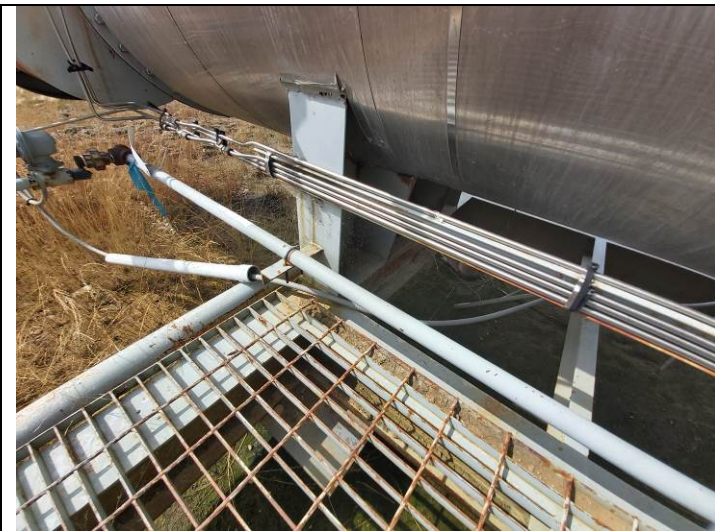
Saddle

External Inspection Items	G	F	P	N/A	Comments
Insulation Verify sealed around manways, nozzles, no damage present, and there is no egress of moisture.		X			Shell is 50% insulated and in fair condition – dents and compressed cladding to 20% of area. Egress of moisture detected at west saddle.
External Condition Assess paint condition, areas peeling, record any corrosion, damage, etc (record location, size and depth of corrosion or damage)	X				Paint is in condition – no exposed metal.
Leakage Record any leakage at flanges, threaded joints, weep holes on repads, etc.	X				No leaks observed.
Saddle/skirt Assess condition of paint, fire protection, and concrete. Look for corrosion, buckling, dents, etc. Look at vessel surface area near supports. Verify no signs of leakage at attachment to vessel and attachment welds are acceptable. Ground wire attached?	X				Saddle: No buckling or dents. No evidence of corrosion at saddle to shell area – no leaks. Ground wire attached to skid

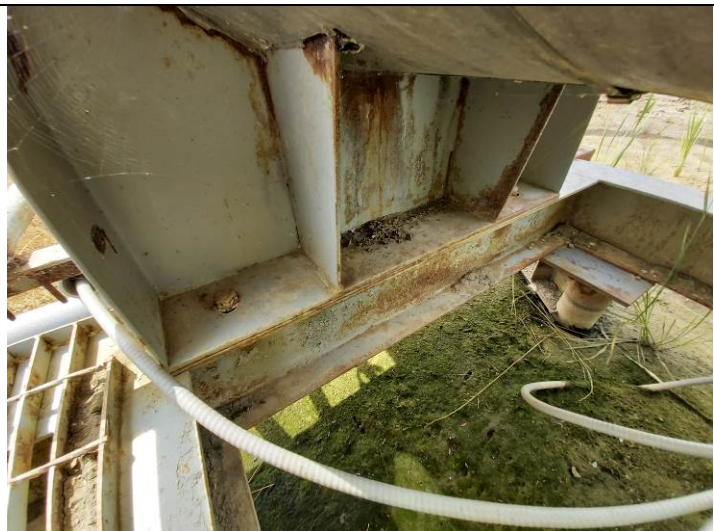
Anchor Bolts Hammer tap to ensure secure. Look for cracking in treads or signs of deformation.	X				Anchor bolts are secure – no cracking – no deformation.
Concrete foundation Check for cracks, spalling, etc.				X	Steel skid.
Ladder / Platform Describe general condition, ensure support is secure to vessel, and describe any hazards.				X	None.
Nozzle Assess paint, look for leakage, and ensure stud threads are fully engaged. Record any damage, deflection, etc. Are nozzles gusseted?	X				Threaded and flanged connections fully engaged. No deflection – no leaks. No gussets.
Gauges Ensure gauges are visible, working, no leakage, and suitable for range of MAWP/ Temp.	X				Pressure gauge: 0 to 7000 kPa. Below range of piping MAWP. Temp gauge: 40 to 400°F. Within range of MAWT. Liquid sight glass on expansion tank. Clear and clean – no leakage.
External Piping Ensure pipe is well supported. All clamps, supports, shoes, etc. in place. Look for evidence of structural overload, deflection, etc. Paint condition, external corrosion?	X				Piping is well supported; no deflection, all clamps and supports are in place. Paint is in good condition – no corrosion.

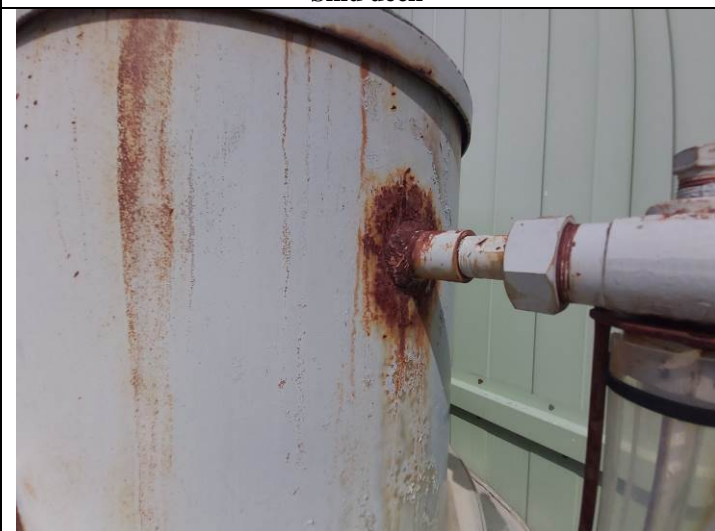
Surface corrosion on accumulator / expansion tank
