A0438939_Name plate_28Mar2012

Field Inspection Report

Client	CNRL		Date of Inspection	March 28, 2012					
Prov. Reg.#	A0438939		Inspection Type	VE & UT					
Equipment	Line Heater		Location	5-21					
Tag/Equip. #			LSD	05-21-012-14W4M					
Vessel Status	In Service		Comp./Unit #						
Manufacturer	Plains Oil Ltd.		MAWP / Temp						
Serial #	2133CB3	CRN #	N 9595.213	MDMT@ Pressure					
Corrosion Allowance	1.6mm	Shell Material	SA106B	Shell Thickness					
Year Built	1998	Head Material	SA106B	Head Thickness					
Diameter	60" OD / 30" OD	Length		Height		RT	RT-1	HT	Yes
Service	Sour	Next Inspection		Next Insp. Type					
ASME Stamp	No	Next Inspection		Next Insp. Type					
PSV Tag #		CRN#		Set Pressure					
Manufacturer			NB#		ASME Stamp				
Type/Model		Serial		Inlet Size					
Capacity		Service Company		Outlet Size					
Service Date			Next Service Date						
Valve Location	On Vessel On Piping Vents to Flare • Vents to Atmosphere	Valve Connection	Threaded Flanged Welded	ABSA CODE TYPE

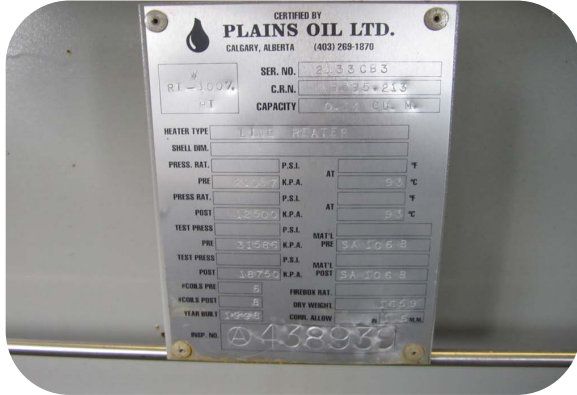
A0438939_Name plate_28Mar2012

- Name plate was attached and readable.
- External paint was in fair condition with slight external corrosion present at TML 50.
- Slight surface corrosion in form of rusting.

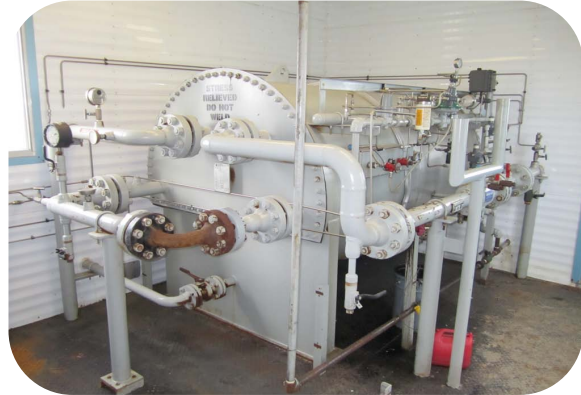
A0438939_Inlet and Outlet piping_28Mar2012

- All associated piping was intact and secure.
- Vessel is grounded to the building; ground cable was in good shape.
- UT survey found no areas of concern, see attached UT Report.

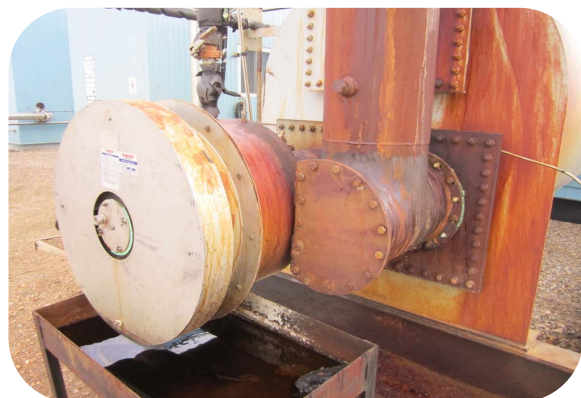
A0438939_Burner and Stack assembly_28Mar2012

- Saddles were bolted securely to the floor and skid.
- All external nozzles were in good condition.
- Leaking gasket on Stack side flange.
- Flame arrestor and stack were intact and in good shape.

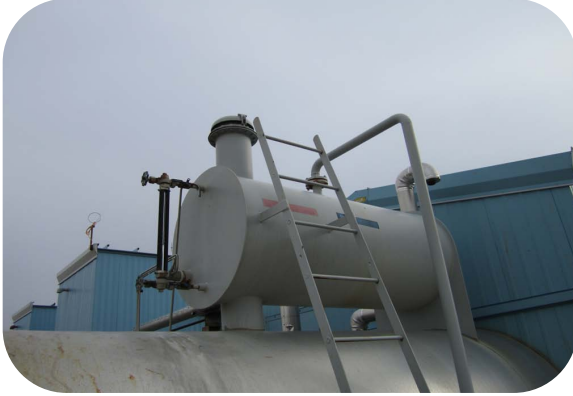
A0438939_50,50 Reservoir tank_28Mar2012

- No deflection or deformation of the shell, end plates or nozzles.
- 50/50 top reservoir tank was in good shape.
- Reservoir tank thief hatch was in good working order.

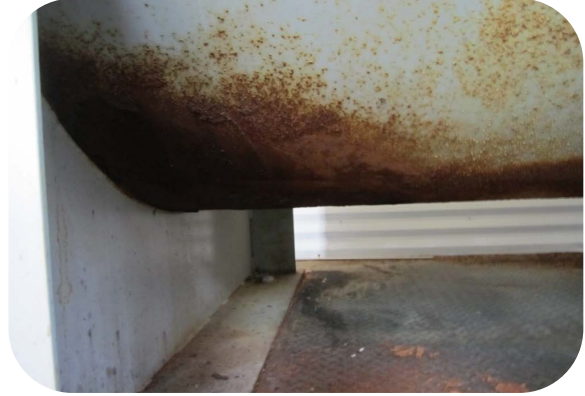
A0438939_Surface rusting_28Mar2012

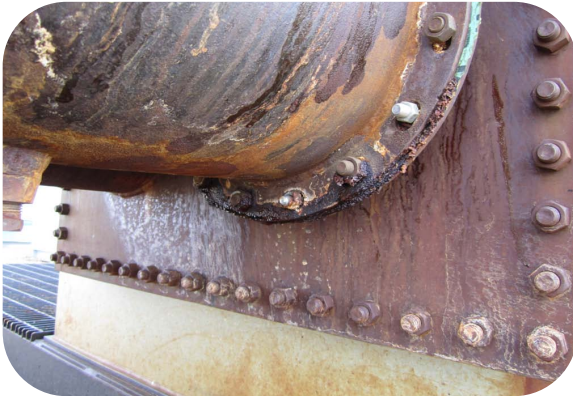
A0438939_Gasket leak on Stack_28Mar2012

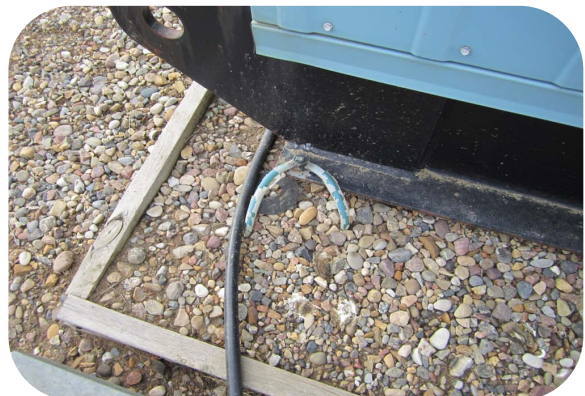
A0438939_Ground cable secure_28Mar2012
