## **Ultrasonic Inspection Report**

--UT-BV-1
 March 28, 2012

## **UT Readings for Line Heater A0438939**

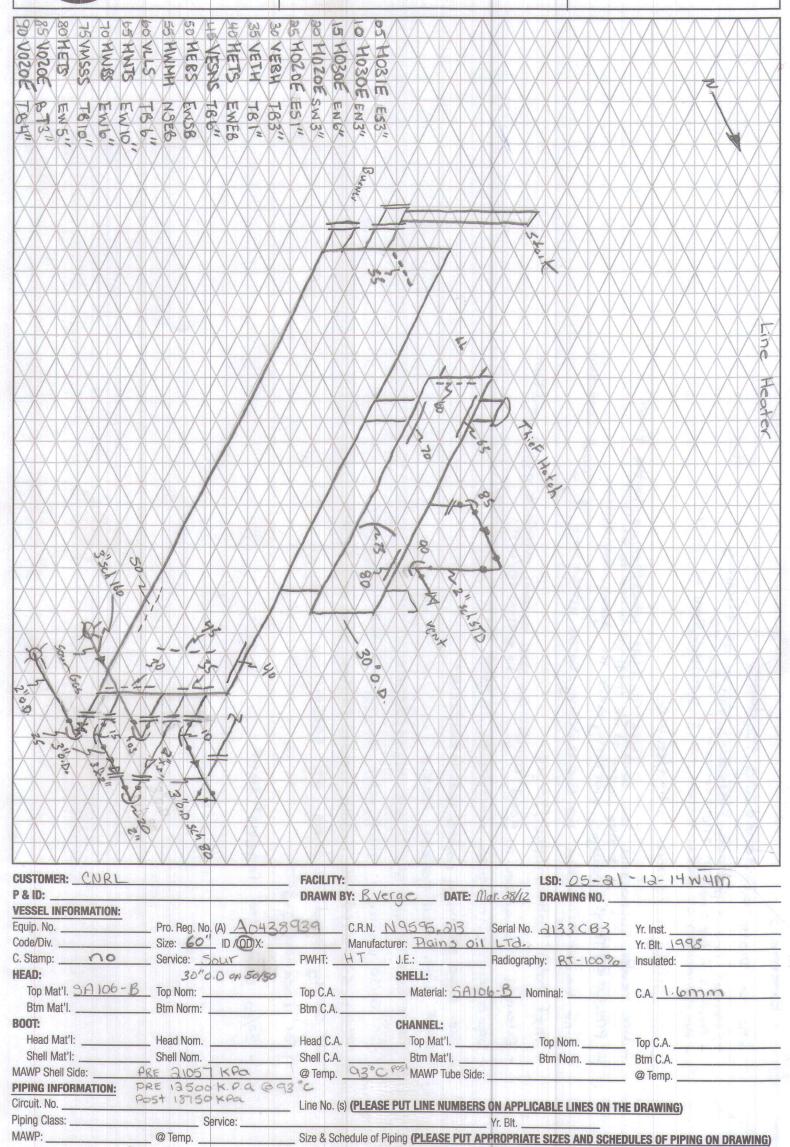
<u>Minimum</u>	<u>Maximum</u>	<u>Average</u>
LOC 5	0.442	0.453	0.448
LOC 10	0.305	0.333	0.316
LOC 15	0.436	0.449	0.443
LOC 20	0.339	0.349	0.343
LOC 25	0.167	0.191	0.173
LOC 30	0.267	0.268	0.268
LOC 35	0.272	0.277	0.277
LOC 40	0.301	0.302	0.302
LOC 45	0.304	0.307	0.305
LOC 50	0.289	0.289	0.289
LOC 55	0.267	0.275	0.27
LOC 60	0.239	0.258	0.256
LOC 65	0.249	0.252	0.251
LOC 70	0.251	0.252	0.252
LOC 75	0.254	0.255	0.255
LOC 80	0.255	0.256	0.256
LOC 85	0.142	0.174	0.166
LOC 90	0.141	0.162	0.154
