**Canadian Natural Resources Limited
GENERAL PRESSURE VESSEL INFORMATION**

Job # 10.113785

District: Fort St John, BC				Skid No.			
Facility: West Blueberry Gas Gathering				Location (LSD): b-28-L/94-A-12			
Vessel Name Equipment Number: Line Heater							
Orientation: Horizontal							
Status: In Service				Regulatory Inspection			
PRESSURE VESSEL NAMEPLATE DATA							
"A" or "G" or "S" (Sask.) or BC Registration Number. A0418376				CRN Number: M-1551.21			
Vessel serial number: BW139.073				Size: 30 in X 12 ft			
Shell thickness: 7.9 mm				Shell material: SA 36			
Head thickness: 7.9 mm				Head material: SA 36			
Tube wall thickness:				Tube material:			
Tube diameter:				Tube length:			
Channel thickness:				Channel material:			
Design pressure	Shell: Atmos			Operating pressure	Shell:		
	Tubes: Coil A 2500 PSI Coil B 1300 PSI				Tubes:		
Design Temp.	Shell:			Operating temperature	Shell:		
	Tubes: 200 deg F				Tubes:		
X-ray: RT-1 coil only				Heat treatment: No			
Code parameters: ASME B 31.3				Coated: No

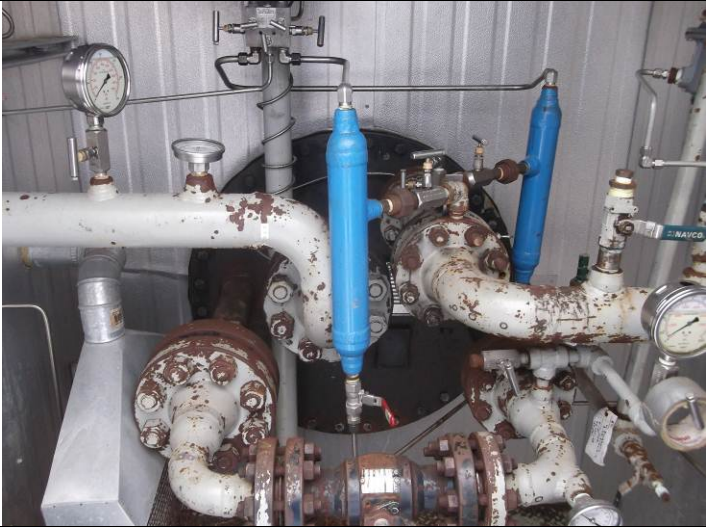
vessel Overview

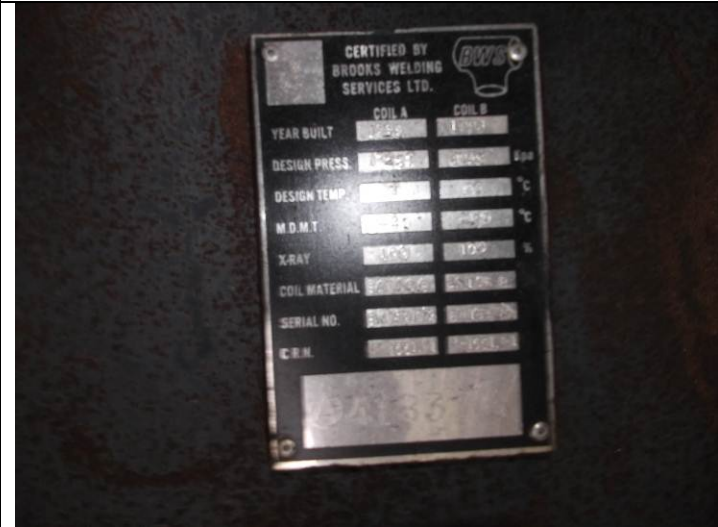
vessel data plate

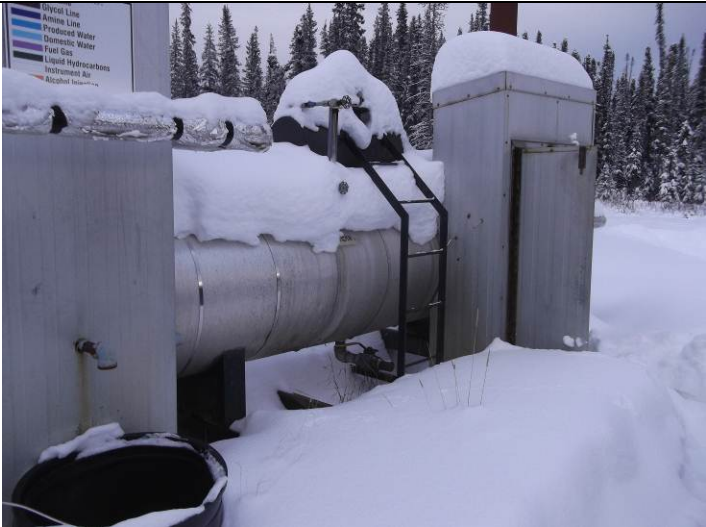
External overview
