**Canadian Natural Resources Ltd.
GENERAL PRESSURE VESSEL INFORMATION**

Job# 105.00774

District: Fort St John, BC	Skid No.
Facility: West Blueberry Gas Gathering	Location (LSD): b-28-L/94-A-12
Vessel Name Equipment Number: Line Heater	
Orientation: Horizontal	
Status: In service	Regulatory Inspection

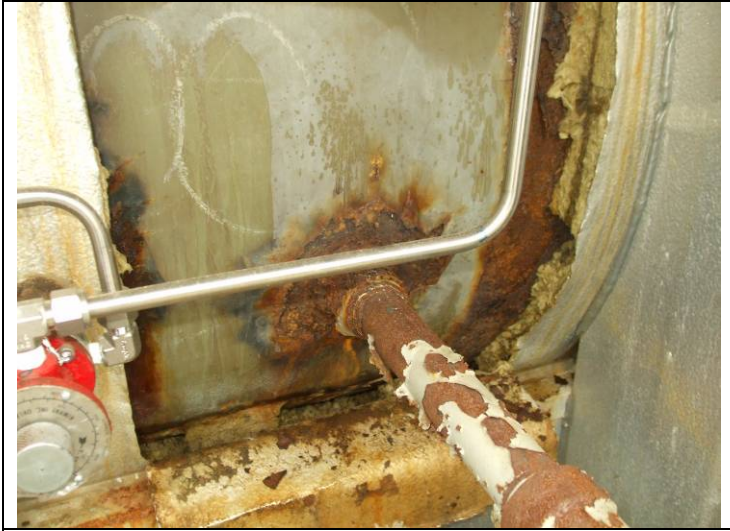
Shell external corrosion
