**Canadian Natural Resources Limited  
GENERAL PRESSURE VESSEL INFORMATION**

**Job # 05.001952**

District: <b>Ft St John B.C.</b>		Skid No.				
Facility: <b>West Blueberry Battery</b>		Location (LSD): <b>12 – 29 – 88 – 25 – W6M</b>				
Vessel Name & Equipment Number: <b>Heat Medium Heater</b>						
Orientation: <b>Horizontal</b>						
Status: <b>Operating</b>		<b>Regulatory Inspection</b>				
<b>PRESSURE VESSEL NAMEPLATE DATA</b>						
Registration Number <b>A 403525</b>		CRN Number <b>N 5217.21</b>				
Vessel serial number: <b>C 756A.0B</b>		Size: <b>48 in. x 16 ft. S/S</b>				
Shell thickness: <b>9.5 mm</b>		Shell material: <b>SA 36</b>				
Head thickness: <b>9.5 mm</b>		Head material: <b>SA 36</b>				
Tube wall thickness:		Tube material:				
Tube diameter:		Tube length:				
Channel thickness:		Channel material:				
Design pressure	Shell: <b>21609 Kpa</b>	Operating pressure	Shell: <b>0 – 30000 Kpa</b>			
	Tubes:		Tubes:			
Design Temp.	Shell: <b>93 deg C</b>	Operating temperature	Shell:			
	Tubes:		Tubes:

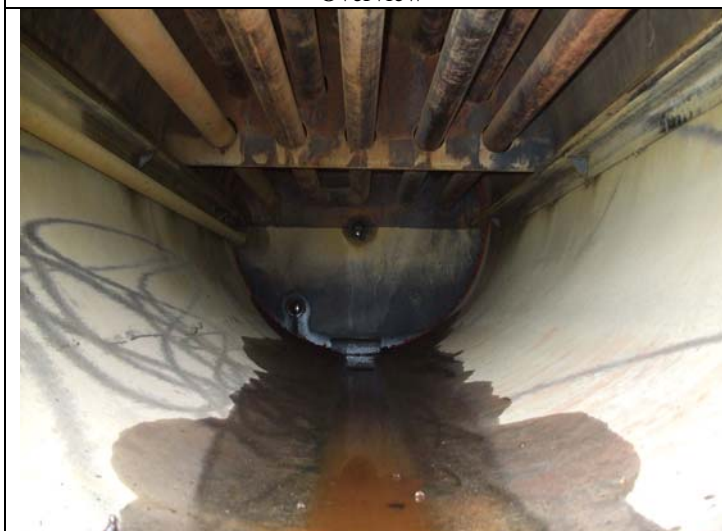
Internal overview

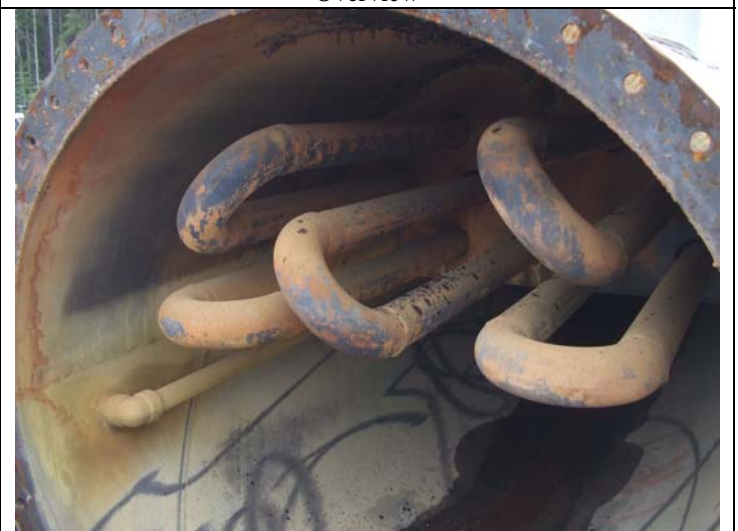
Heater coil overview
