**Canadian Natural Resources Limited  
GENERAL PRESSURE VESSEL INFORMATION**

**Job 10.114114**

District: <b>Fort St. John</b>	Skid No.
Facility: <b>Merion Compressor - Ladyfern</b>	Location (LSD): <b>10-19-94-12W6M</b>
Vessel Name Equipment Number: <b>Line Heater</b>	
Orientation: <b>Horizontal</b>	
Status: <b>In Service</b>	<b>Regulatory Inspection</b>

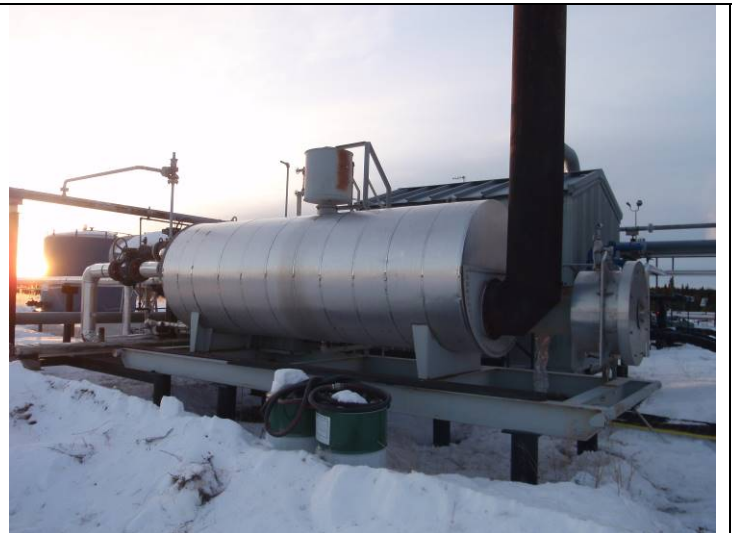
Overview

**Summary:** This vessel is in good condition, visual external and ultrasonic thickness inspection carried out – shell and pipe metal thickness detected below nominal. Thickness calculations carried out to ensure sufficient metal exists for safe operation.

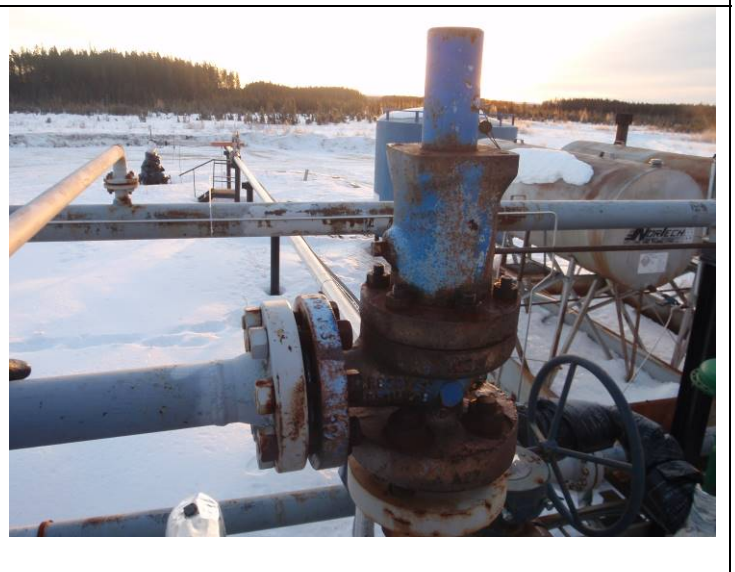
<b>Valving</b> Ensure no leaks are visible. Valves are properly supported and chained if necessary.	X				<b>No leaks detected – valves are properly supported</b>
<b>PSV</b> Ensure PSV is set at pressure at or below that of vessel. Discharge piping is same size as valve outlet and is properly supported and routed. Are PSV seals in place? Ensure no block valves between PSV and vessel, or if there are, that they are locked/sealed open.	X				<b>PSV is set at vessel MAWP - Discharge piping is same size as valve outlet and is properly supported and routed – seal is intact – no block valve – PSV is overdue for service</b>

**Recommendations:** Service PSV

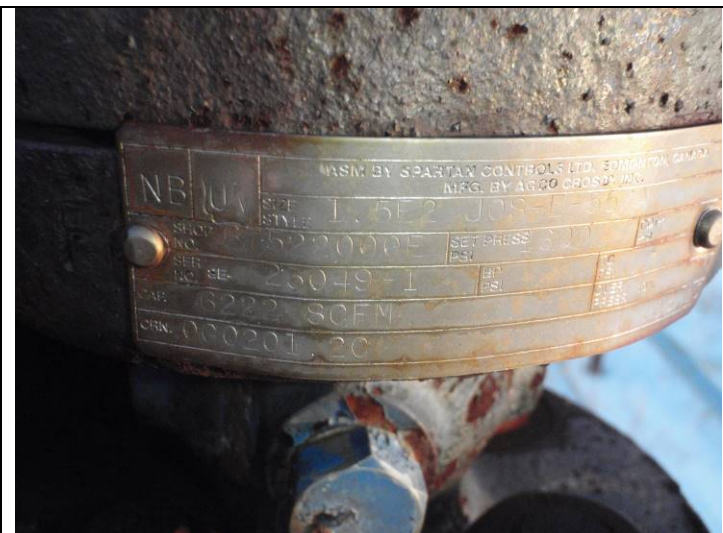
PSV data plate

PSV Tag #	Manufacture / Model / Serial	Set Pressure (PSI / kPa)	Capacity (scfm)	Size	Block Valve	Location	Service by / Date
n/s	Crosby / JOS-E-55/A / 23049-1	1600 PSI	6222 SCFM	1.5 x 2	No	Inlet piping	None – mfg. 2000
