Client	Canadian Natural Resources Ltd.	LSD	05-03-063-11W6	Location	Narraway
Provincial Reg #	A457189	Inspection Date	09-Apr-2015	Next Inspection Date	DD-MM-YYYY
Equipment Type	Line heater	Inspection Type	VE	Next Insp. Type	
Manufacturer	Maloney Industries Inc	Vessel Status	Not In Service		
Unit #	Line Heater Building	Tag #		NB Stamp	No
Serial #	CC-C4936-3001	CRN #	K1237.12	Year Built	2000
MAWP	30000 KPA @ 93 C	MDMT	-40 C	@ 30000 KPA	Coil 1 (A) 3"
MAWP	13962 KPA @ 93 C	MDMT	-40 C	@ 13962 KPA	Coil 2 (B) 6"
MAWP	13962 KPA @ 93 C	MDMT	-29 C	@ 13962 KPA	Coil 3 (C) 2" (Hot Oil)
Shell Material		Shell Thickness	0.6 in	CA	0.0625 in
Diameter		Length		Vessel Orientation	Horizontal
Head Material		Head Thickness		CA	
ASME STAMP	B31.3	Foreman	Dan Morrison	Service	Sweet

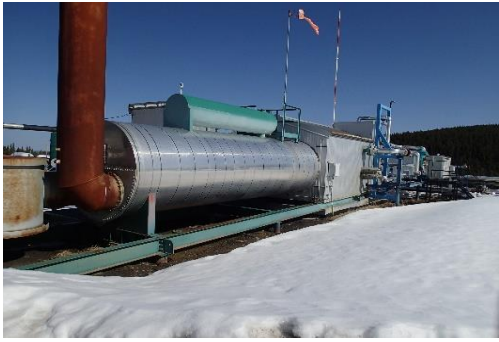
Figure 1: Vessel Overview

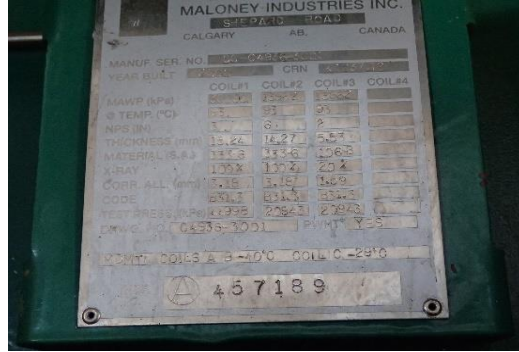
Figure 2: Vessel Nameplate 1

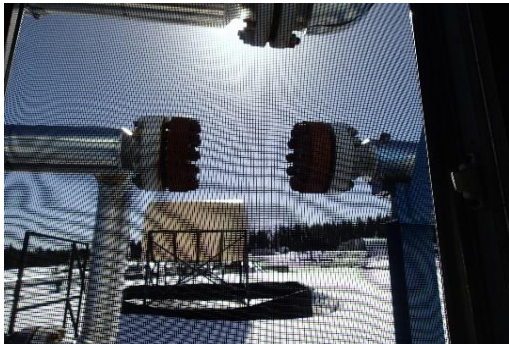
Figure 3: inlet - spool removed

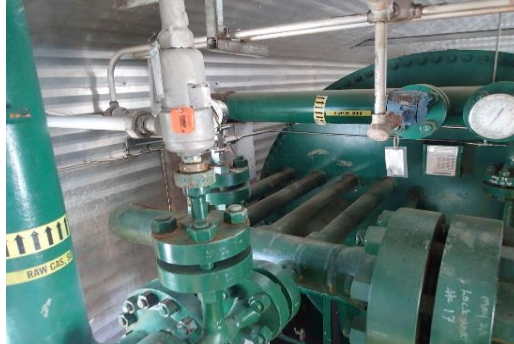
Figure 4: Coil 1 PSV

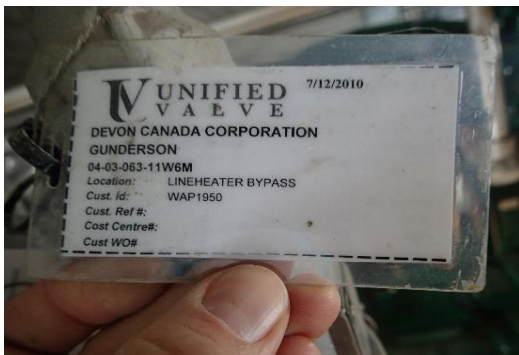
Figure 5: Coil 1 PSV service tag side A

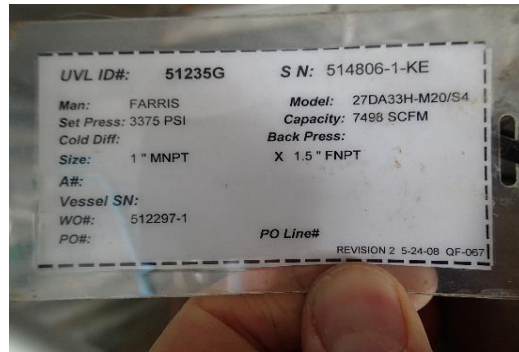
Figure 6: Coil 1 PSV service tag side B

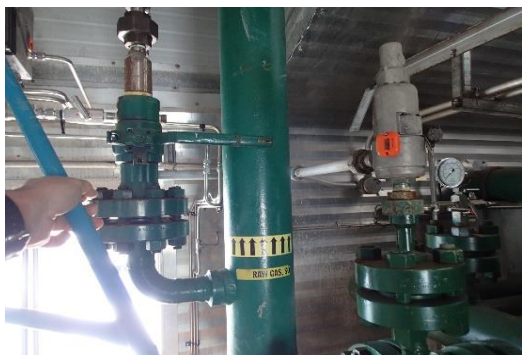
Figure 6: Coil 2 PSV

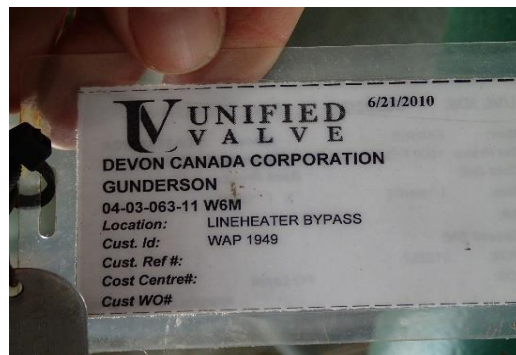
Figure 7: Coil 2 PSV service tag side A

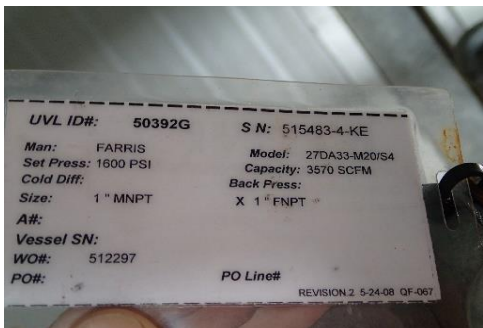
Figure 8: Coil 2 PSV service tag side B

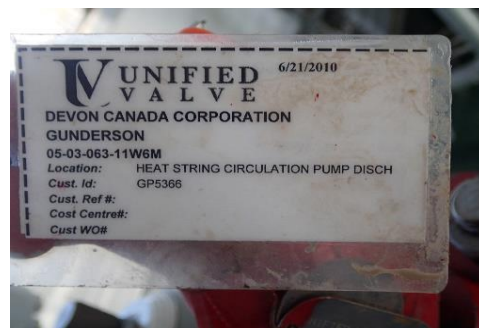
Figure 9: Coil 3 PSV service tag side A
