VESSEL INSPECTION SUMMARY

Report #: 137848-BV-08
Inspect Date: 05/20/2009
Page: 1 of 2
IRISNDT #: 137848

Client: CNRL District: Medicine Hat East, Alberta Field: Alderson East
Facility: 13-31-014-07W4M Unit: LSD: 13-31-014-07W4M
Jurisdiction #: A0467849 Equip Tag #: Serial #: C-022
CRN #: Nat'l Bd #: Year Built: 2001
Manufacturer: RJV Gas field services limited Equipment Description: Line heater
Status: In Service Date Removed From Service: Service: Select
MAWP Shell Psi @ °F Height/Length: in. Code Stamp: Y X N
MAWP Tube Psi @ °F Size/Diameter: in. O.D. Insulated: Y X N
Support Type: RT: Volume: ft³ / m³ PWHT: Y X N
C.A. Coated Y X N Clad: Y X N Manway: Y X N

External visual inspection and UT corrosion survey was carried out on line heater A0467849 to check the integrity for service.

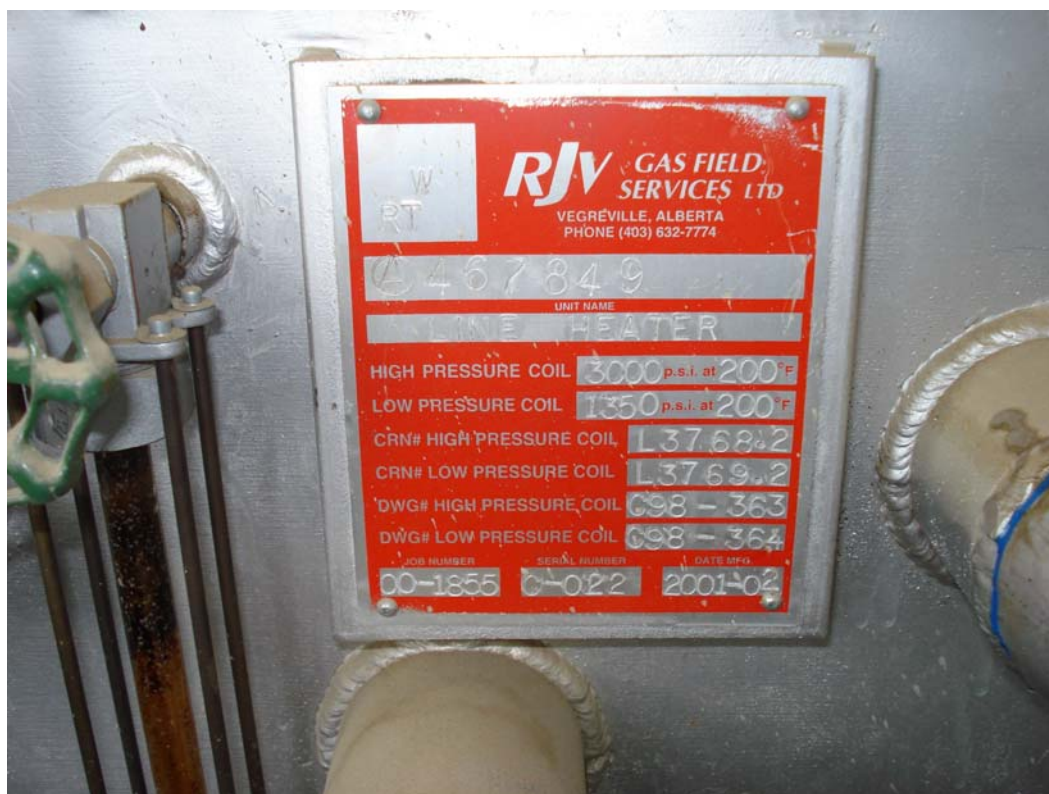
A0467849_Name plate_May212009

Name plate was attached and readable.

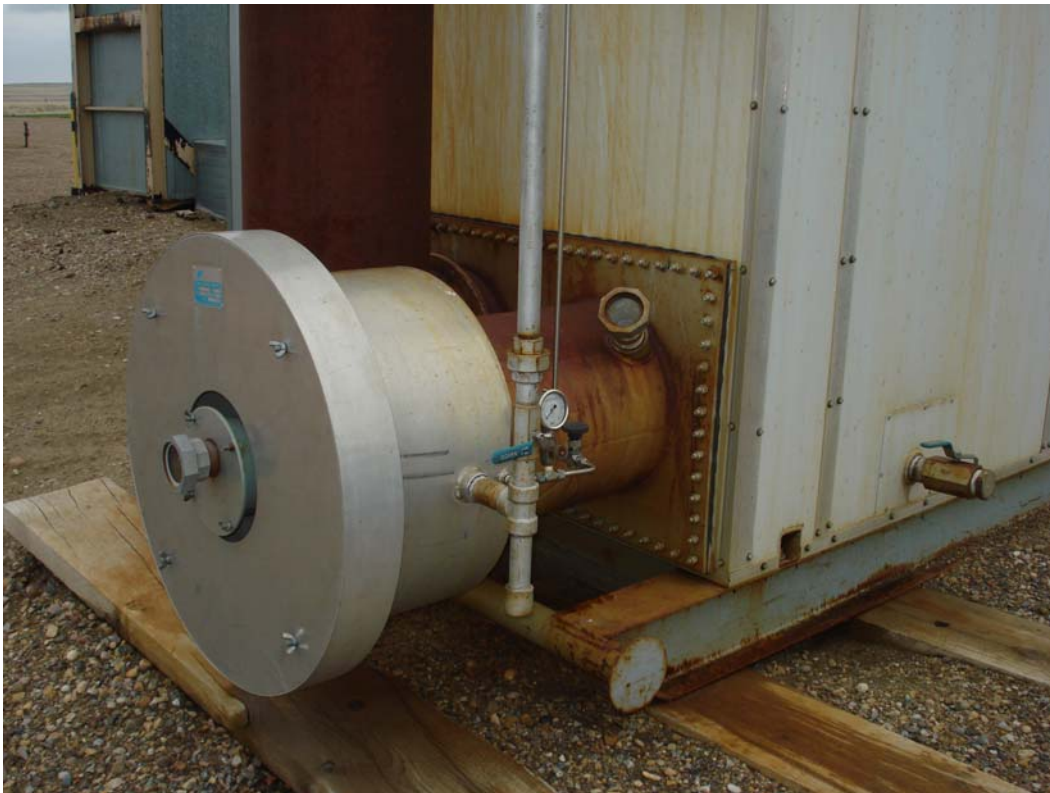
Burner and stack assembly in good shape.

A0467849_Burner assembly in good shape_May212009

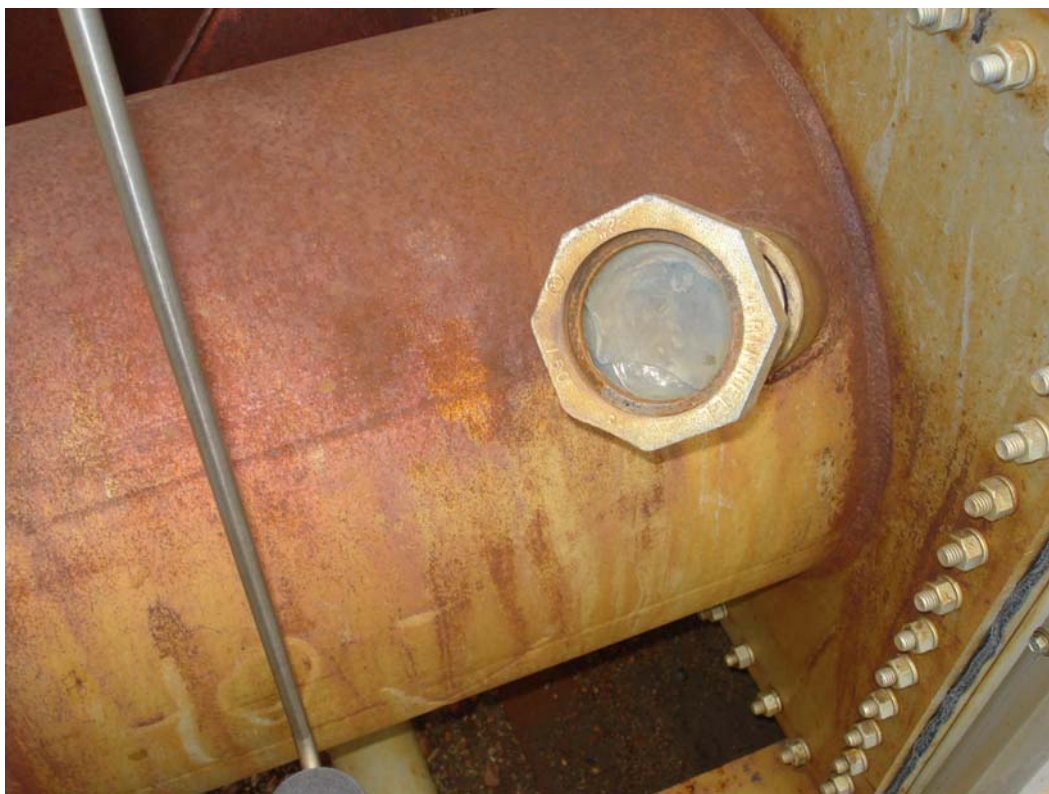
Liquid level sight glass on the burner broken and should be replaced.

A0467849_Cracked sight glass_May212009

Replace liquid level glass tube.
