**Canadian Natural Resources Ltd.
GENERAL PRESSURE VESSEL INFORMATION**

Job# 105.00774

District: Fort St John, BC	Skid No.
Facility: West Blueberry Gas Gathering	Location (LSD): 08-04-88-25-W6M
Vessel Name Equipment Number: Line Heater	
Orientation: Horizontal	
Status: In service	Regulatory Inspection

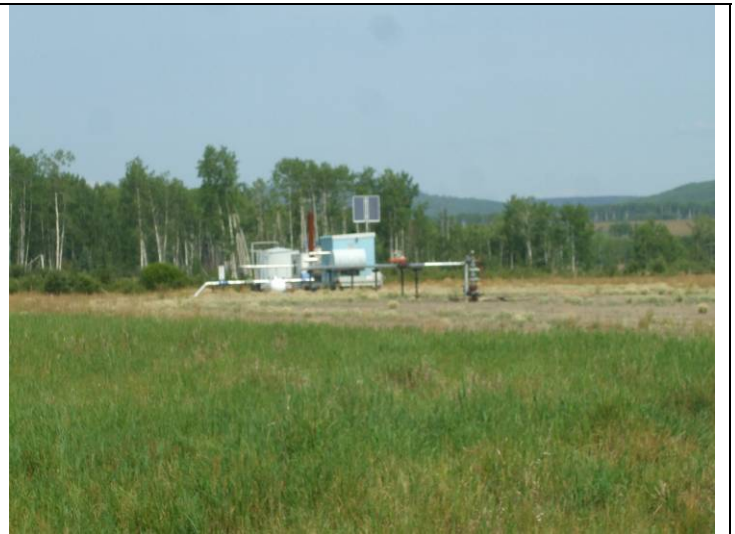
Site overview

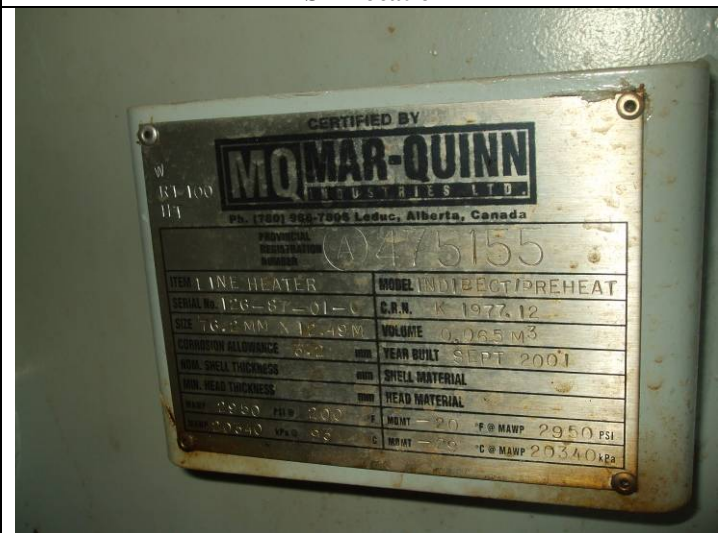
Data plate

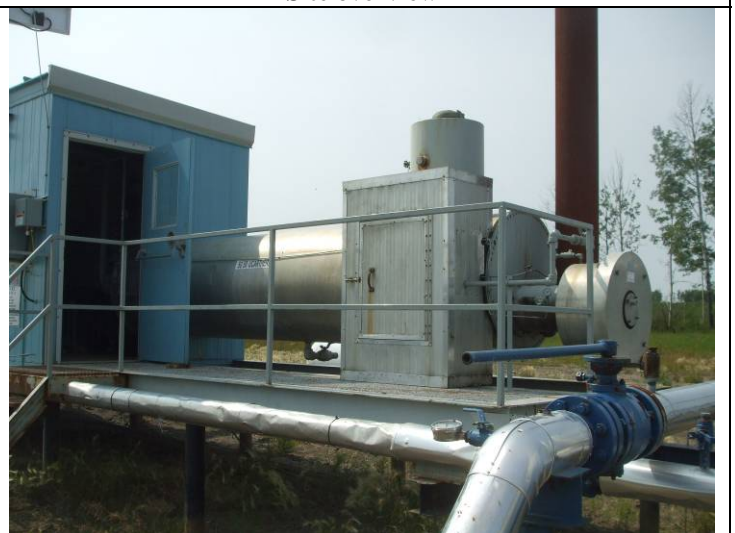
Vessel overview

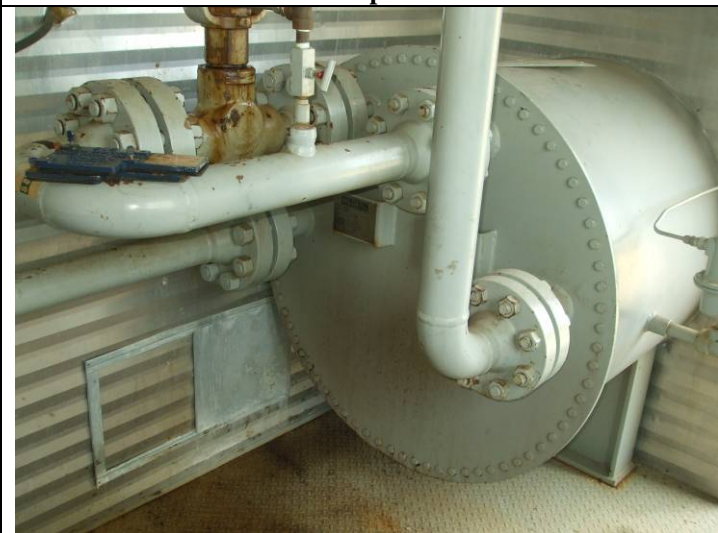
Anchor Bolts Hammer tap to ensure secure. Look for cracking in treads or signs of deformation.	X				Anchor bolts are secure. No signs of deformation.
Concrete foundation Check for cracks, spalling, etc.				X	None
Ladder / Platform Describe general condition, ensure support is secure to vessel, describe any hazards.				X	None
Nozzle Assess paint, look for leakage, and ensure stud threads are fully engaged. Record any damage, deflection, etc. Are nozzles gusseted?	X				Paint coating on nozzles are in good condition. No leaking detected no damage or deflection. All bolts/studs engaged to nuts. No gussets.
Gauges Ensure gauges are visible, working, no leakage, and suitable for range of MAWP/ Temp.	X				Temperature gauge is visible, working and suitable for Temp. 0 to 250 deg F / 60 deg F @ gauge.
External Piping Ensure pipe is well supported. All clamps, supports, shoes, etc. in place. Look for evidence of structural overload, deflection, etc. Paint condition, external corrosion?	X				Paint in good condition, no corrosion. Well supported, no loose or missing clamps. No evidence of structural overloading.

Anchor bolts secured

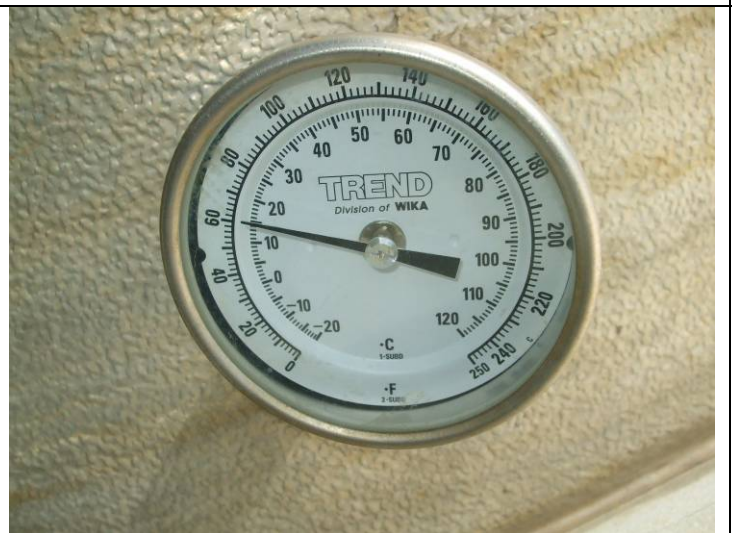
Temperature gauge
