**Canadian Natural Resources Limited  
GENERAL PRESSURE VESSEL INFORMATION**

**Job # 05.002851**

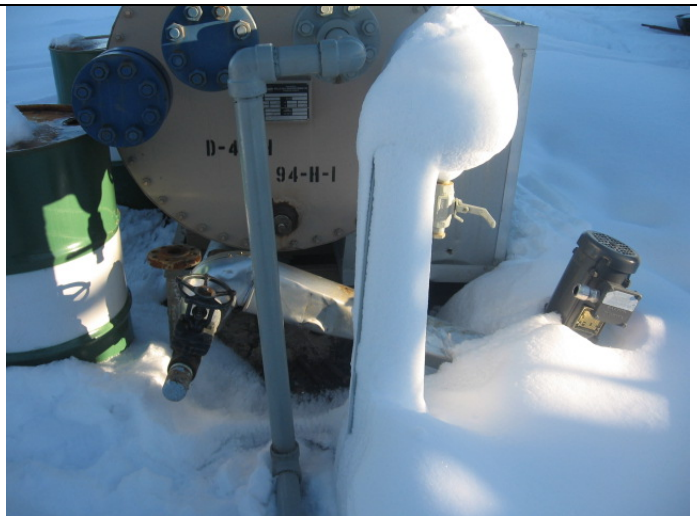
Inlet piping frozen up.

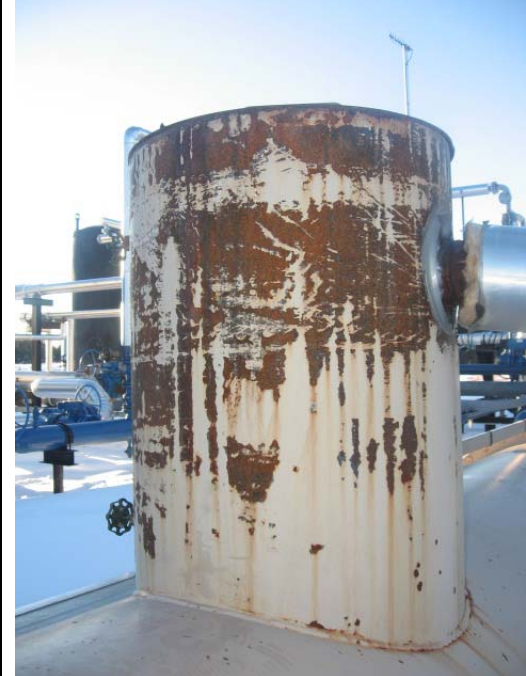
Accumulator – missing paint
