# Pressure Equipment Static Data

## Pressure Vessel External Inspection

## Pressure Vessel Internal Inspection

# UT CORROSION SURVEY REPORT READINGS

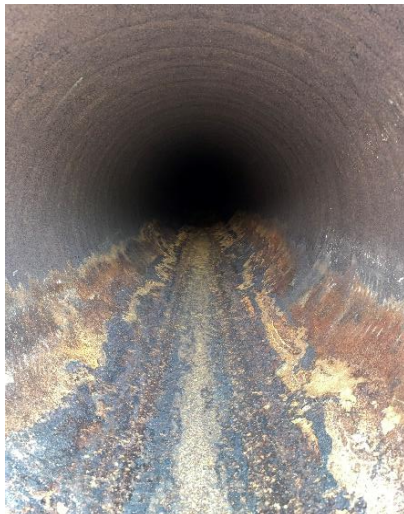
STACK SIDE INTERNAL OVERVIEW

MINOR INTERNAL CORROSION WAS NOTED THROUGHOUT THE 6 O'CLOCK POSITION OF THE STACK SIDE TUBE. THERE WAS NO SIGNIFICANT WALL LOSS NOTED IN ANY OF THE INSPECTED RETURN BENDS. SEE BELOW FOR LOCATIONS AND RESULTS.

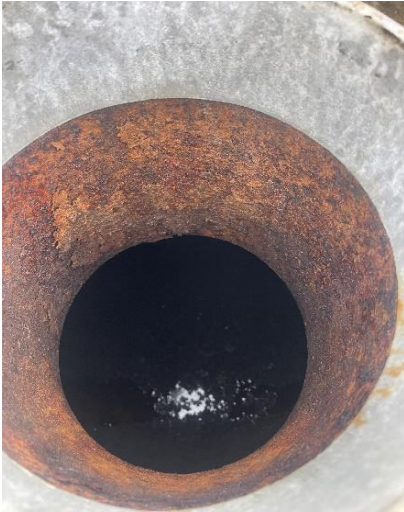
<b>Welds</b>	Acceptable	Accessible welds were in good condition. There was no visible corrosion. All accessible welds had full profile and had the same general appearance as the HAZ and the parent material.	
<b>Coating</b>	N/A		
<b>Firetube</b>	Acceptable	24" Firetube was in good overall condition. There was no significant corrosion or mechanical damage noted. Minor corrosion noted inside the stack side tube at the 5-7 o'clock position. There was no visible hot spots or deformation noted during inspection.	
<b>Tubesheet</b>	Acceptable	Firetube tubesheet is in good overall condition. There was no visible corrosion, mechanical damage, or deflection noted at time of inspection.	
<b>Tube Bundle</b>	N/A		
<b>Other</b>	Observation	Thief hatch is in good overall condition and was in good working order. Minor corrosion noted in nozzle neck. All corrosion was less than 0.020" deep. Hatch seal is in poor condition and needs to be replaced.

EXPANSION TANK THIEF HATCH NOZZLE NECK

<b>Recommendations</b>			<b>NCR #</b>
Replace thief hatch seal prior to start up.

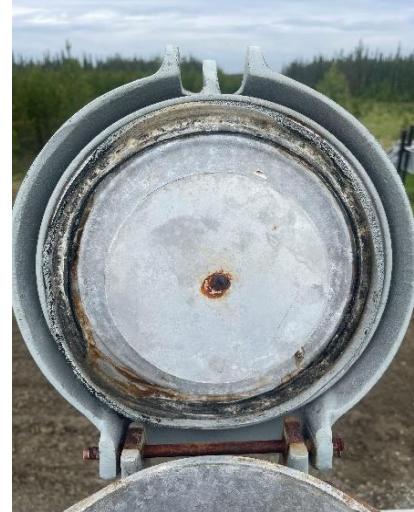
EXPANSION TANK THIEF HATCH GASKET CONDITION

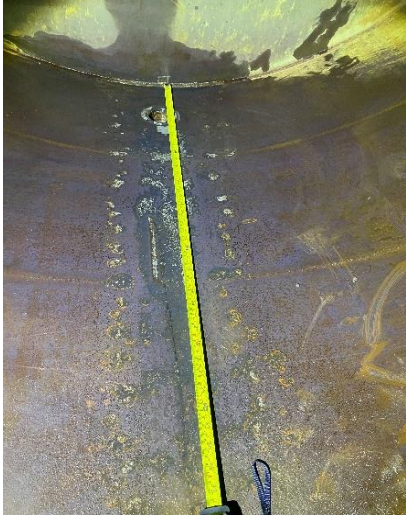
GENERAL CORROSION AT BACK END OVERVIEW

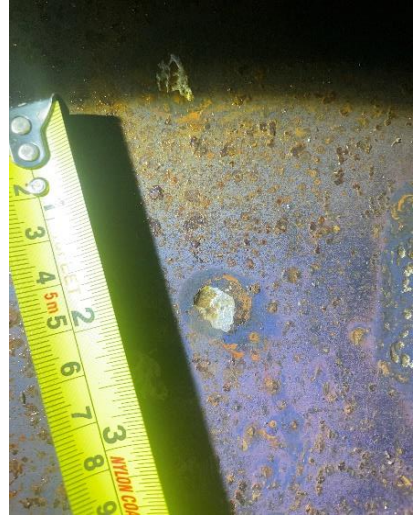
TYPICAL CORROSION CLOSE UP AT BACK END

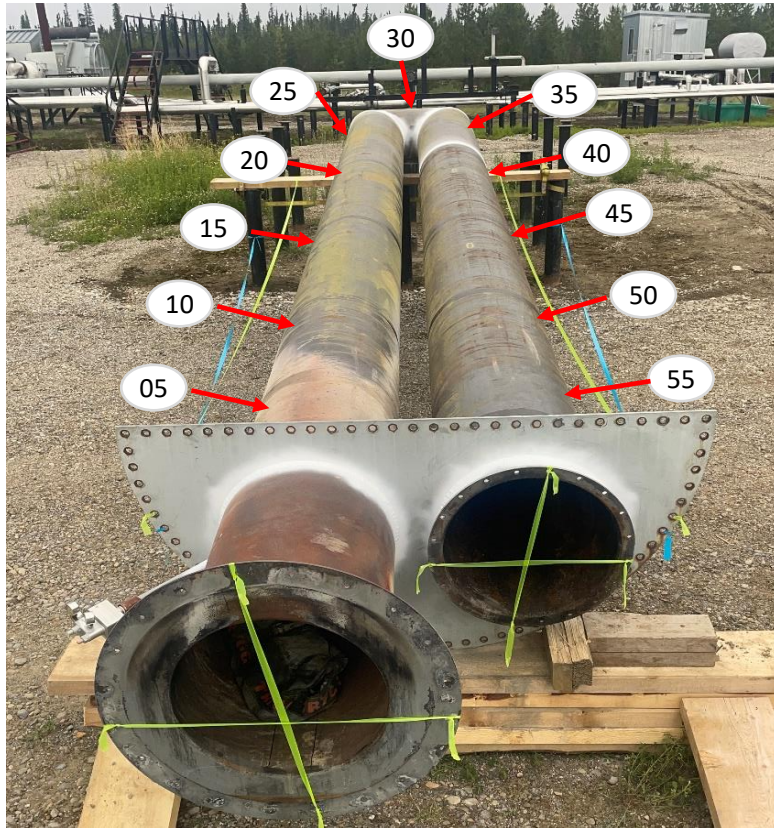
O.D	24"
LENGTH	28'
NOM.	0.375"

LOCATION	LOW	AVG
05	0.356"	0.367"
10	0.357"	0.366"
15	0.353"	0.366"
20	0.362"	0.369"
25	0.361"	0.377"
30	0.367"	0.372"
35	0.372"	0.381"
40	0.351"	0.373"
45	0.336"	0.364
50	0.341"	0.367"
55	0.351"	0.369"

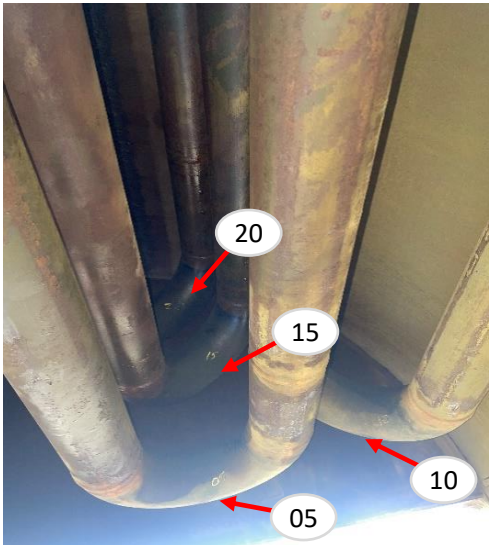
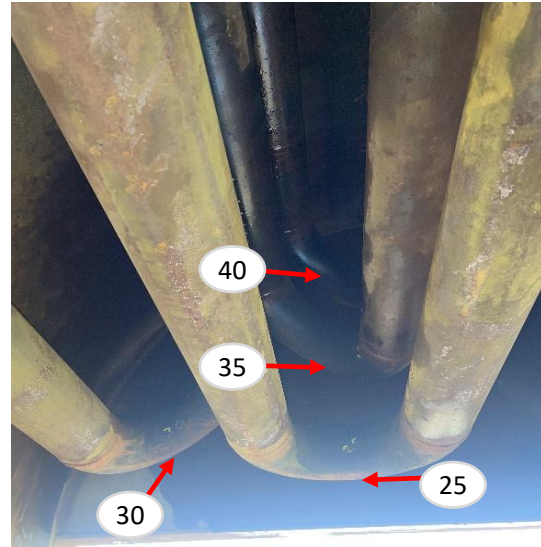
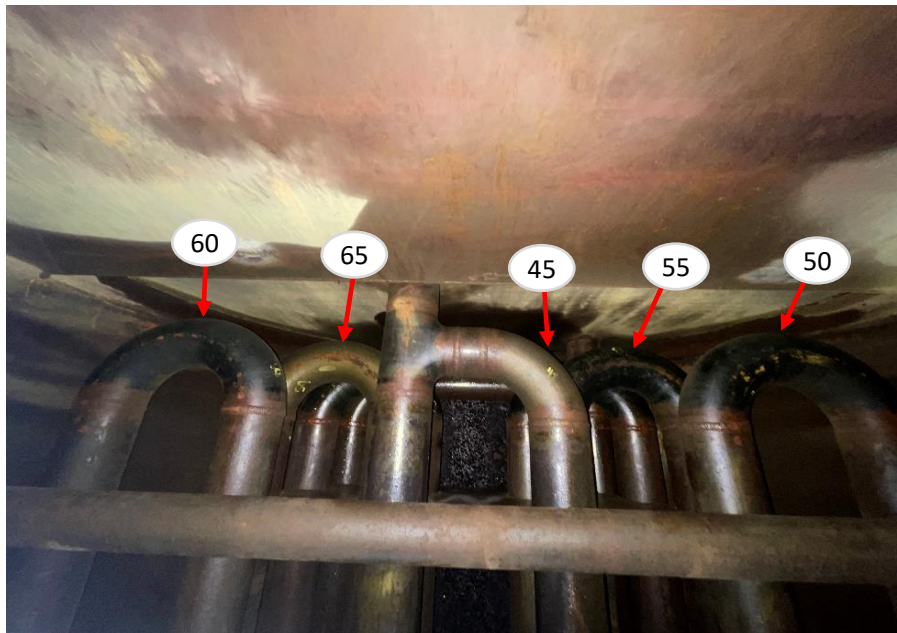
LOCATION	LOW	AVG
05	0.309"	0.323"
10	0.317"	0.332"
15	0.327"	0.337"
20	0.339"	0.346"
25	0.304"	0.328"
30	0.319"	0.329"
35	0.321"	0.341"
40	0.321"	0.332"
45	0.346"	0.353"
50	0.302"	0.329"
55	0.328"	0.349"
60	0.321"	0.339"
65	0.328"	0.347"

4.5" O.D. - 0.337" ASSUMED NOMINAL
