Pressure Vessel Visual External Inspection Form

District	Grande Prairie	Field	Smokey Field	LSD:	05-19-58-02 w6m	Date	Feb. 25, 2014
Equipment #	399355	Equipment Name		Line Heater		Inspector	Steve Utz

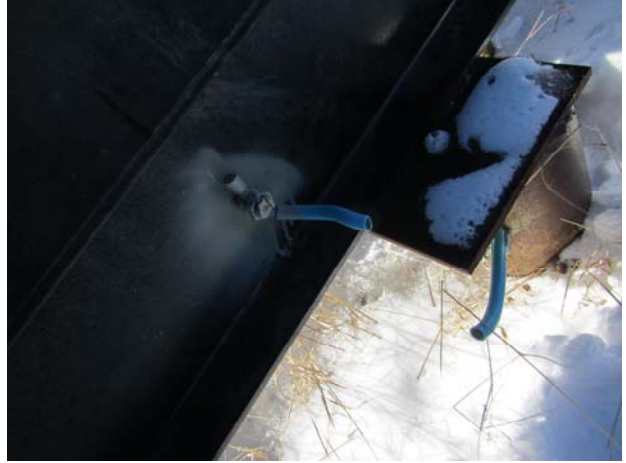
Grounding connection			x	Ground cable is cut.
Anchor Bolts				
Hammer tap to ensure secure	x			Anchor Bolts are present, tight with no damage visible.
No cracking in threads or signs of deformation	x			
Concrete Foundation				
No cracks or spalling, deterioration			x	No concrete.
Ladder/Platform				
Support is secure	x			Appears secure, no damage visible.
Attachment clips, welds and bolts	x			Appears secure, no damage visible.
Any hazards present	x			
Nozzles				
No signs of leakage, damage, deflection	x			No damage, leaks or deflections.
External Piping				
Proper supports in place	x			All piping appears well supported.
Paint condition	x			Paint is in fair condition.
No signs of damage, structural overload, etc	x			No visible damage or signs of overload.
Manways/Quick Release Closures/Davits				
No signs of cracking or mechanical damage			x	No manway.
No loose bolts or damage to swing arm			x	
Gauges				
Visible, functioning, no sign of leakage			x	No gauges.

Ground Cables Cut
