**Canadian Natural Resources Limited
GENERAL PRESSURE VESSEL INFORMATION**

Job # 05.004099

District: Fort St. John, BC.	Skid No.
Facility: Murray River Field	Location (LSD): b-77-J/93-I-14
Vessel Name Equipment Number: Line Heater // H-101	
Orientation: Horizontal	
Status: In Service	Regulatory Inspection

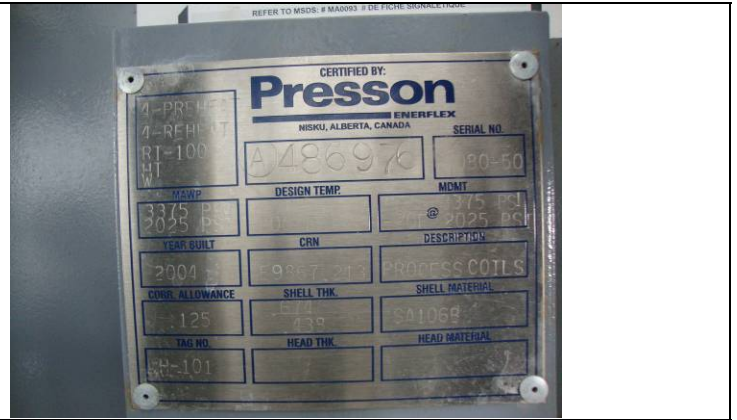
Vessel data plate

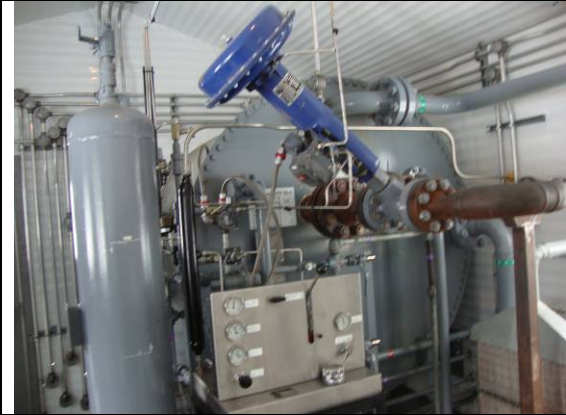
Vessel inlet overview

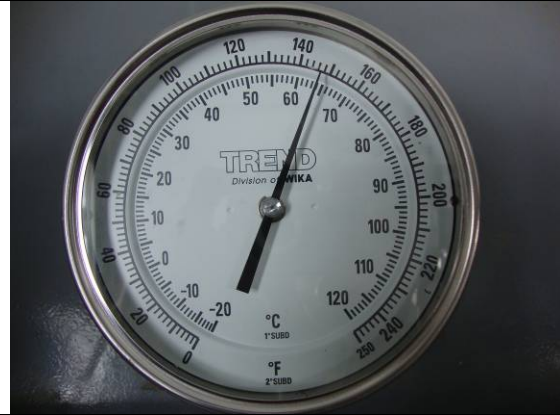
Vessel temperature gauge

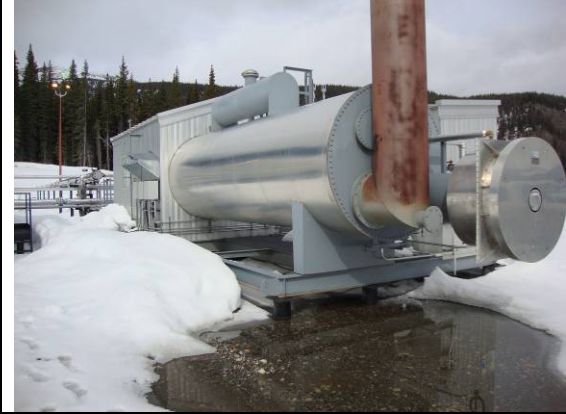
Vessel overview
