**Canadian Natural Resources Limited
GENERAL PRESSURE VESSEL INFORMATION**

Job 10.114525

District: Fort Saint John, B.C.	Skid No.
Facility: Wolverine	Location (LSD): d-66-D / 93-P-02
Vessel Name Equipment Number: Line Heater	
Orientation: Horizontal	
Status: In Service	Regulatory Inspection

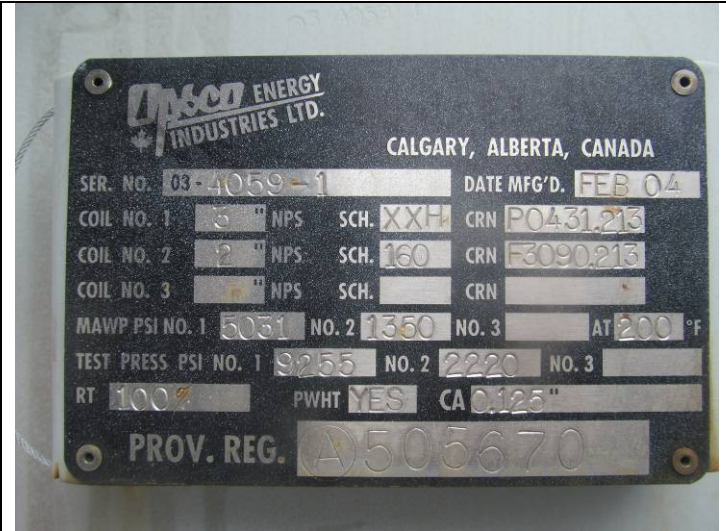
Data plate

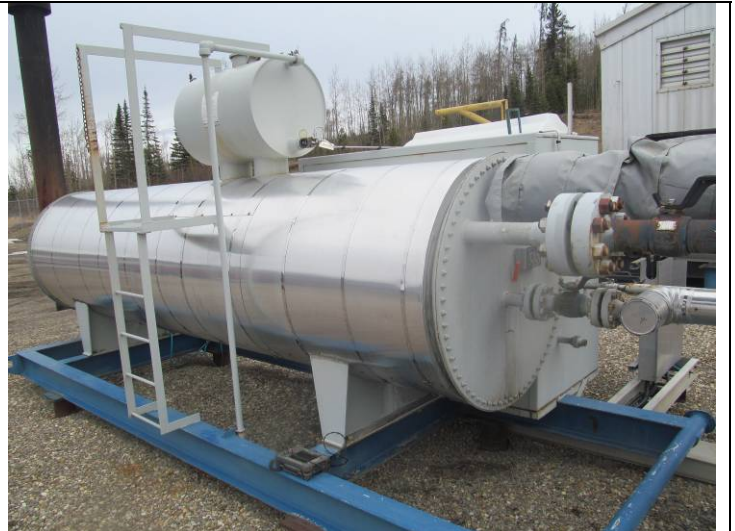
Overview

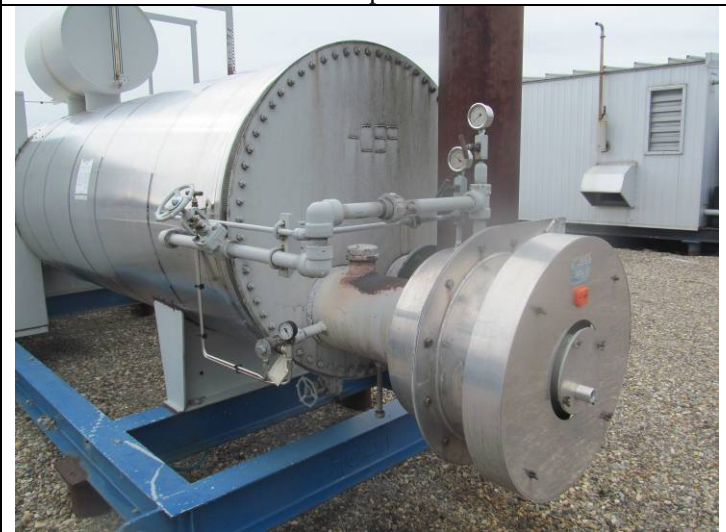
Overview

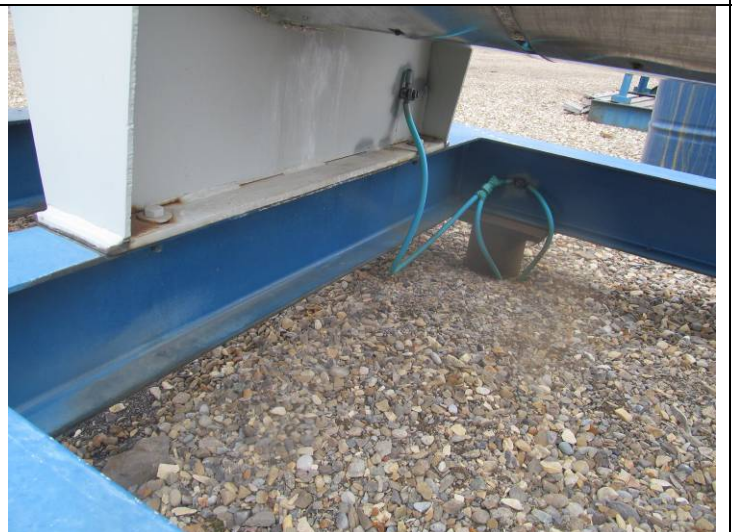
Ground
