**Canadian Natural Resources Limited  
GENERAL PRESSURE VESSEL INFORMATION**

**Job 10.180192**

District: <b>Fort St. John, BC.</b>		Skid No.					
Facility: <b>Thunder Creek Compressor Station</b>		Location (LSD): <b>d-31-H/93-I-15</b>					
Vessel Name & Equipment Number: <b>Line Heater</b>							
Orientation: <b>Vertical</b>							
Status: <b>Operating</b>		<b>Regulatory Inspection</b>					
<b>PRESSURE VESSEL NAMEPLATE DATA</b>							
"A" or "G" or "S" (Sask.) or BC Registration Number.  <b>A0528515</b>		CRN Number  P 9412.132					
Vessel serial number: BW 336.003		Size: 48 in. OD x 15 ft. S/S					
Shell thickness: 9.5 mm		Shell material: SA 36					
Head thickness: 9.5 mm		Head material: SA 36					
Tube wall thickness:		Tube material:					
Tube diameter:		Tube length:					
Channel thickness:		Channel material:					
Design pressure	Shell: 4651 kPa	Operating pressure	Shell:				
	Tubes:		Tubes:				
Design Temp.	Shell: 38°C	Operating temperature	Shell:				
	Tubes:		Tubes:				
X-ray: RT 1		Heat treatment: Nil

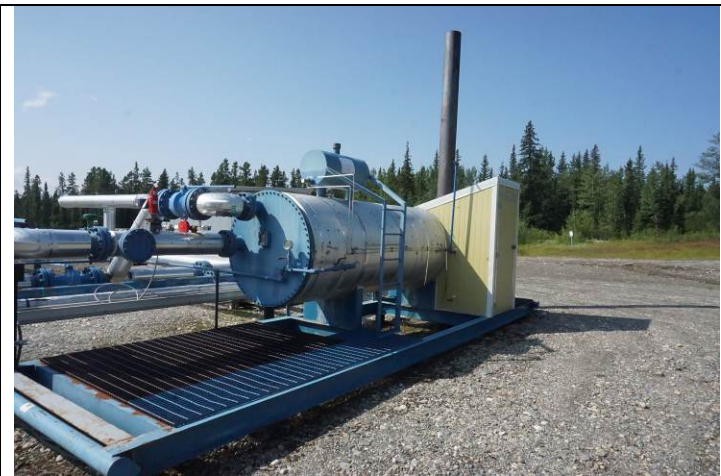
Vessel overview

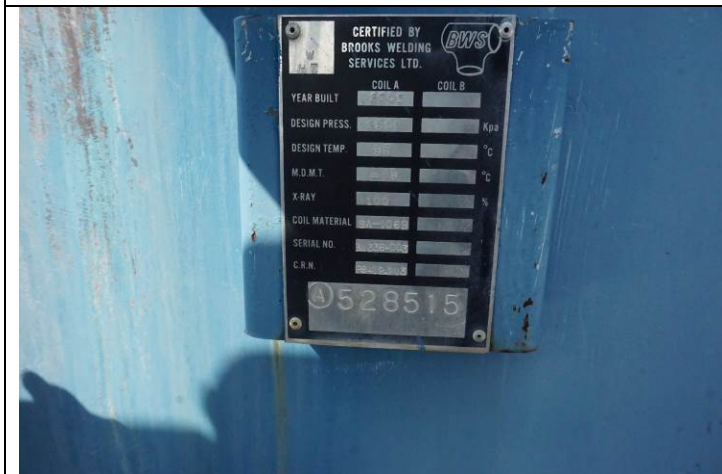
Data plate

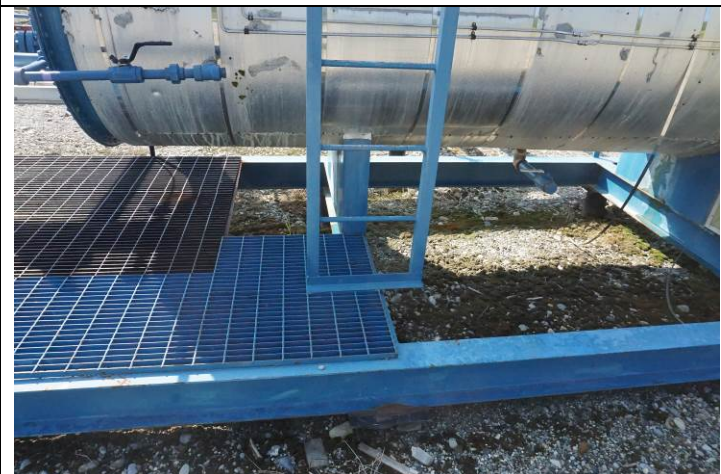
Pilings

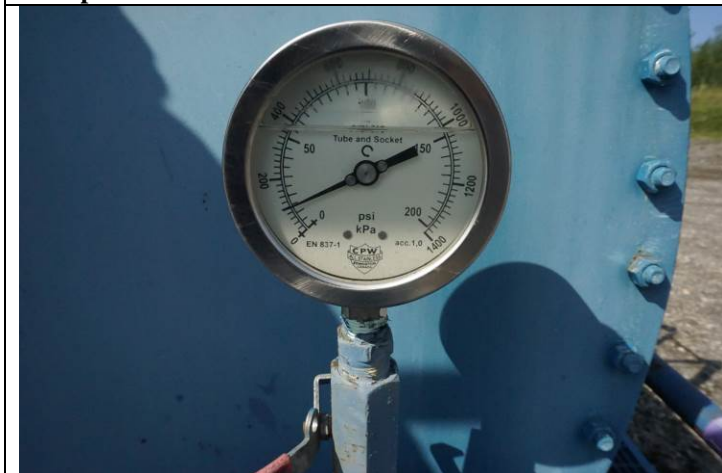
Pressure gauge

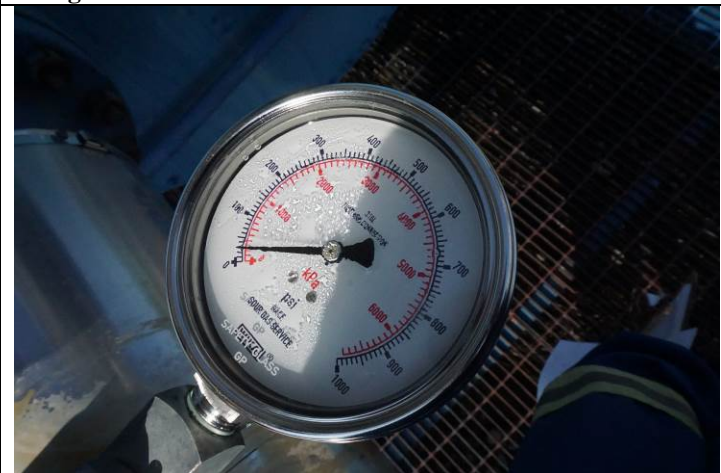
Pressure gauge

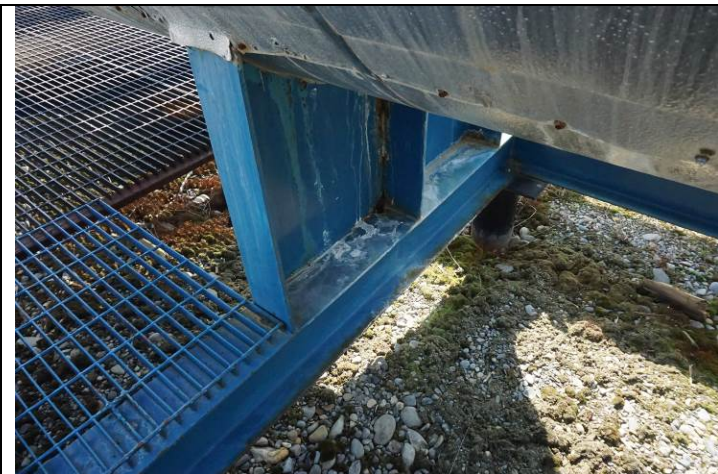
Saddle support

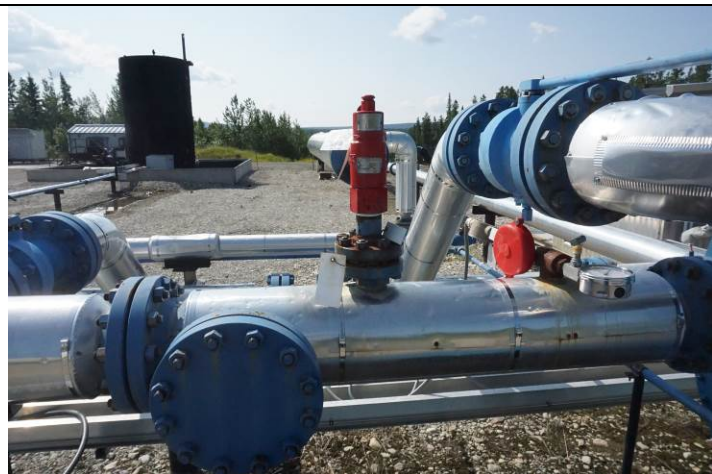
PSV location

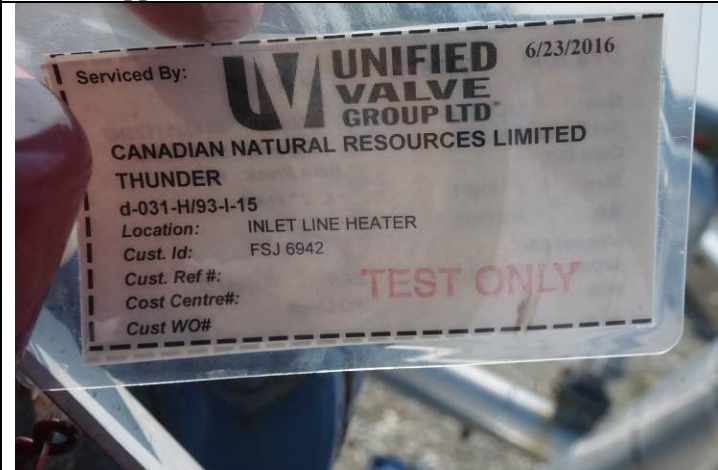
PSV service tag

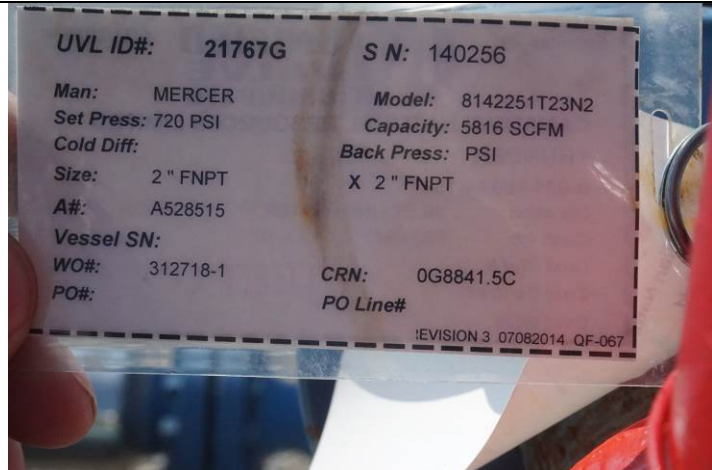
PSV service tag
