**Canadian Natural Resources Limited  
GENERAL PRESSURE VESSEL INFORMATION**

**Job # 10.111452**

<b>District: Grande Prairie AB</b>	Skid No.
<b>Facility: Spring Lake Gas Gathering</b>	<b>Location (LSD): 03-17-76-11W6M</b>
<b>Vessel Name Equipment Number: Line Heater</b>	
<b>Orientation: Horizontal</b>	
<b>Status: In Service</b>	<b>Regulatory Inspection</b>

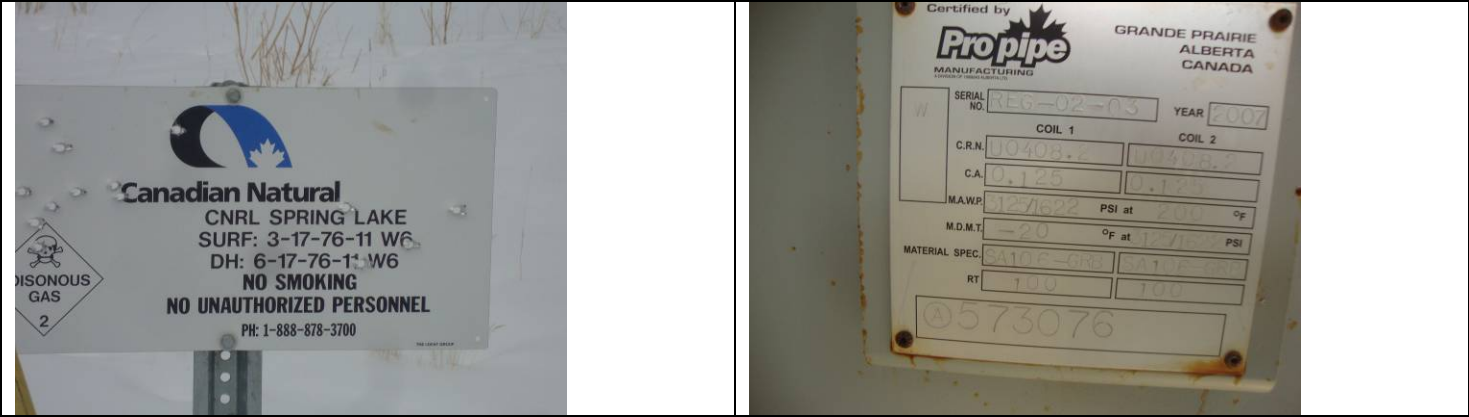
LSD

Vessel data plate

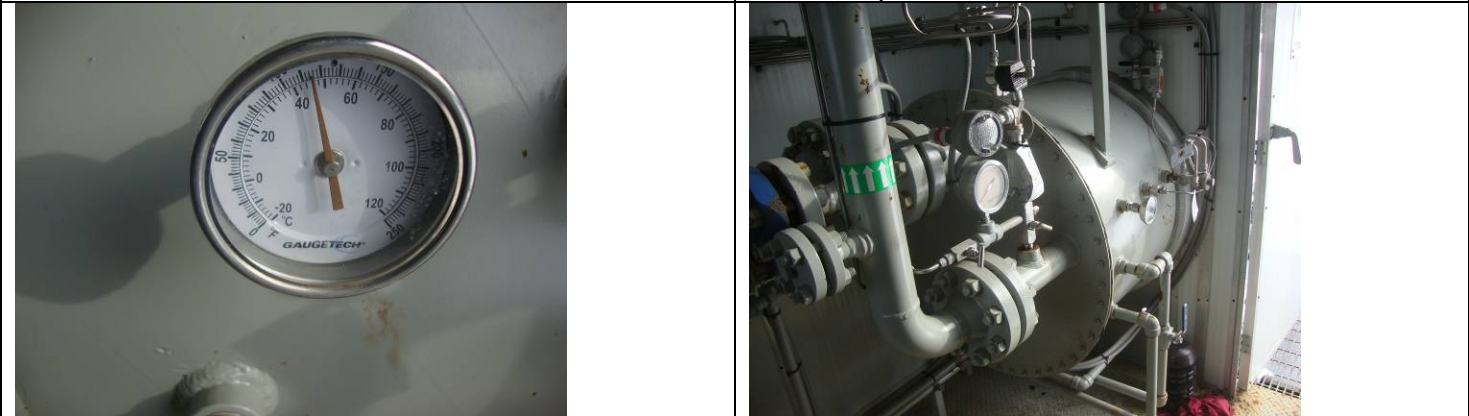
Temperature gauge

Vessel overview

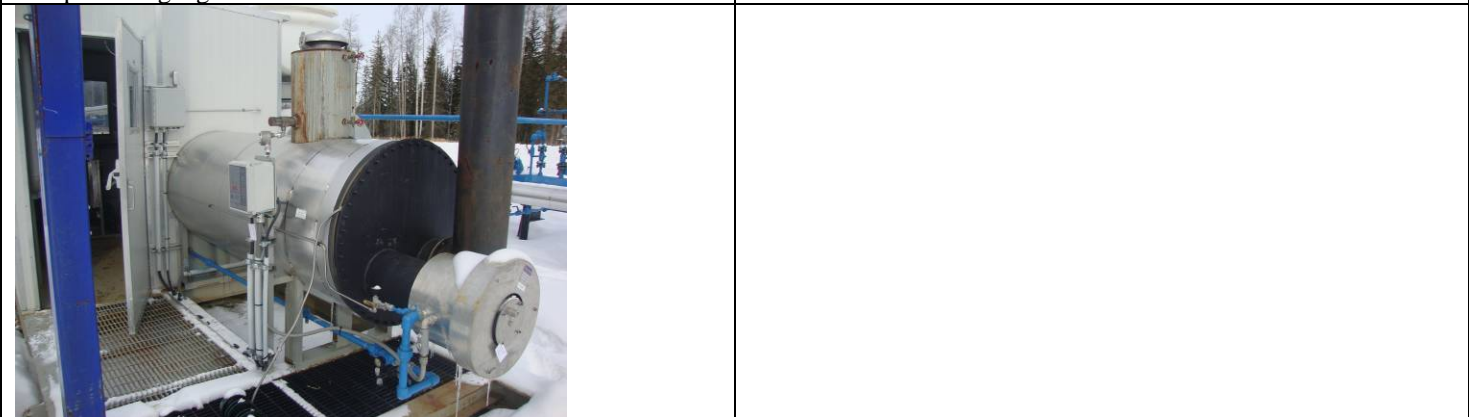
Vessel overview
