**Canadian Natural Resources Limited
GENERAL PRESSURE VESSEL INFORMATION**

Job# 10.110181

District: Fort St John, B.C.	Skid No.
Facility: Drake LadyFern Compressor	Location (LSD): c-10-J/94-H-01
Vessel Name Equipment Number: Line Heater	
Orientation: Horizontal	
Status: Not in Service – Inventory only	Regulatory Inspection

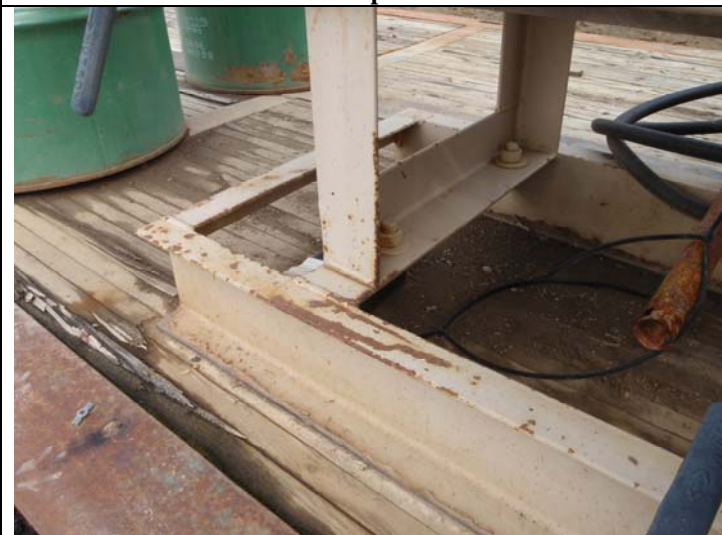
External Inspection Items	G	F	P	N/A	Comments
Insulation Verify sealed around manways, nozzles, no damage present, and there is no egress of moisture.	X				No damage present- sealed around nozzles and saddles. No egress of moisture. Straps are secure and in place.
External Condition Assess paint condition, areas peeling, record any corrosion, damage, etc (record location, size and depth of corrosion or damage)	X				Paint in good overall condition – No exposed metal.
Leakage Record any leakage at flanges, threaded joints, weep holes on repads, etc.	X				No leaks observed.
Saddle/Skirt Assess condition of paint, fire protection, concrete. Look for corrosion, buckling, dents, etc. Look at vessel surface area near supports. Verify no signs of leakage at attachment to vessel and attachment welds are acceptable. Ground wire attached?	X				Saddle: welded directly to skid frame. Skid sits on wood rig mat No buckling or dents. No corrosion at attachment welds to vessel. No Ground wire attached to skid

Skid not Grounded

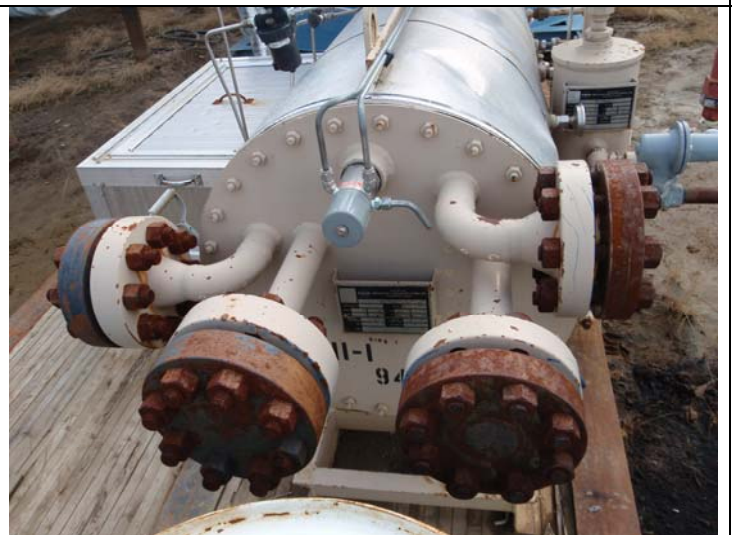
Process Piping disconnected
