GENERAL INSPECTION FORM						
District: HAM #1			Skid No. :			
Facility: Hamburg Gas Gathering			Location (LSD) Surface: 15-09-96-11- W6M			
Vessel Name & Equipment Number: Line Heater						
Orientation: Horizontal <input checked="" type="checkbox"/> or Vertical <input type="checkbox"/>			Location (LSD) Downhole:			
Status: In Service <input checked="" type="checkbox"/> or Out of Service (blinded / fully isolated) <input type="checkbox"/>			Commissioning Inspection <input type="checkbox"/> or Regulatory Inspection <input type="checkbox"/>			
PRESSURE VESSEL NAMEPLATE DATA						
"A" or "G" or "S" (Sask.) or BC Registration Number. A# 465074			CRN Number D-4268.213			
Vessel serial number: CB-10189			Size (diameter x length- estimate if necessary): 48 in x 142 ft.			
Shell thickness: Not stated			Shell material: Not stated			
Head thickness: Not stated			Head material: Not stated			
Tube wall thickness:			Tube material:

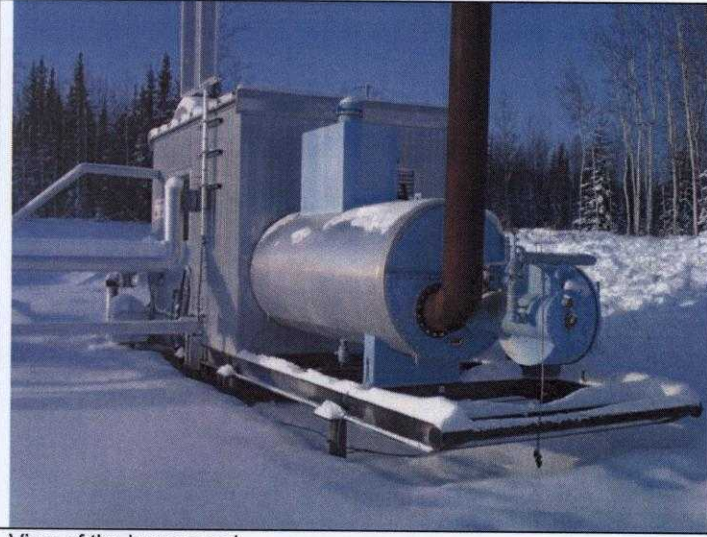
View of the burner end

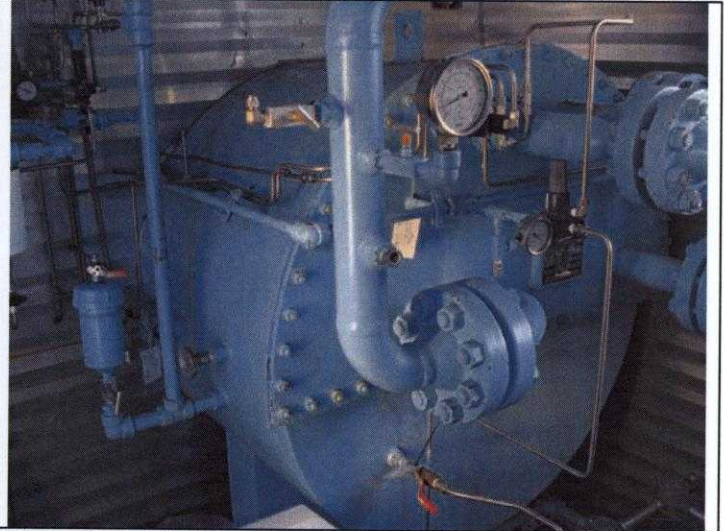
View of the insulation.
