PRESSURE VESSEL & COLUMN INSPECTION REPORT

LSD: 02-31-022-11W4M Date: MAY 16, 2014 SAP Equipment ID: 66047500

VESSEL STATIC DATA							
Plant	Wardlow Oil Battery	Op Unit		System			
Prov. Insp. #	A2619721	CRN	K0237.2	Equip Tag #	V-100, barcode 067134		
Equipment Description	Inlet Separator			Serial #	2015.90		
Manufacturer	Sure Weld			Vessel Class			
Internal Access:	YES	Description: 18" manway		Year Built	1990		
MAWP	9800	kPa	@ 38	°C	MDMT	0 °C	
CODE :	UM- U U2	RT : 1		PWHT : no			
Diameter	42"	Length (s/s)	120 in (approx.)	OAL	mm / in	Vertical	
Shell	Mat'l	SA-516-70N	Thickness	in	Corr Allowance	1.6 mm	
Head	Mat'l		Thickness	in	Corr Allowance	1.6 mm	
Nozzle	Mat'l		Thickness	mm / in	Corr Allowance	mm / in	
Internal Coating:	NO		Internal Clad :	NO		Capacity	m ³
Manway :	YES		Inspection Port :	YES		SKIRT	
Nozzle Rating	600	lb ANSI	Painted :	YES		Insulated	NO
PROCESS DATA							
Product Description	Emulsion, gas, produced water			Sweet			
Operating Pressure	kPa / PSI		Operating Temperature				°C / °F
PSV STATIC DATA

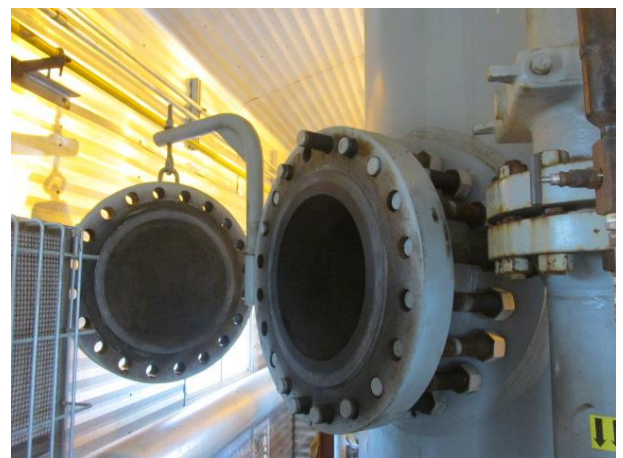
Manway - 18"

An internal visual inspection was conducted on vessel after it had been cleaned. Vessel access is through 18" manway. Vessel is uncoated. There is a vertical baffle plate running down middle of vessel, across from manway. This baffle plate limits cleaning and visual inspection of shell to manway side of vessel only. Due to the presence of the baffle plate, only a "head and shoulders" inspection through the manway was possible. Shell and bottom head (as visible) was found to be in good condition. No significant corrosion or damage noted. Baffle plate is in good condition and securely welded to shell. There is no visual access to top head due to presence of demister. The demister was found to be in good condition. No damage was noted to demister or supports, and all supports appear secure. The manway nozzle and gasket surface is in good condition. Manway flange is double nutted.

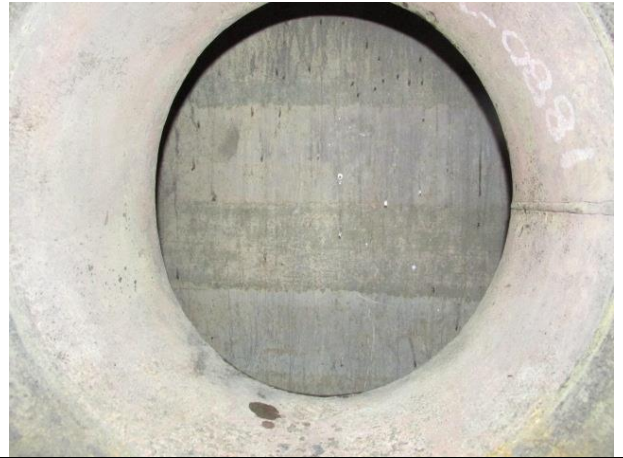
V23	Baffle/Wier	Good	Down center of shell		No damage, welds in good condition, secure. Limits inspection to half of vessel only
V24	Sparger	n/a			
V25	Thermowells	n/a			
V26	Metallic Linings	n/a			
V27	Nonmetallic Linings	n/a			Vessel is un-coated
V28	Trays	n/a			
V29	Tray Rings	n/a			
V30	Other Welded Attachments

Baffle plate across from manway, limits internal cleaning and visual to half of vessel only

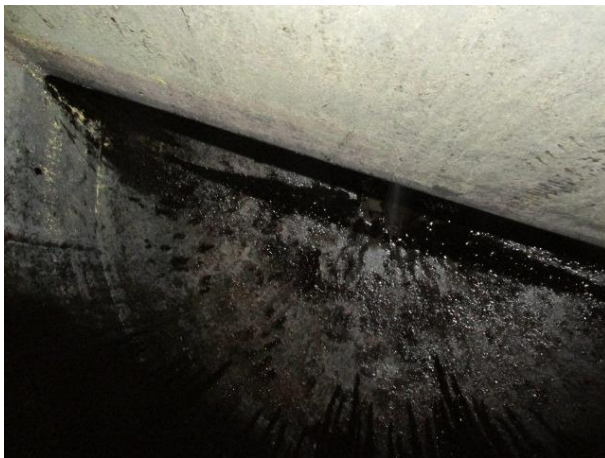
Bottom head

A boroscope was used to aid in visual inspection of bottom head, especially for portion of bottom head behind baffle. A Boroscope inspection was also done through 2" thread-o-lette on side shell (opposite manway). This area of vessel shell was not cleaned so inspection was limited. No significant concerns noted during boroscope inspection on areas not visible from manway.

Review UT corrosion survey data to verify bottom head and drain condition.

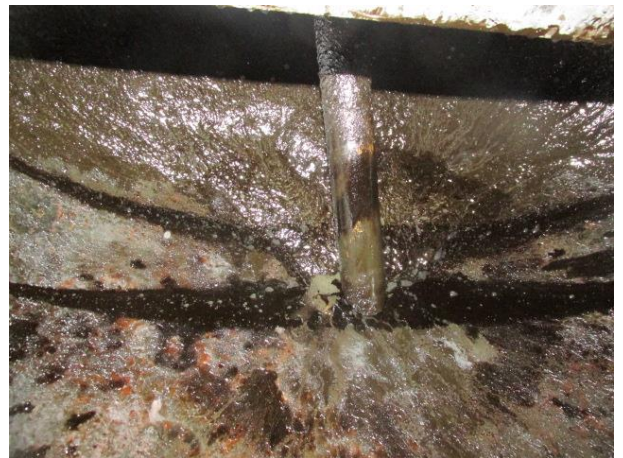
Bottom head and draw off line

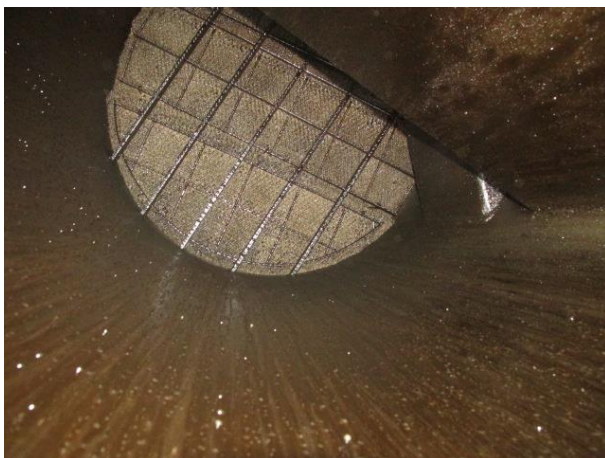
ID	Description	Condition	Location	NCR	Comments
V1	General Other (Please Explain)	Good			Only partial internal inspection was possible
V2	Corrosion (depth, length, width)	n/a			No internal corrosion noted
V3	Erosion	n/a			No internal erosion noted
V4	Distortion	n/a			No distortions noted
V5	Blisters	n/a			
V6	Deposits	n/a			No deposits noted
V7	Heads	Good			No visual access to top head due to demister. No significant corrosion noted on bottom head as visible
V8	Welds	Good			No weld defects or corrosion noted, as visible
V9	Nozzles	Good	Manway nozzle		No corrosion or damage to manway nozzle internal surface noted
V10	Shell	Good			No corrosion or damage noted, as visible
V11	Gasket Surfaces	Good			No corrosion or damage noted
V21	Internals Other (Please explain)	Good	Baffle plate, draw off line, demister and demister supports		All internal attachments are in good condition and secure
V22	Demister	Good			No damage noted, well supported

Shell and demister

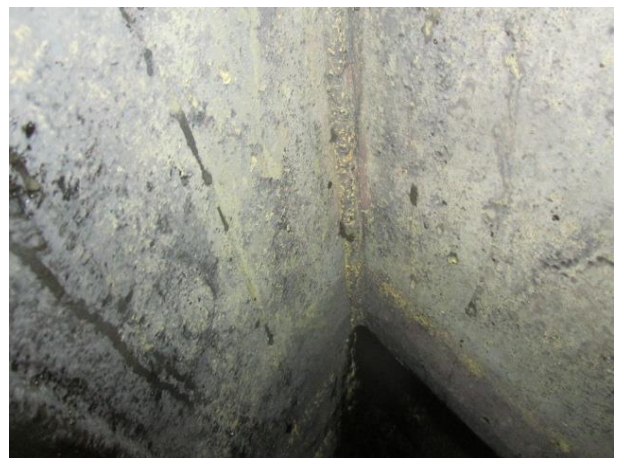
Baffle plate to shell weld
