Field Inspection Report

Client	CNRL		Date of Inspection	March 13, 2012					
Prov. Reg.#	A2664161		Inspection Type	VE, UT					
Equipment	Horizontal Separator		Location	Redcliff South					
Tag/Equip. #	V 102		LSD	08-23-012-07W4M					
Vessel Status	In Service		Comp./Unit #						
Manufacturer	Sure Weld Industries Ltd		MAWP / Temp	259 PSIG @ 140 F					
Serial #	2059.90	CRN #	K 1666.23	MDMT@ Pressure	-20 F @ 259 PSIG				
Corrosion Allowance	0.059"	Shell Material		Shell Thickness					
Year Built	1990	Head Material		Head Thickness					
Diameter	36" OD	Length		Height		RT	RT-2	HT	
Service	Sweet	Next Inspection		Next Insp. Type					
ASME Stamp	Yes	Next Inspection		Next Insp. Type					
PSV Tag #	ID 36886B	CRN#		Set Pressure		125 PSIG			
Manufacturer	Farris			NB#		ASME Stamp			
Type/Model	27-FA45-M20	Serial	459169-8-KE	Inlet Size		1.5"			
Capacity	857 SCFM	Service Company	Unified Valve	Outlet Size		2"			
Service Date	September 20, 2011		Next Service Date

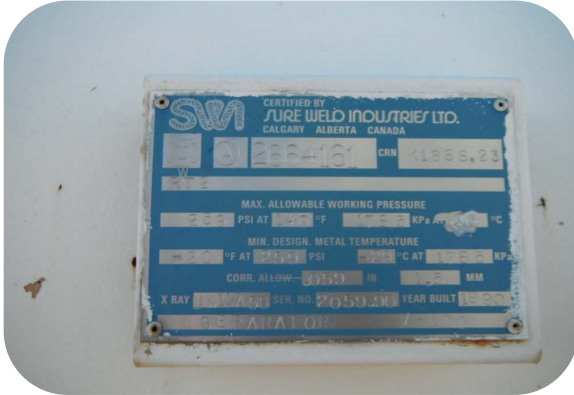
A2664161_Name Plate_14March2012

- Name plate was attached and readable.
- External paint was in fair condition with slight external corrosion present but not measurable.
- Vessel is supported on saddles, shell to saddle welds were in good shape.
- Saddles were bolted securely.
- All external nozzles were in good condition, no leaking flanges, gaskets, or threaded connections.
- All bolting hardware was intact.
- Pressure gauge was in good working order.
- Liquid level sight glass was in good shape with no cracks or leaks.
- No deflection or deformation of the shell, heads or nozzles.
- Repad weep holes were open and no signs of leakage.
- Manway davit arm was in good working order.
- All associated piping was intact and secure.
- Vessel is grounded.
- PSV was located without restrictions, Service date and Set pressure acceptable.
- UT survey found no areas of concern, see attached UT Report.

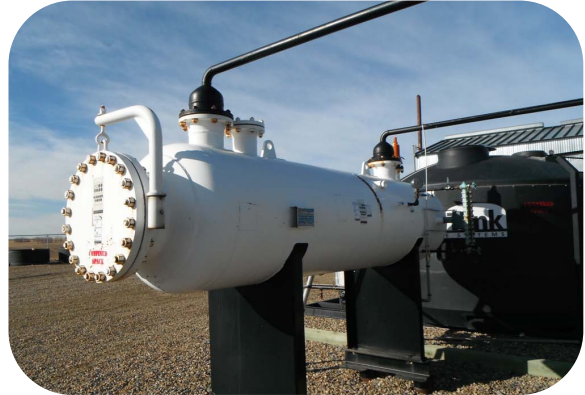
A2664161_Side View_14March2012

General Comment's: Horizontal Separator was found to be in good general condition.

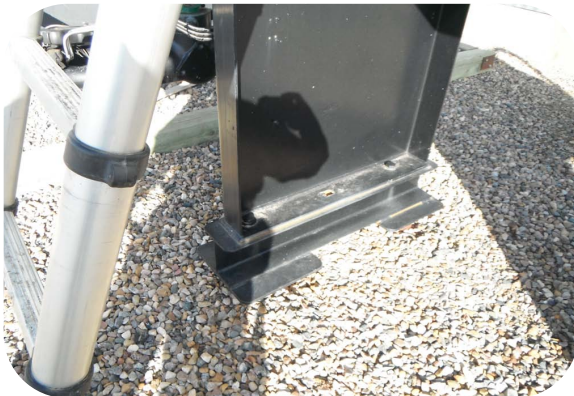
A2664161_Vessel supported on
saddles_14March2012
