Re: **Ultrasonic Corrosion Survey of Redcliff South Compressor Station**

SUMMIT Inspection Services Ltd.

Re: **Baseline Ultrasonic Corrosion Survey of Redcliff South Compressor Station**

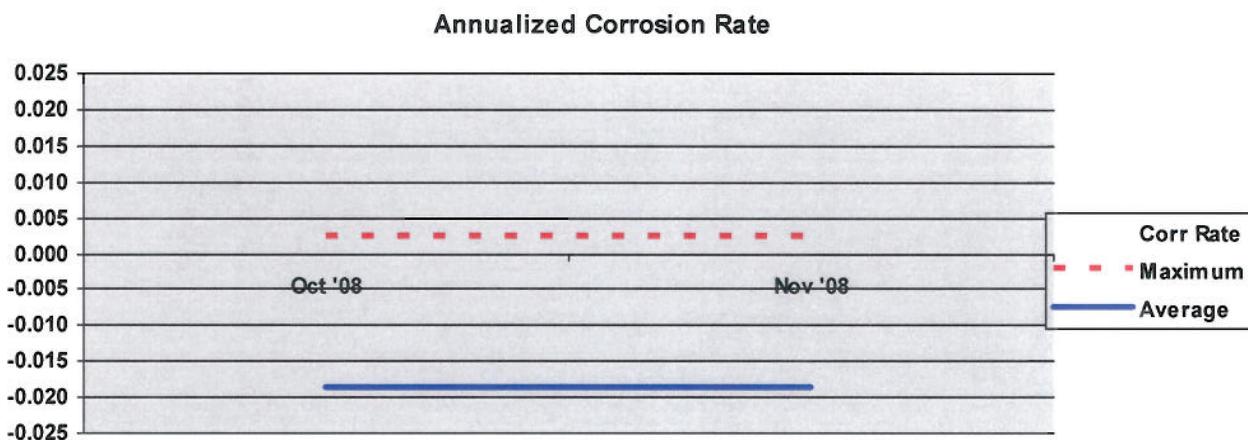
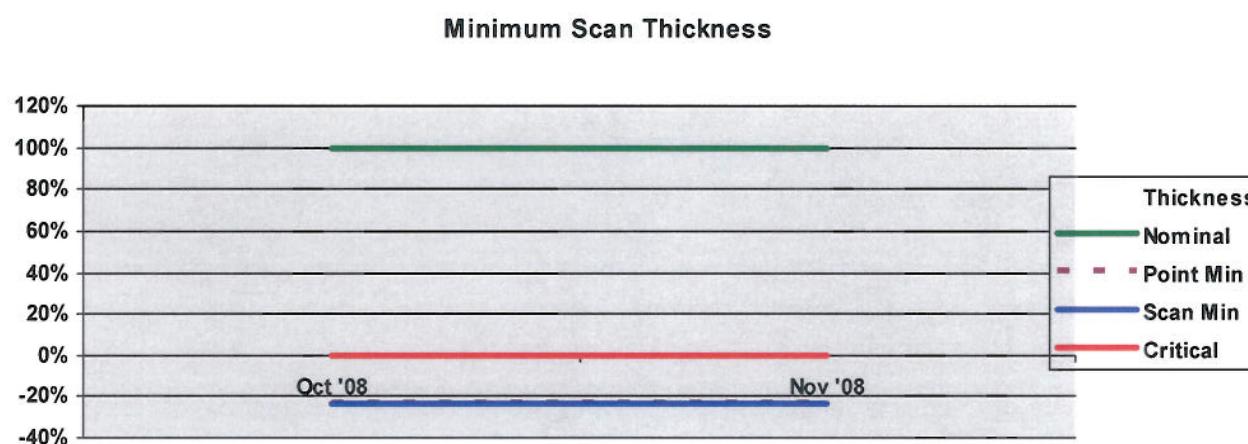
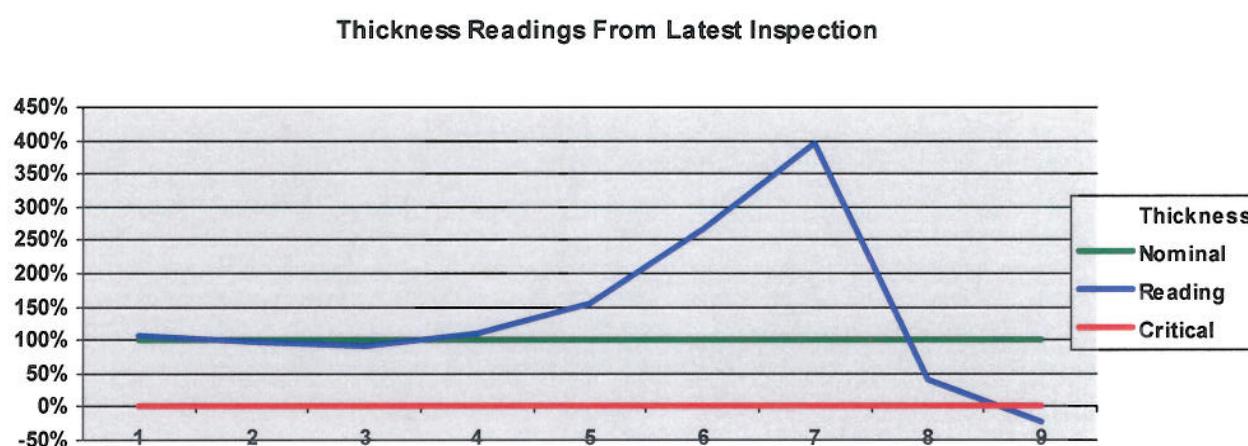
Tab 8, Unit #1 Compressor (north)
Component (g) 1st. Stage Discharge Bottle (south stage)
Item 824, Top West Head, -6.2 years to critical thickness.
