**Canadian Natural Resources Limited
GENERAL PRESSURE VESSEL INFORMATION**

District: Fort St. John, BC	Skid No.
Facility: Cecil Gas Gathering	Location (LSD): B11-23-84-18 W6M
Vessel Name Equipment Number: Test Separator	
Orientation: Vertical	
Status: In service	Regulatory Inspection

A. S. S.
API 20981 / PESL 275
Inspected By: Dellas Wiedman

Date: October 23, 2014

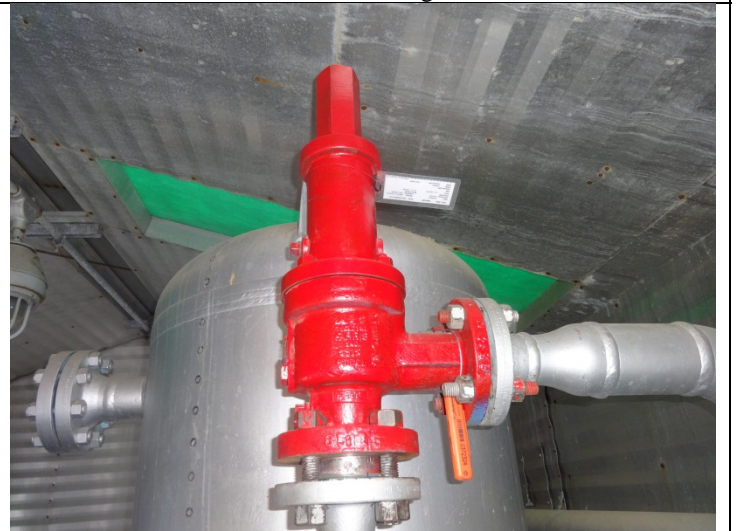
PSV Overview

PSV Ensure PSV is set at pressure at or below that of vessel. Discharge piping is same size as inlet to valve and is properly supported and routed. Ensure no block valves between PSV and vessel or if there are they are locked open.	X				Located on top shell– set to MAWP of vessel. Seal is intact / No block Valve / discharges to atmosphere. PSV is properly supported.
