Ultrasonic Corrosion Survey

OWNER	DEVON CANADA	REG. NO	A2813745	NOTES
DISTRICT	CENTRAL	NAME	SEPARATOR	
FACILITY	MARION LAKE	SIZE	24" X 7' 6"	
LSD	10-31-37-17W4	OTHER	MLV-9

Separator 2813745

Vessel Summary

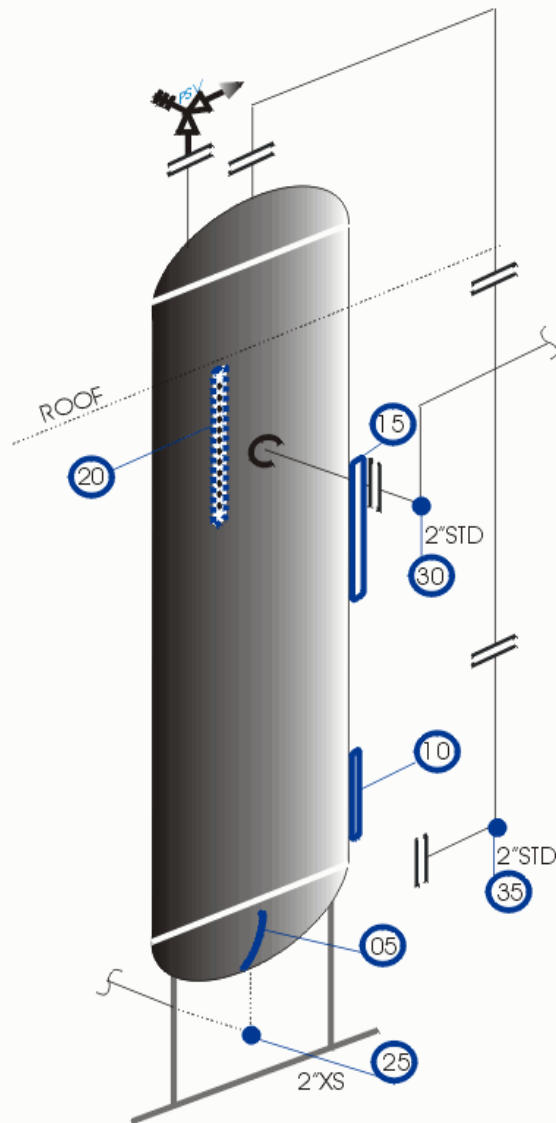
Point Number	Type	Survey Readings (inch)			Point Data (inch)			Calculations		
		Date	Low	Avg	Nom.	C.A.	Nom - CA	T Req (inch)	Long Term Corr Rate	Remaining Half Life
05	Head	Jan 23/06	0.467	0.485	0.437	0.000	0.437	0.392	0.000	99.00
10	Shell	Jan 23/06	0.500	0.502	0.472	0.000	0.472	0.398	0.000	99.00
Readings: 0.503, 0.503, 0.507, 0.500, 0.500, 0.503, 0.503, 0.500, 0.500, 0.503, 0.503, 0.500 Notes: The above readings were used to obtain the min and avg readings for the TML Comments: POINTS FROM T-B										
15	Shell	Jan 23/06	0.493	0.500	0.472	0.000	0.472	0.398	0.000	99.00
Readings: 0.503, 0.493, 0.500, 0.493, 0.497, 0.497, 0.500, 0.507, 0.503, 0.500, 0.503, 0.507 Notes: The above readings were used to obtain the min and avg readings for the TML Comments: POINTS FROM T-B										
20	Shell	Jan 23/06	0.493	0.497	0.472	0.000	0.472	0.398	0.000	99.00
Readings: 0.493, 0.510, 0.497, 0.493, 0.493, 0.497, 0.493, 0.493, 0.497, 0.497, 0.500, 0.497 Notes: The above readings were used to obtain the min and avg readings for the TML Comments: POINTS FROM T-B
