GENERAL PRESSURE VESSEL INFORMATION					
District: Central			Skid No.:		
Facility: Marion Lake			Location (LSD): 04-31-037-17W4		
Name & Equip No: Separator - MLV-8			Orientation: Vertical		
Company: Devon Canada			Cost Code:		
Status: Operating			Operating Province: Alberta		
ABSA					
Plant:			Vessel:		
Process:			Special:		
Amount(\$):					
PRESSURE VESSEL NAMEPLATE DATA					
Registration Number: 2899376			Registration Number (Other):		
Serial Number: VS 6843			CRN Number: M 1280.2		
MAWP: 500.00 (psi)		3447.40 (Kpa)		AT temperature: 100.00 (F) 37.78 (C)	
Size (diam. x length): 36.00 x 120.00 (In) 914.40 x 048.00 (mm)			Manufacturer: LARSEN & D'AMICO MFG. LTD.		
X-Ray: Spot			Lining Or Coated: No		
Year Built: 1993			Heat Treatment: No		
Code parameters:			Corrosion allowance: 0.00 (In) 0.00 (mm)		
Joint efficiency: 0.85			Manway: No		
PIPING NAMEPLATE DATA					
Primary Flange Rating: 300			ASME B16.5 - Table 2-1.1 @ 150F: 740 (psi)

Ultrasonic Corrosion Survey

Separator 2899376

Vessel Summary

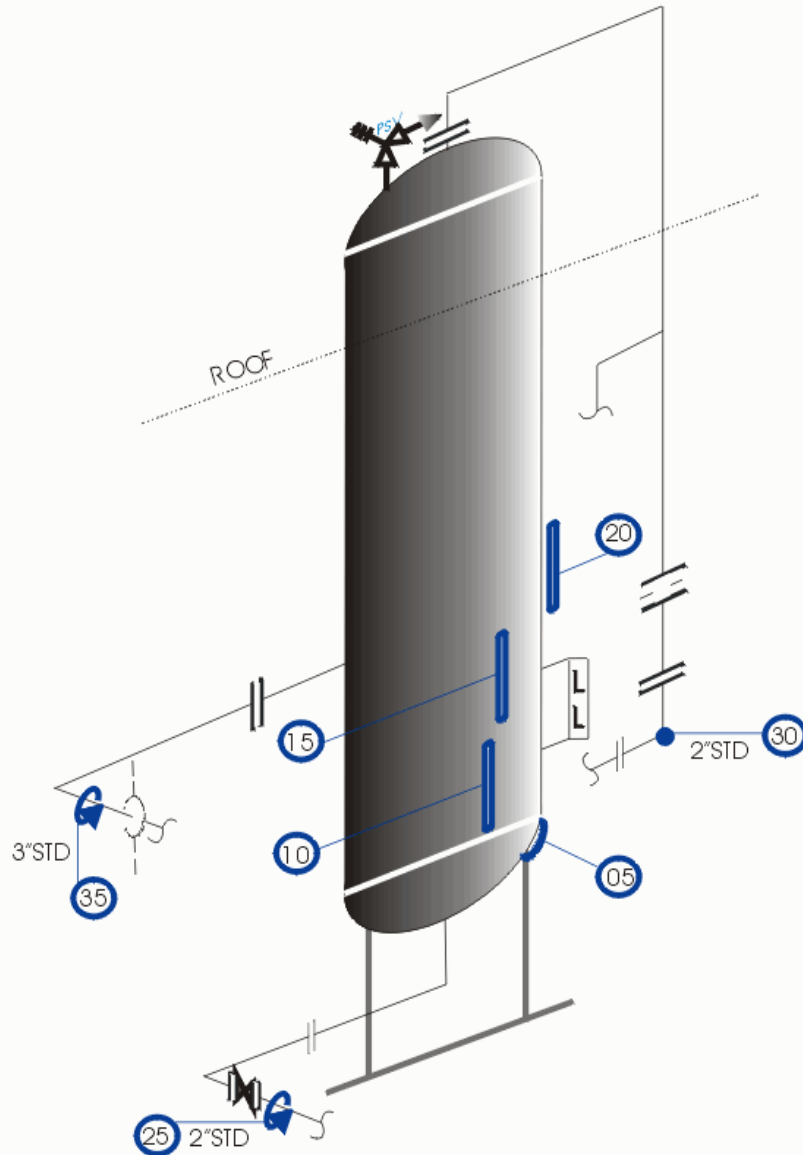
OWNER	DEVON CANADA	REG. NO	A2899376	NOTES
DISTRICT	CENTRAL	NAME	SEPARATOR	
FACILITY	MARION LAKE	SIZE	36" X 120"	
LSD	04-31HZ-37-17W4	OTHER	MLV-8
