Canadian Natural Resources Limited
GENERAL PRESSURE VESSEL INFORMATION **Job # 05.002893**

District: Fort St. John BC.	Skid No.
Facility: Jedney Field	Location (LSD): a-7-K/94-G-8
Vessel Name Equipment Number: Inlet Separator	
Orientation: Vertical	
Status: In Service	Regulatory Inspection

Inspected By: Keith Kowal (API 510 #26812)

Date: February 7th, 2009

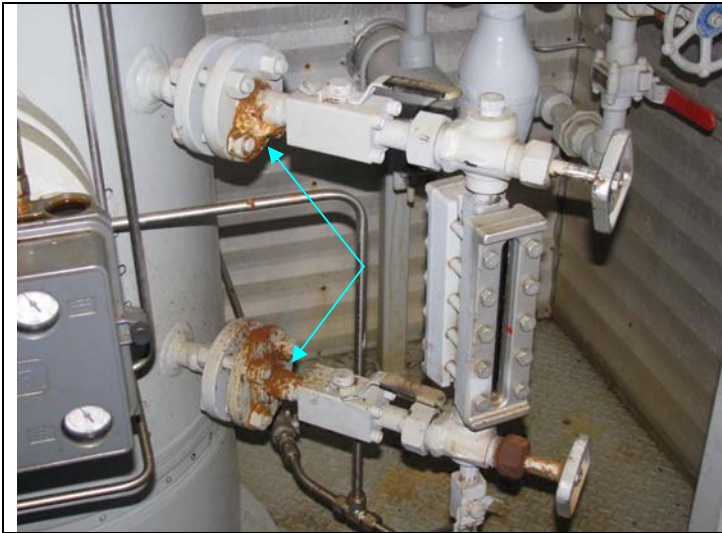
Weeping of the threaded fittings on the sight glass piping.

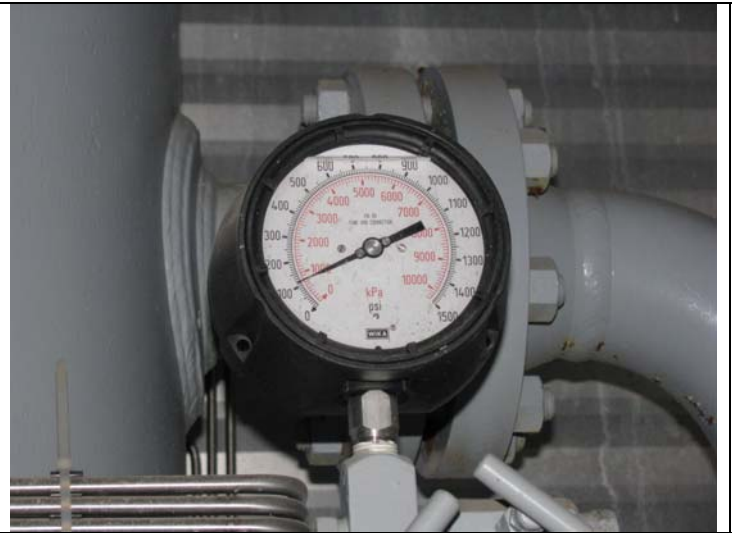
Gauges are in good condition and within range for the MAWP.

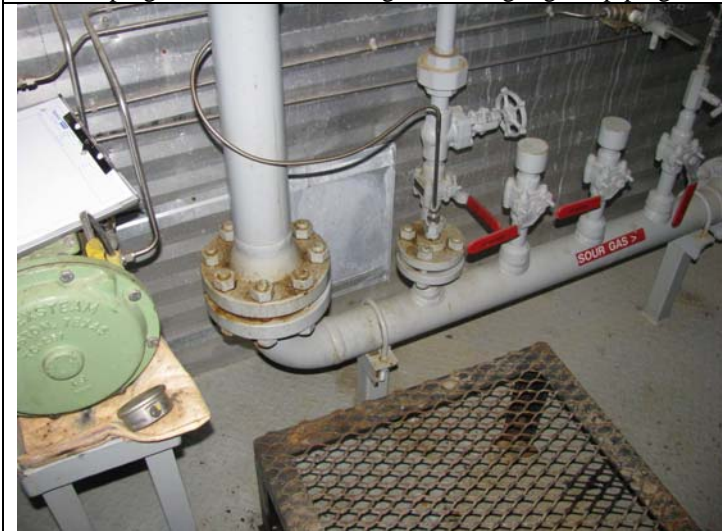
Outlet piping is in good condition and well supported.

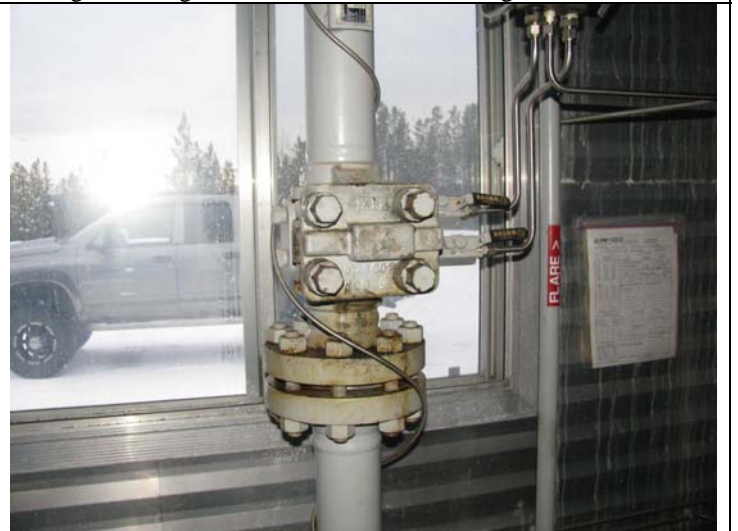
Choke is in good condition with no leaks.

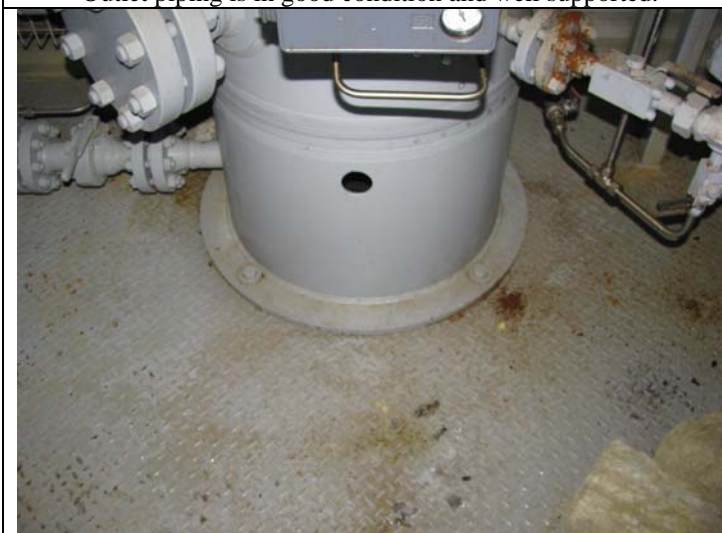
Skirt is in good condition with anchor bolts tight.
