**Canadian Natural Resources Limited
GENERAL PRESSURE VESSEL INFORMATION Job # 10.111579**

District: Fort St. John BC.	Skid No.
Facility: Jedney Field	Location (LSD): a-7-K/94-G-8
Vessel Name Equipment Number: Inlet Separator	
Orientation: Vertical	
Status: In Service	Regulatory Inspection

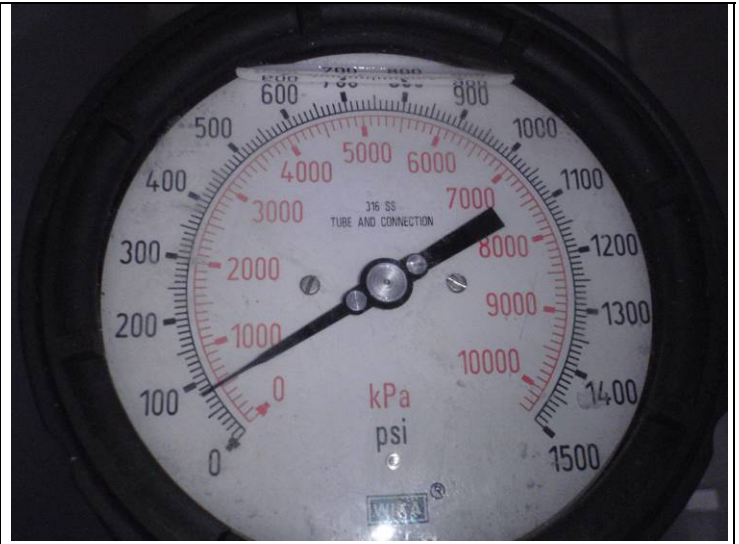
Gauges are in good condition and within range for the MAWP.

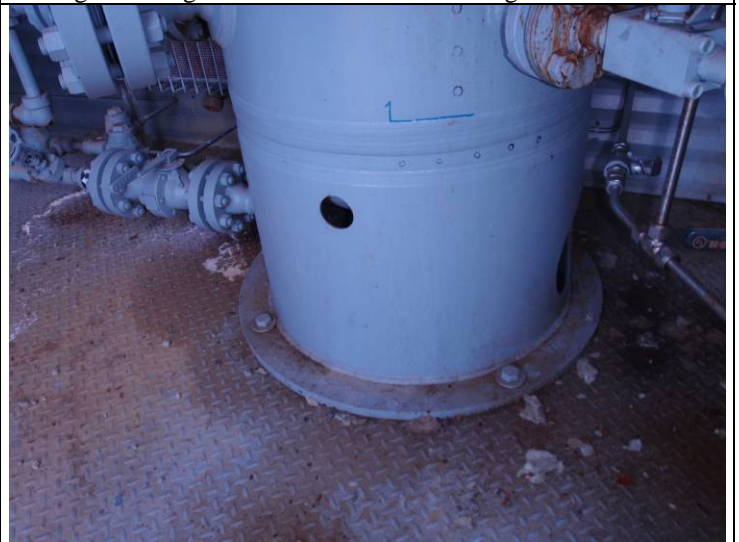
Skirt is in good condition with anchor bolts tight.
